Customer:
 Job Name:
 Title: #888 9" Quarry Stone

Customer:
 Job Name:
 Title: #888 9" Quarry Stone Assembled

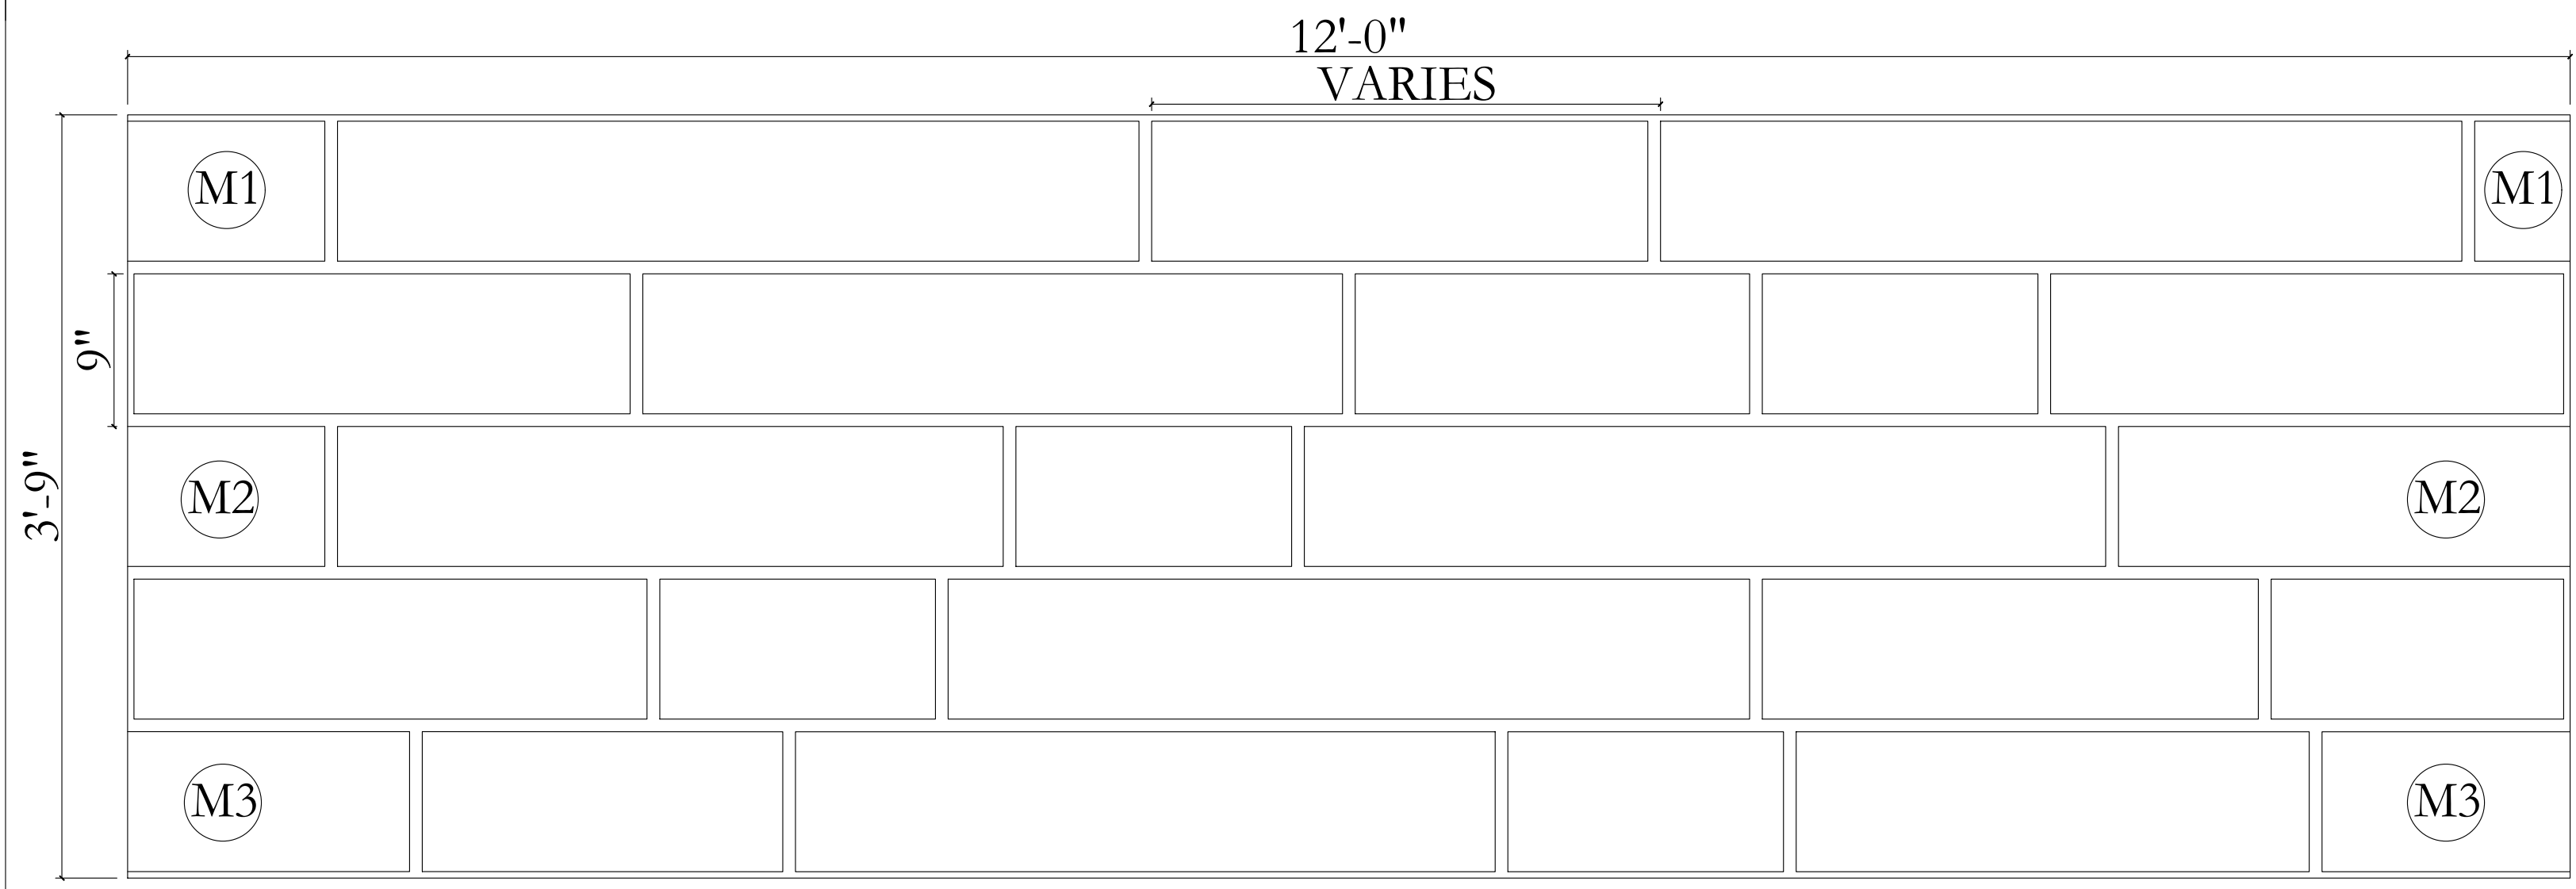
STONE LAYOUT FOR CONCEPT ONLY ACTUAL LAYOUT MAY VARY

24'-0"

A noticeable seam will occur if not properly sealed when stacking liners.

7'-6"
A noticeable seam will occur if not properly sealed when stacking liners.

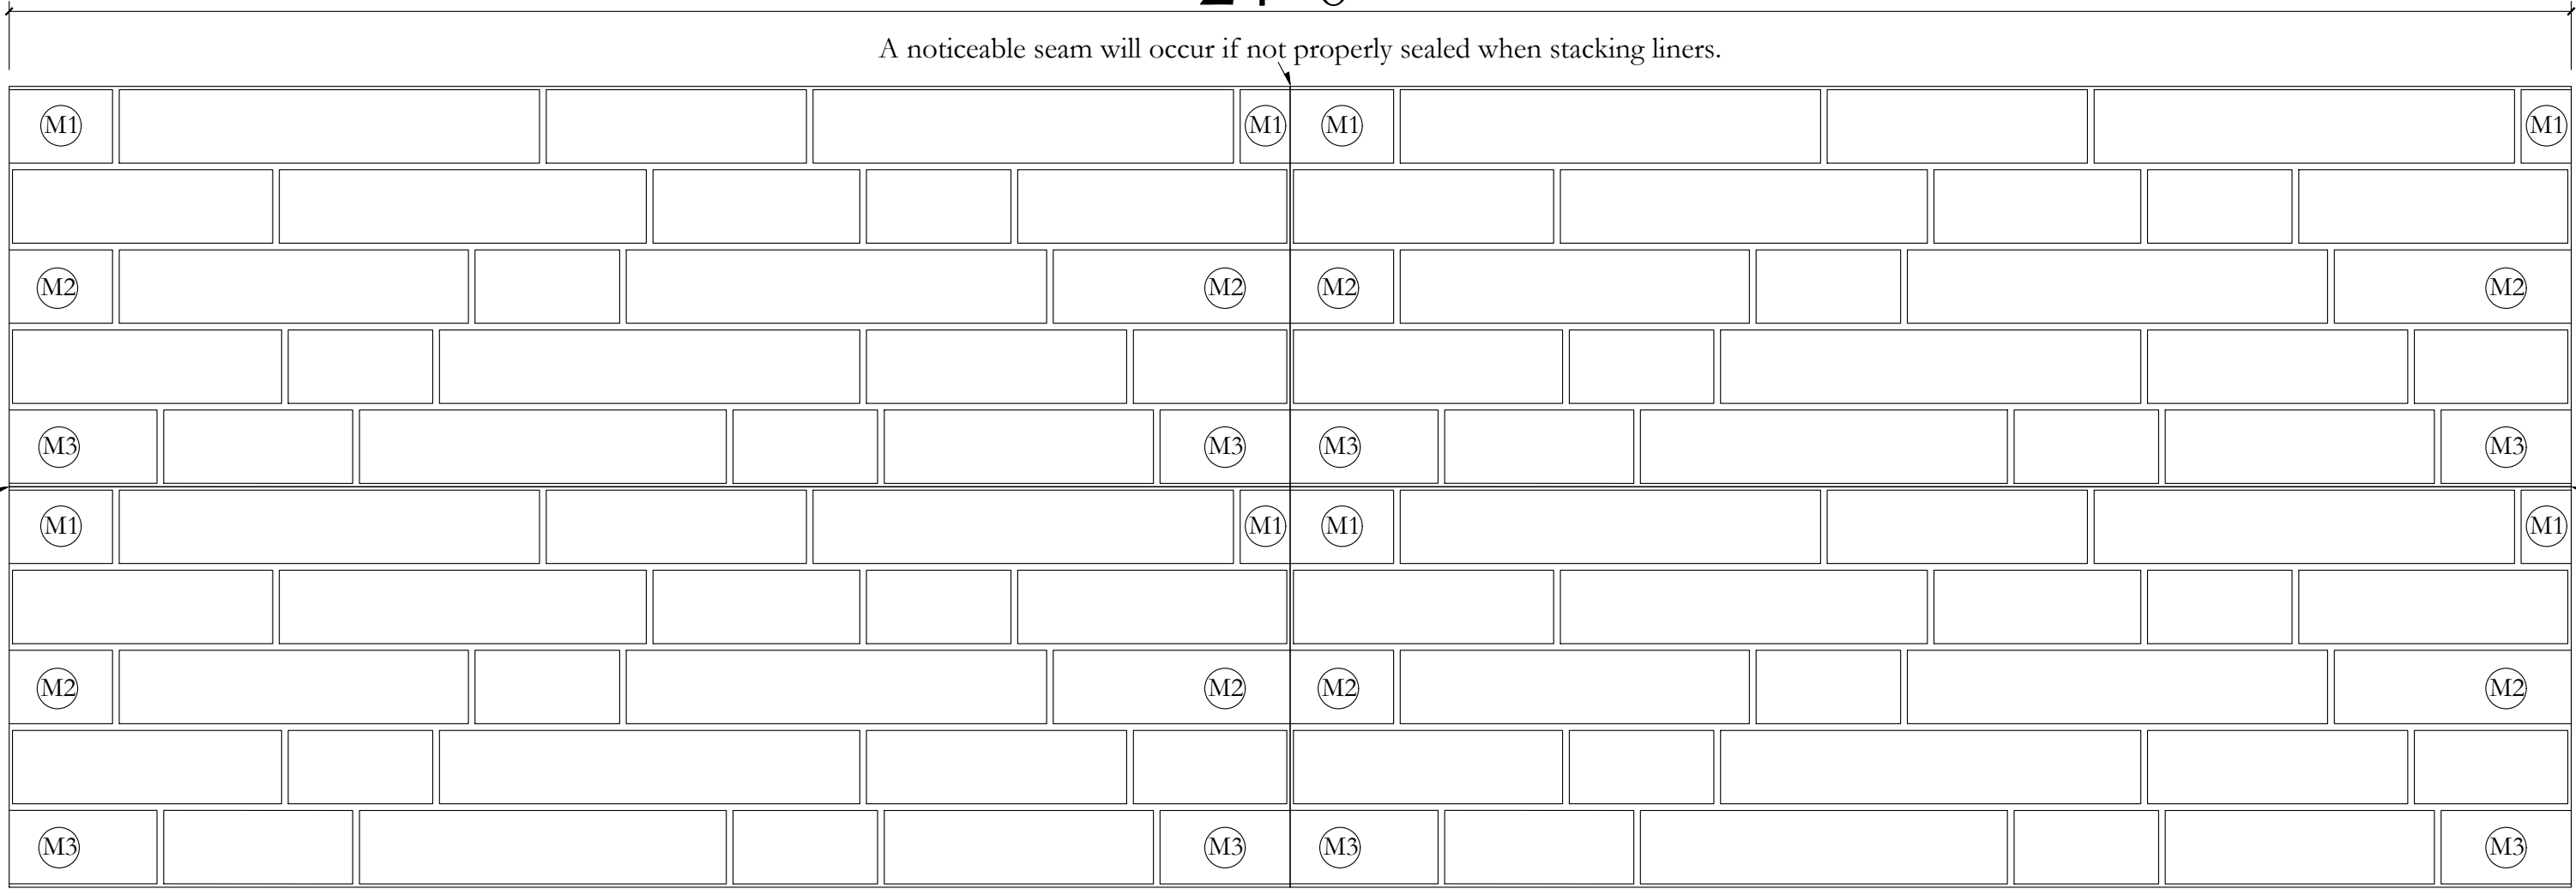
A noticeable seam will occur if not properly sealed when stacking liners.
