Customer:
 Job Name:
 Title: #917 8"x8" Split Block Running bond

Customer:
 Job Name:
 Title: #917 8"x8" Split Block Running Bond Assembled

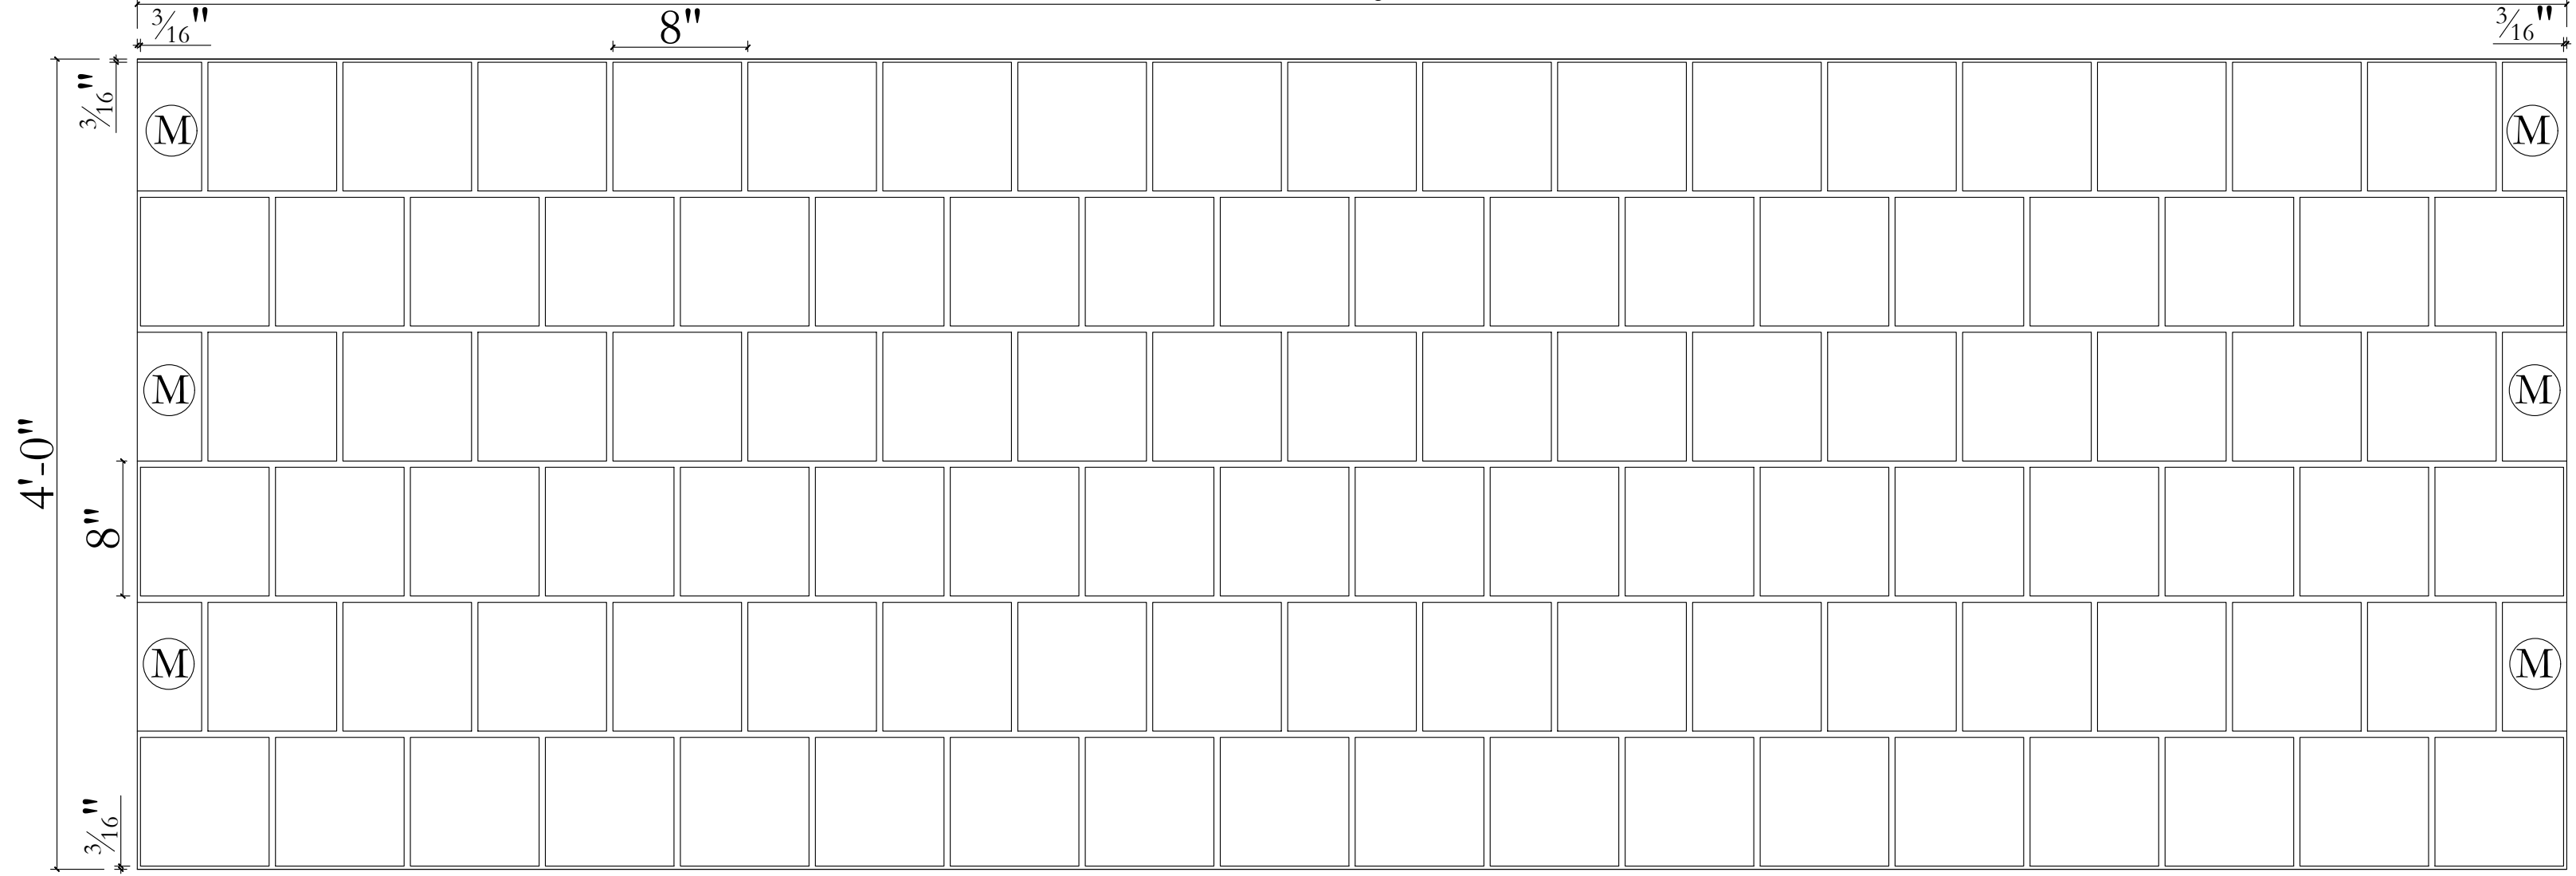
Typical section

12'-0"

Texture Not Shown For Clarity

▲ .060 HIPS Formliner

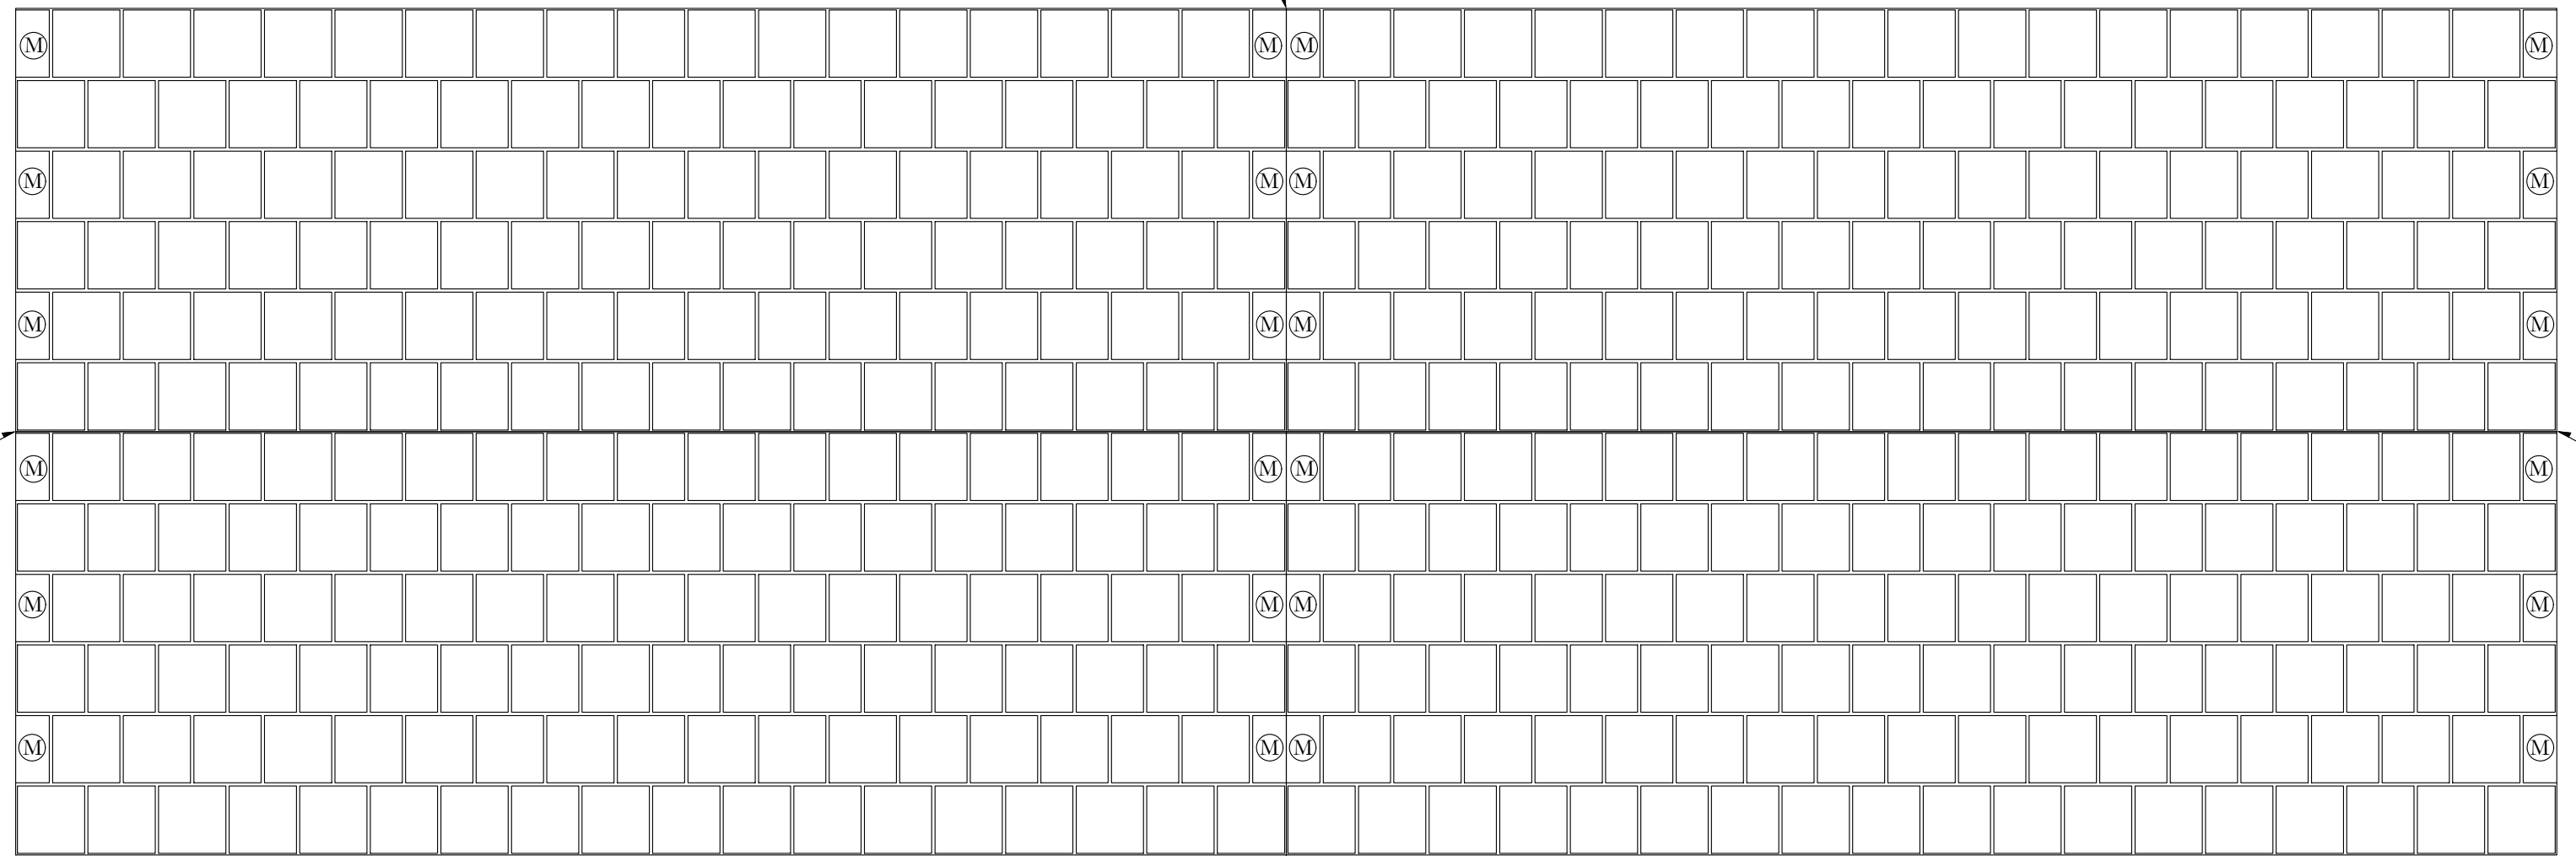
24'-0"

A noticeable seam will occur if not properly sealed when stacking liners.

8'-0"
A noticeable seam will occur if not properly sealed when stacking liners.
