ITEM # 305621

Customer:	
Job Name:	
Title:	#922 Cleaved Limestone

Customer:	
Job Name:	
Title:	#922 Cleaved Limestone Assembled

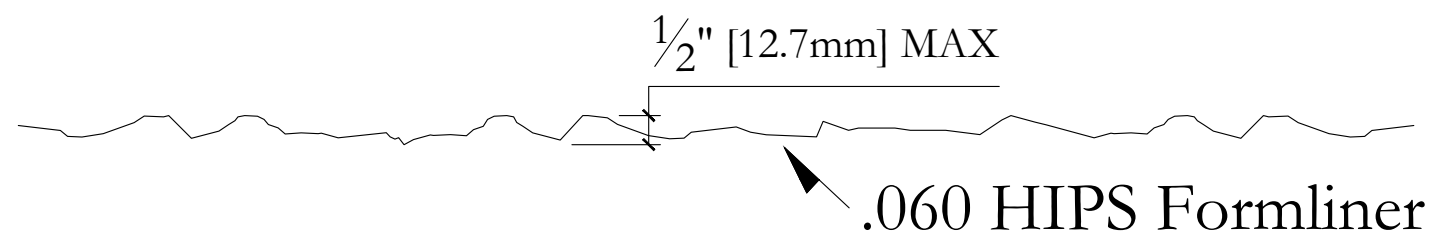
12'-0"

4'-0"

Typical section
