Customer:  
 Job Name:  
 Title: #931 Dry Fit Ashlar

Customer:  
Job Name:  
Title: #931 Dry Fit Ashlar Assembled

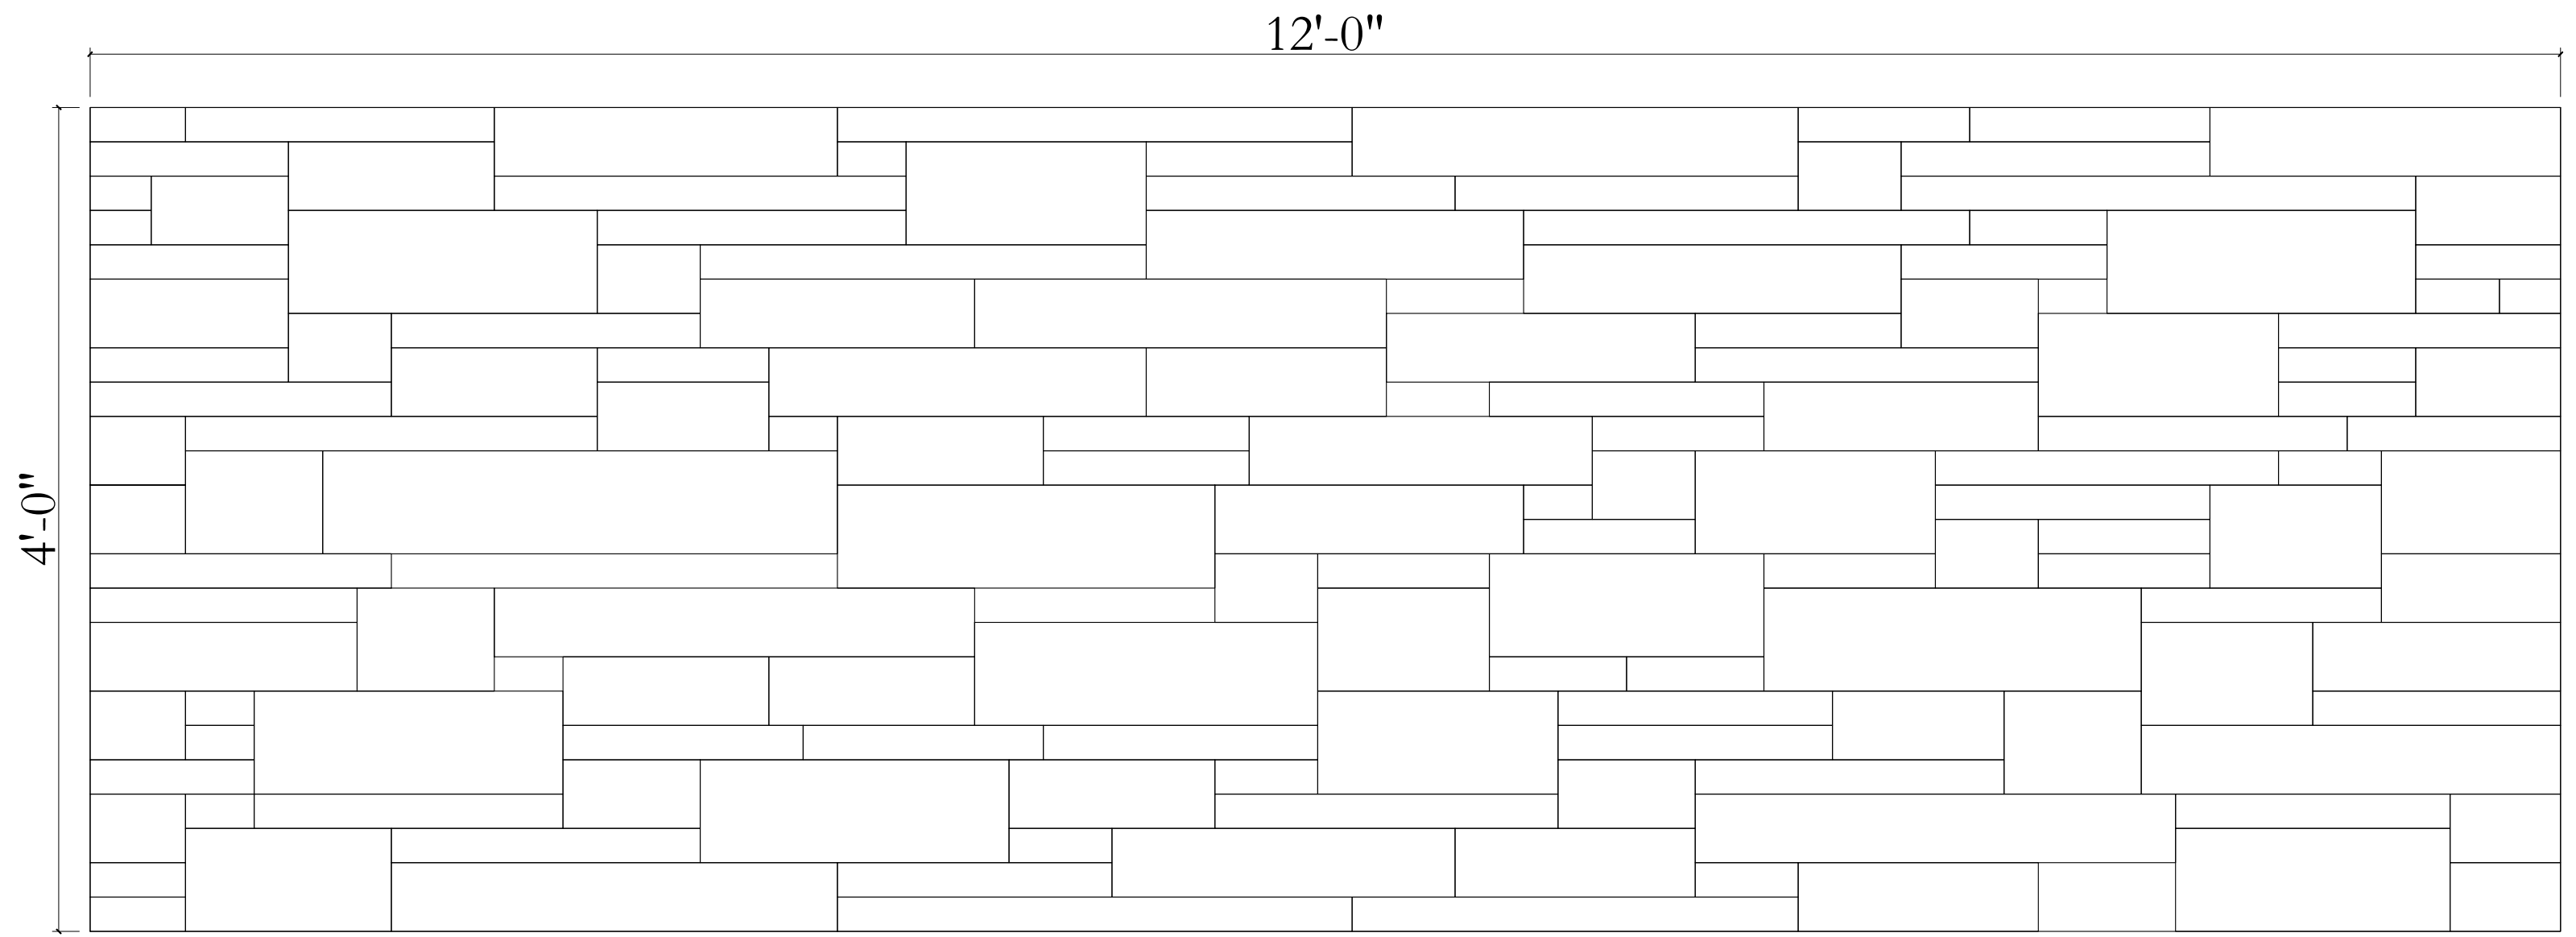
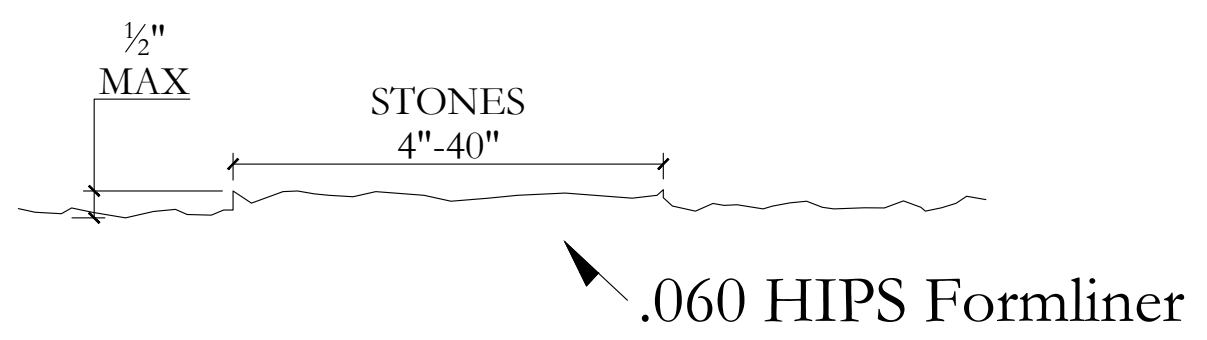
Typical Section

Stone layout for visual reference only, actual stone layout determined by AP

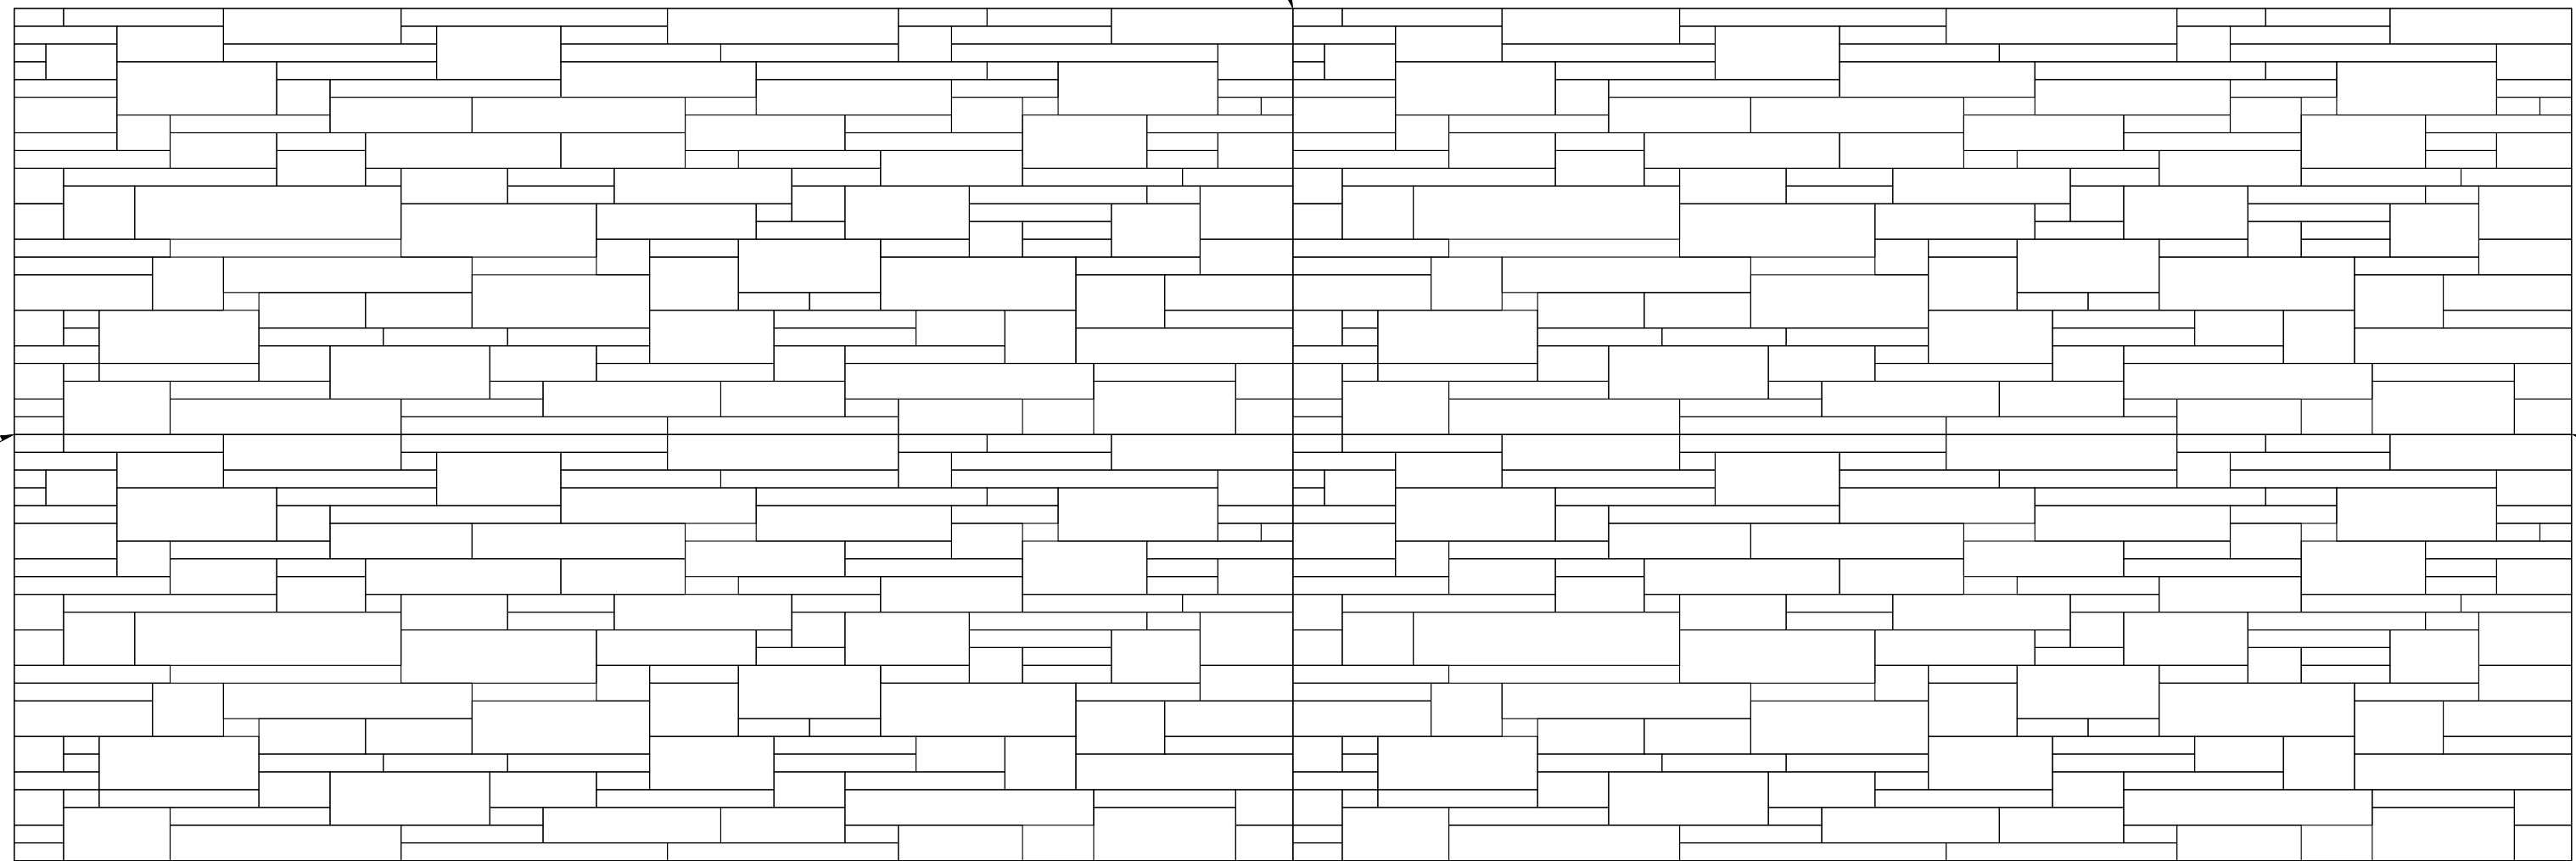
A noticeable seam will occur if not properly sealed when stacking liners.
