Customer:  
 Job Name:  
 Title: #936B 3/4 Split Limestone

Customer:  
Job Name:  
Title: #936B 3/4 Split Limestone Assembled

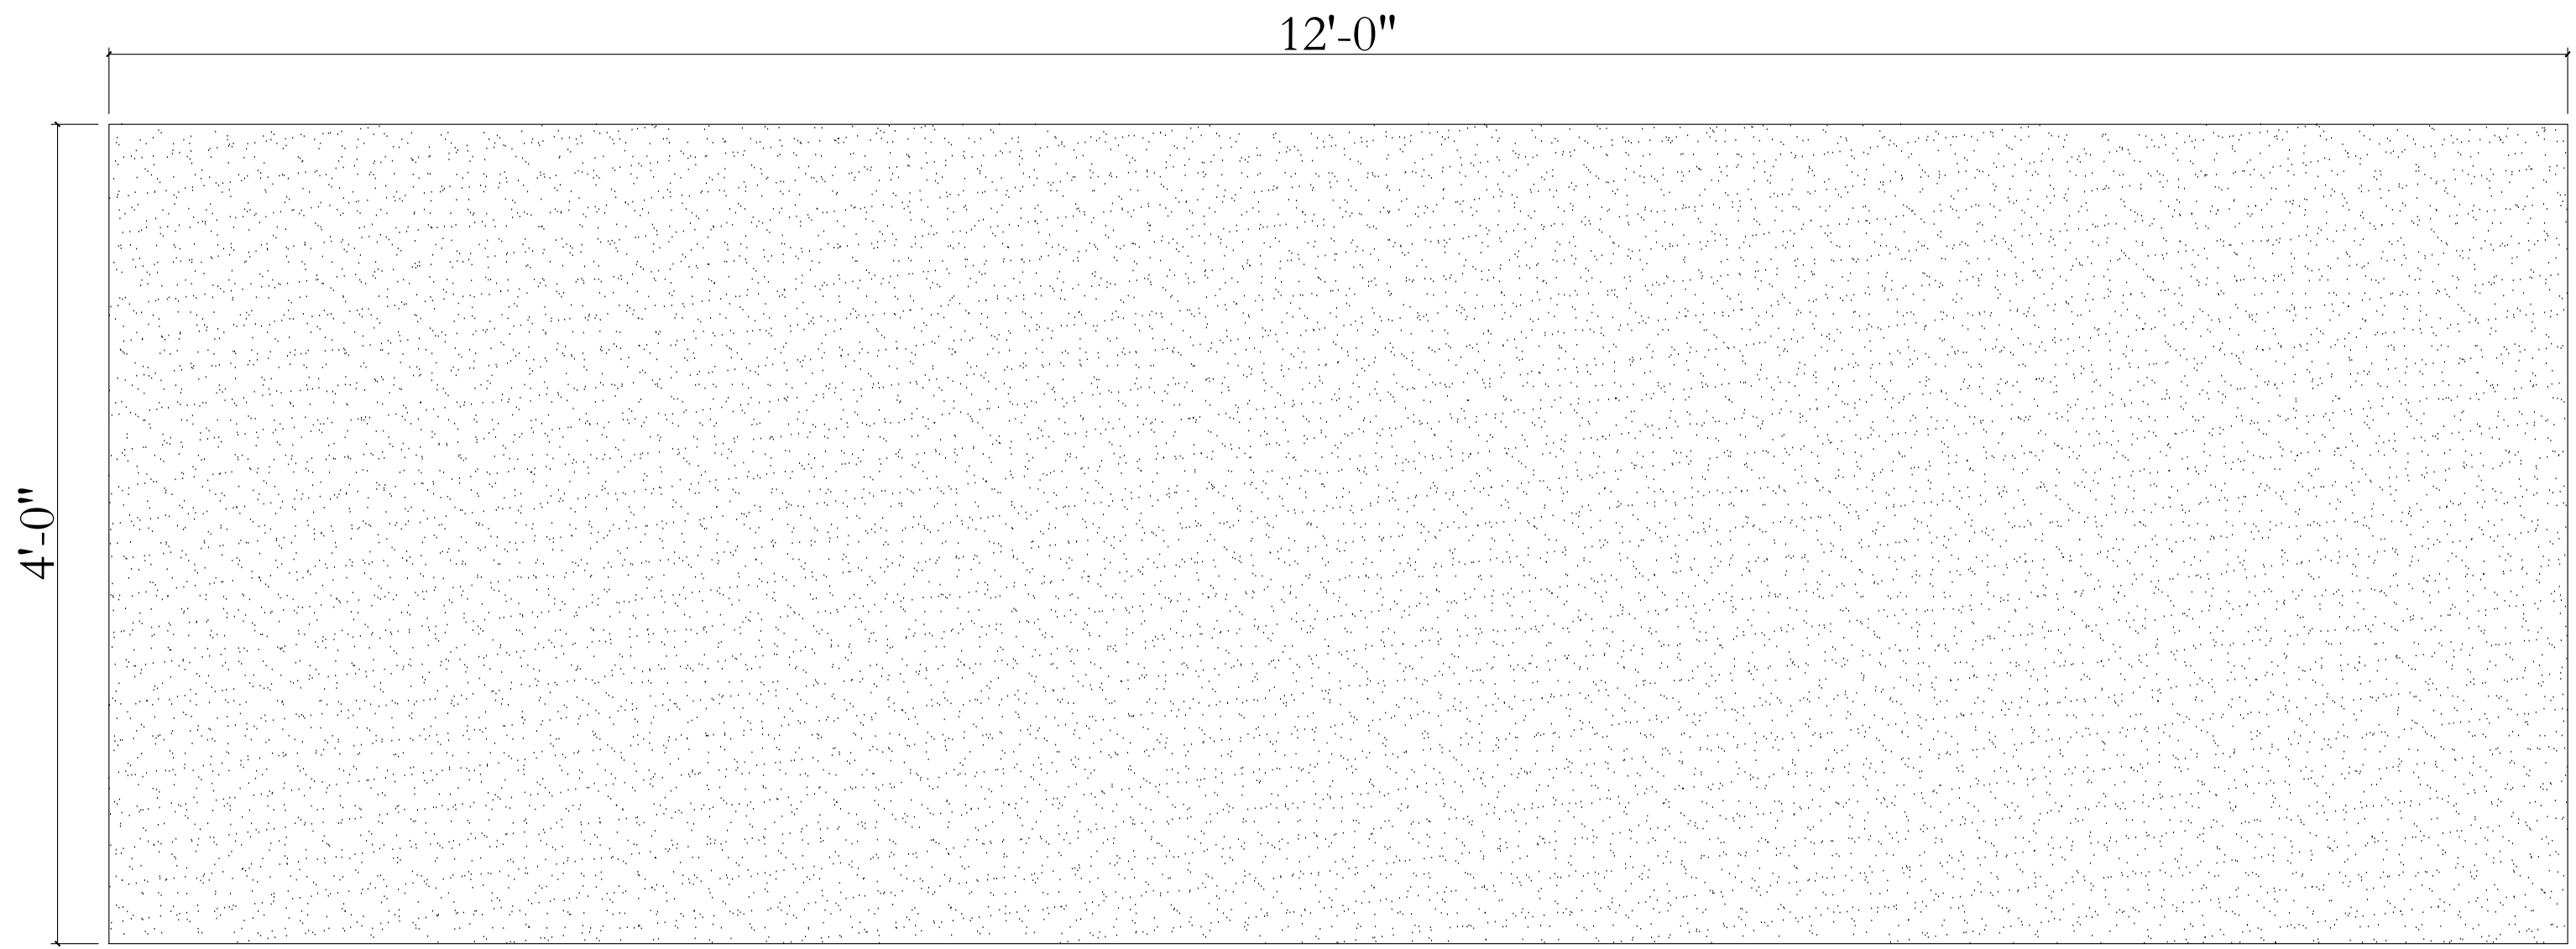
Typical Section

Texture for visual reference only

A noticeable seam will occur if not properly sealed when stacking liners.

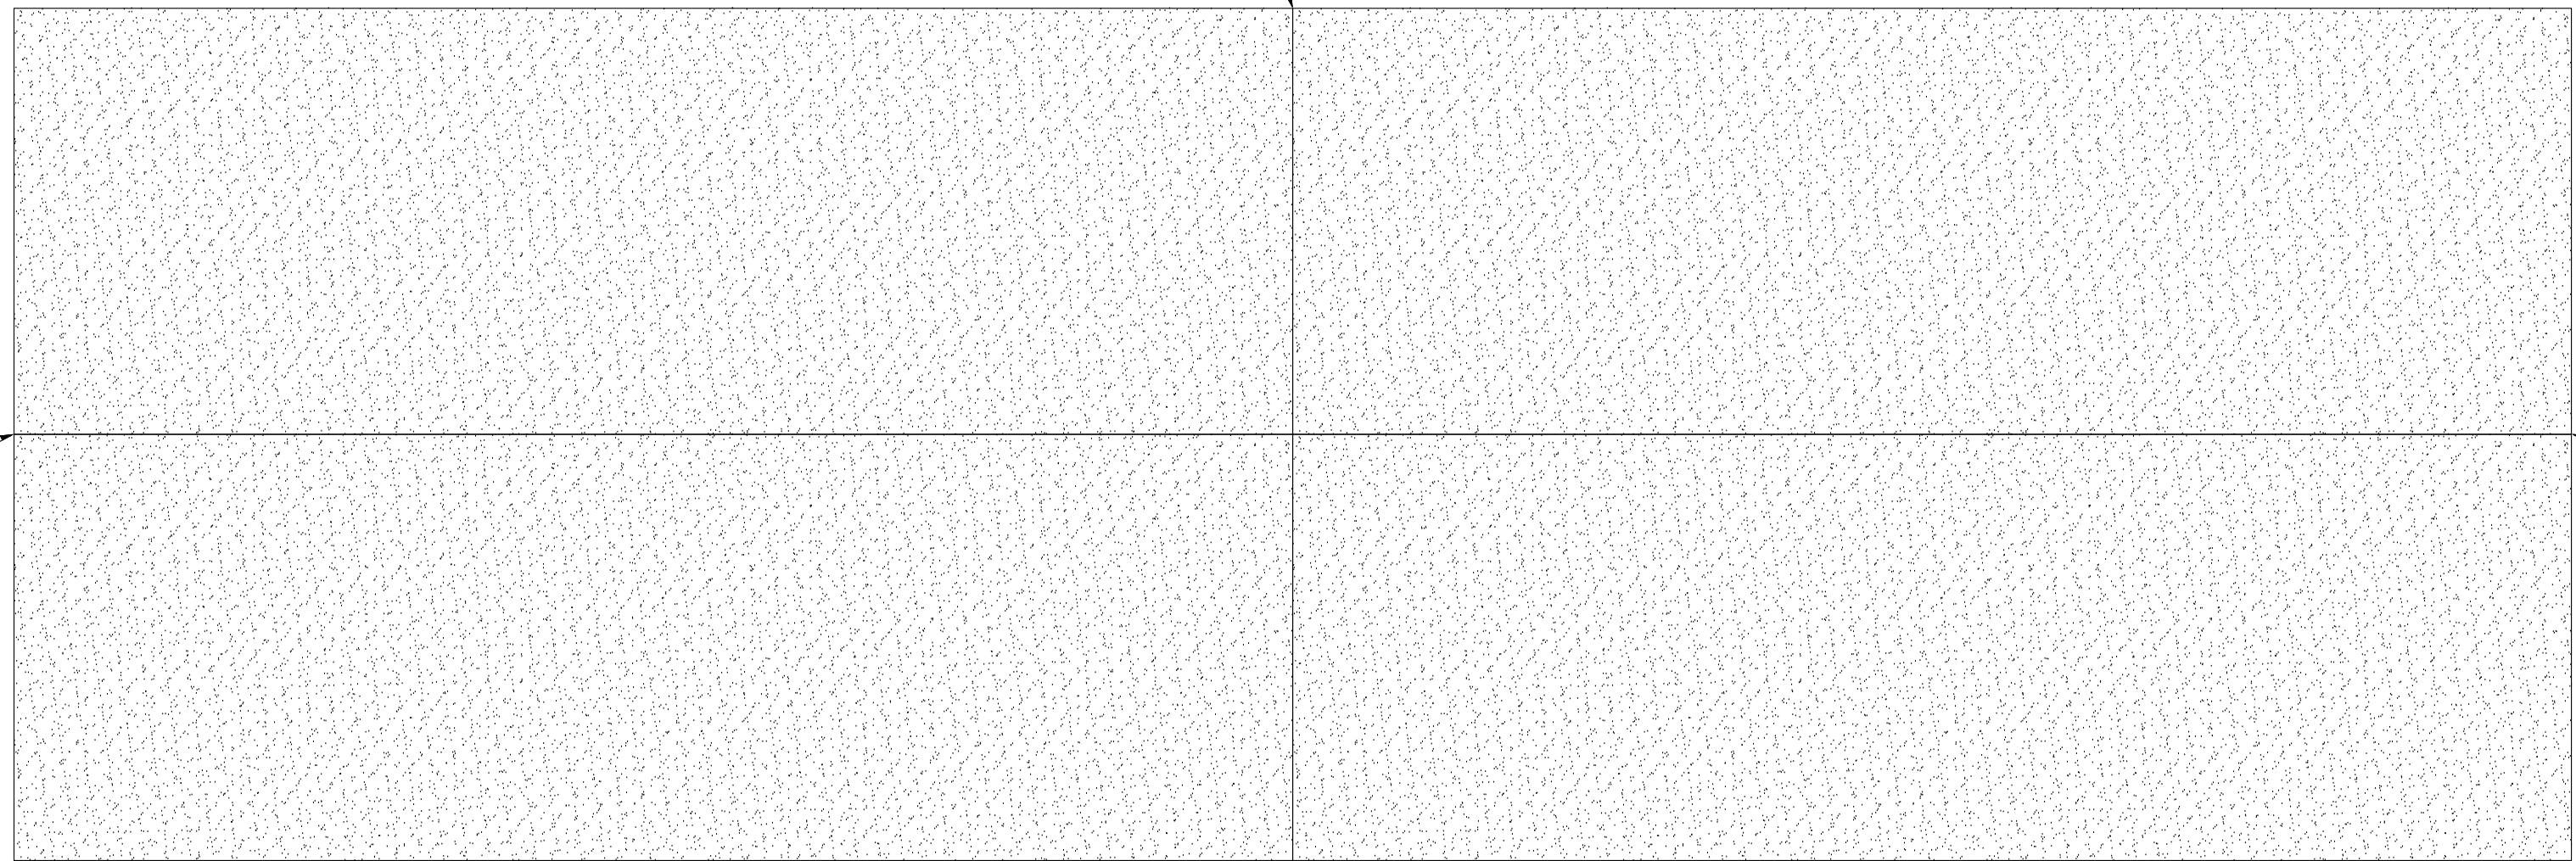
A noticeable seam will occur if not properly sealed when stacking liners.
