Customer:
 Job Name:
 Title: #892A 12in Quarry Stone

Customer:
 Job Name:
 Title: #892A 12in Quarry Stone Assembled

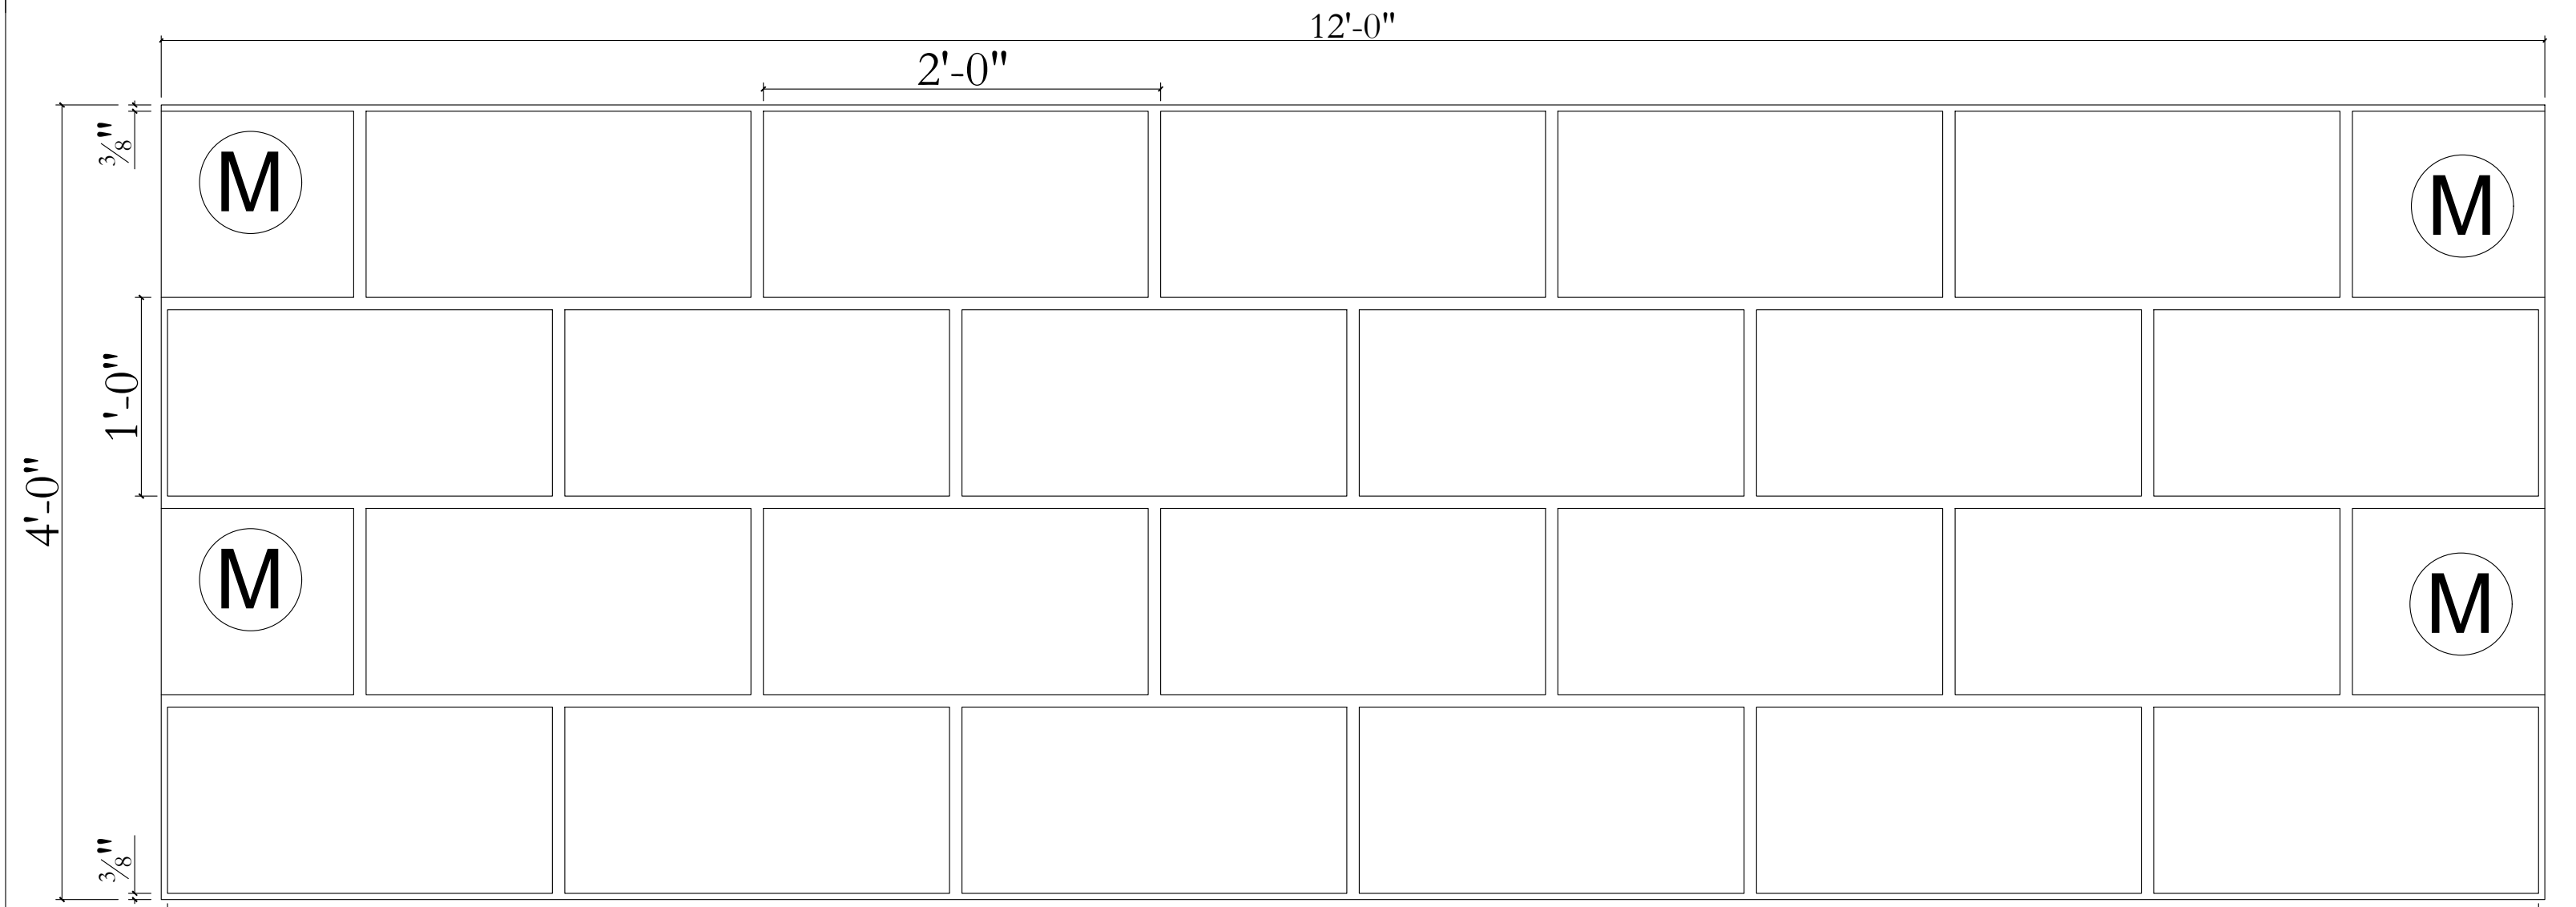
M DENOTES MATCHED STONES LT TO RIGHT

24'-0"
