1035 Little Gap Highway	Customer:					
	Palmerton PA, 18071 610-826-4579	Job Name:					
THERMOFORMING, LLC	Fax: 610-826-4614	Title: #892B 12in Quarry Stone Type 2

ITEM # 309060						
Drawn By:	Date:					
11 ,	Date:					
Scale: None	Tolerance: $\pm 3/16$					
Page: 1	Drawing Number:

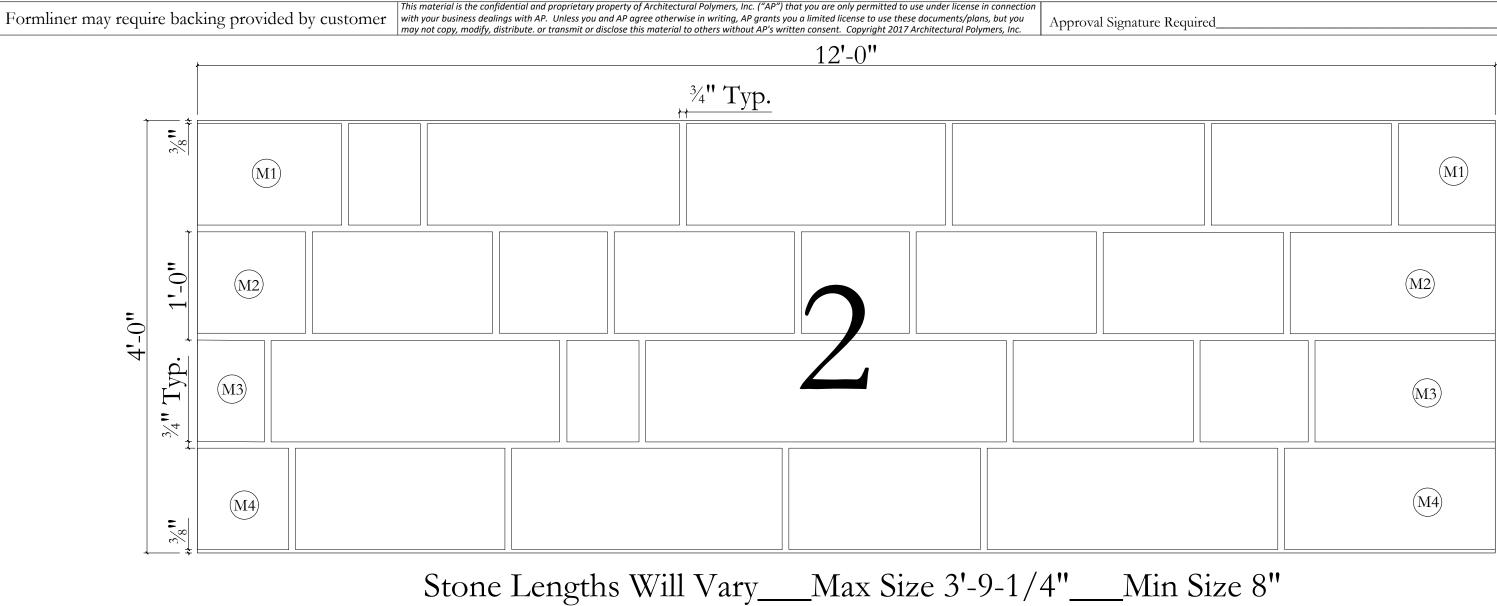
Actual Stone Layout to be determined by AP

Match Stone =Typical Section = $\frac{3}{4}$ " $\frac{1}{4}$ $\frac{1}{4}$.080 HIPS Formliner

Formliner may require backing provided by c	customer
---	----------

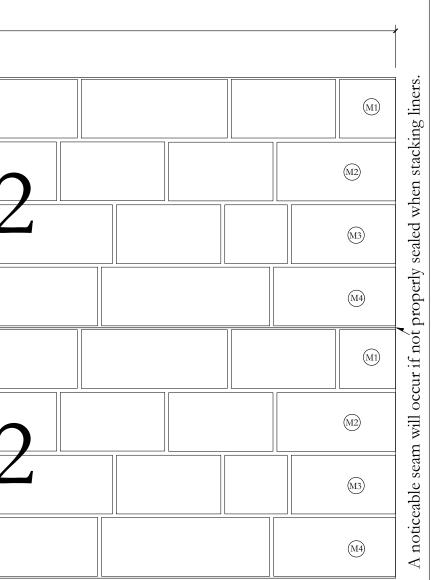
Customer:	
Job Name:	
<i>J</i> =	
Title:	
	$\#902P$ 12 \sim Order way Started Target 2 Associated 1.1
	#892B 12in Quarry Stone Type 2 Assembled

А	noticeable	e seam	n will o cc	ur if not	proper	ly seal	ed wh	en stac	king liner	5.	
-	ng liners.	MI							(M1)	Ml						
	ien stacki	(M2)							(M2)	(M2)						
	sealed when stacking liners	(M3)		Z					(M3)	(M3)						
"0		(M4)							(M4)	(M4)						
8-	A noticeable seam will occur if not properly	(M1)							(M1)	Ml						
	n will occ	(M2)							(M2)	(M2)						
	eable sear	(M3)		2					(M3)	(M3)						
	A notice	(M4)							(M4)	M4

A noticeable seam will occur if not properly sealed when stacking liners.
