Customer:
 Job Name:
 Title: #898A Rustic Ashlar

Customer:	
Job Name:	
Title:	#898A Rustic Ashlar Assembled

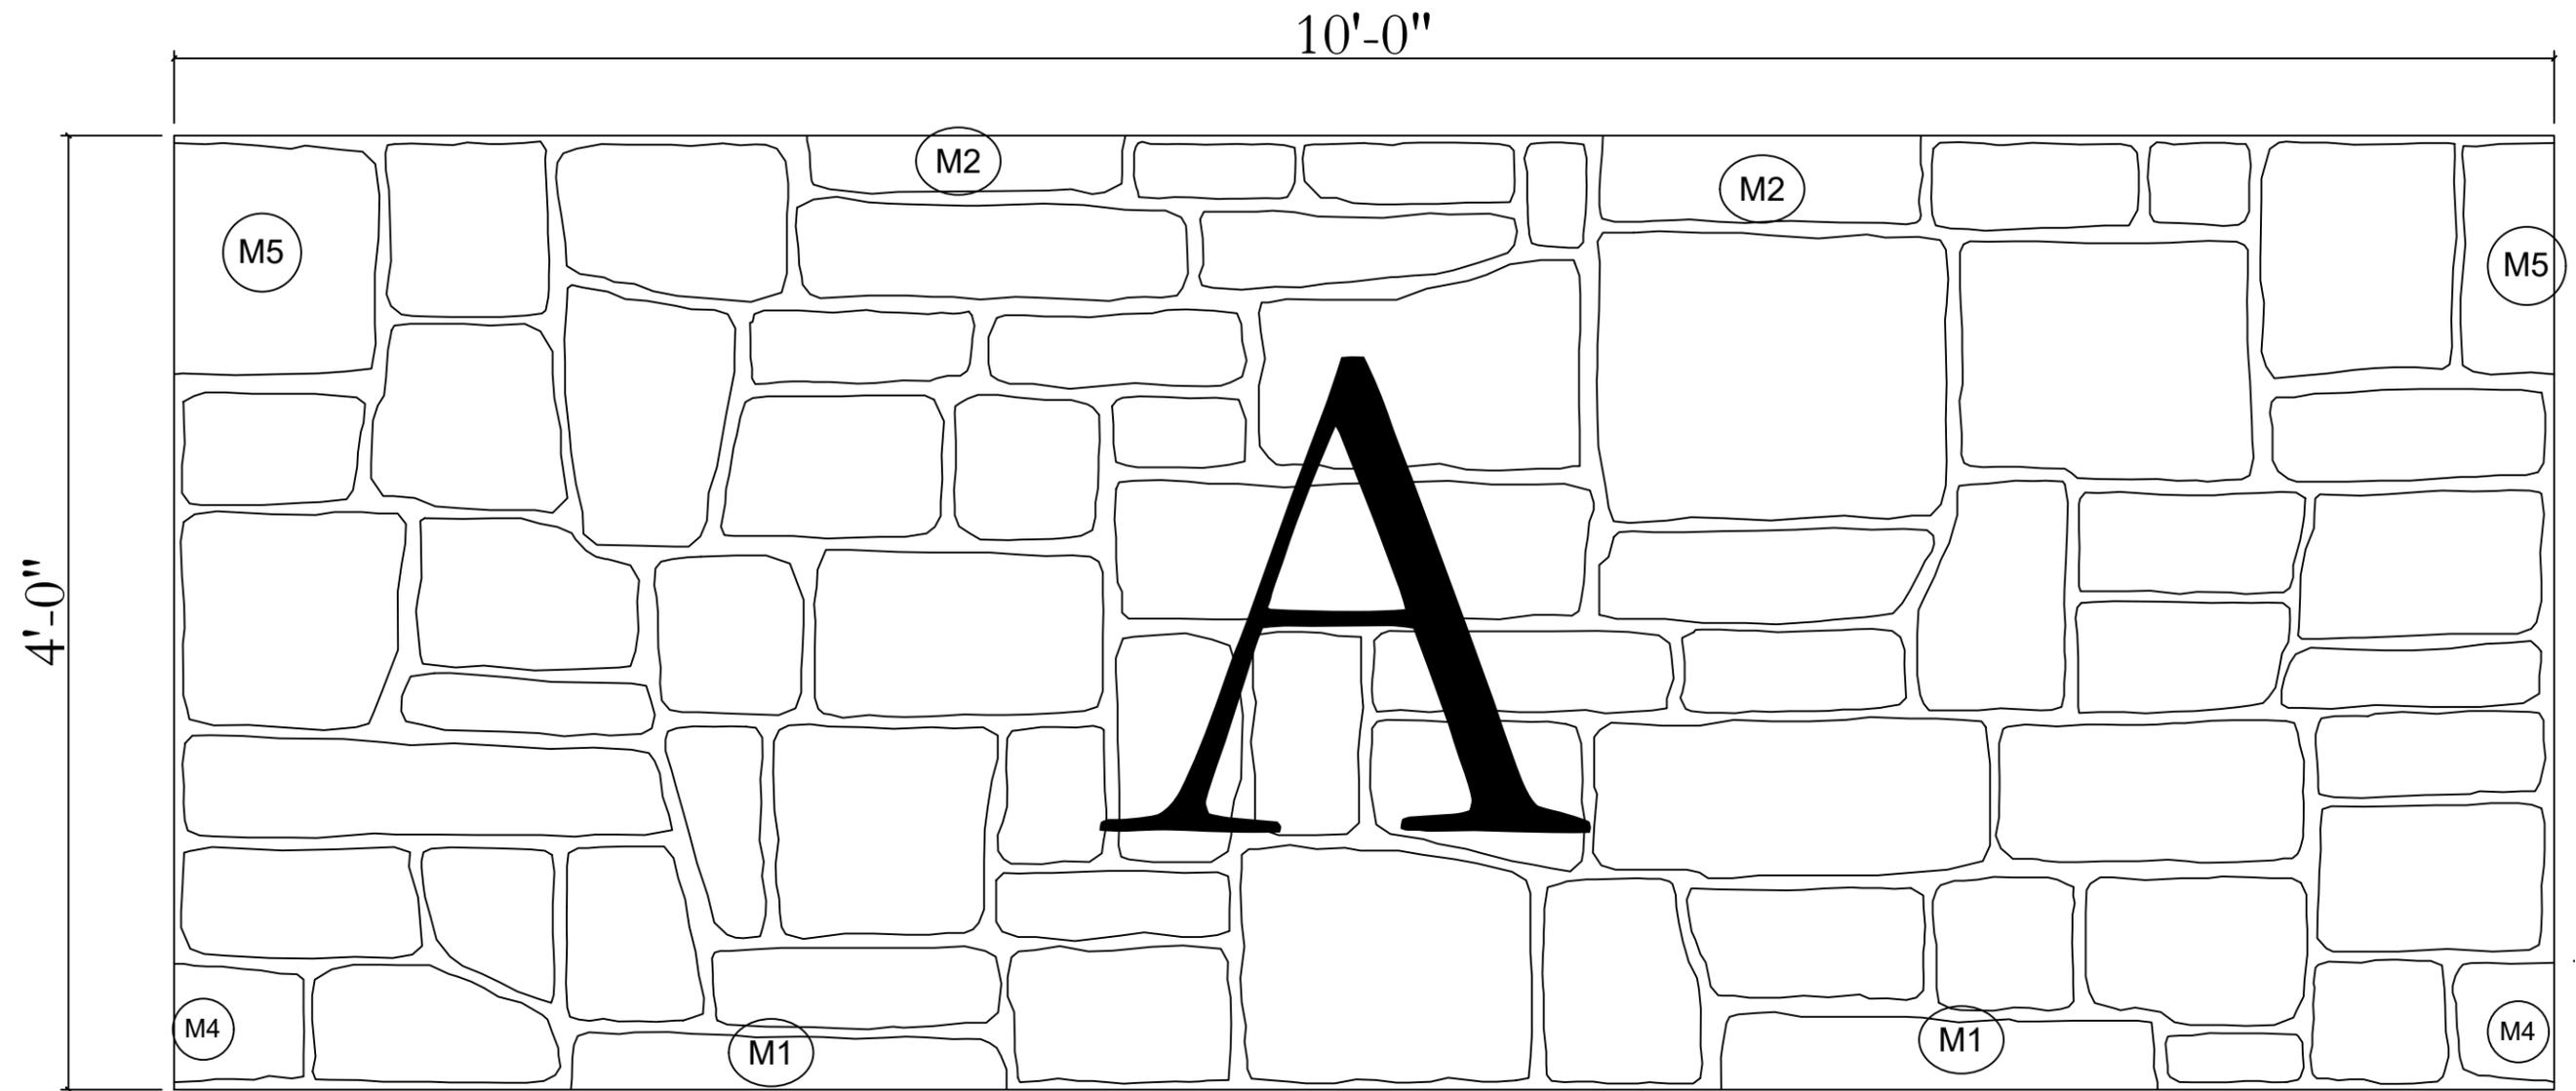
STONE LAYOUT FOR CONCEPT ONLY ACTUAL LAYOUT MAY VARY

20'-0"

A noticeable seam will occur if not properly sealed when stacking liners.

8'-0"
A noticeable seam will occur if not properly sealed when stacking liners.

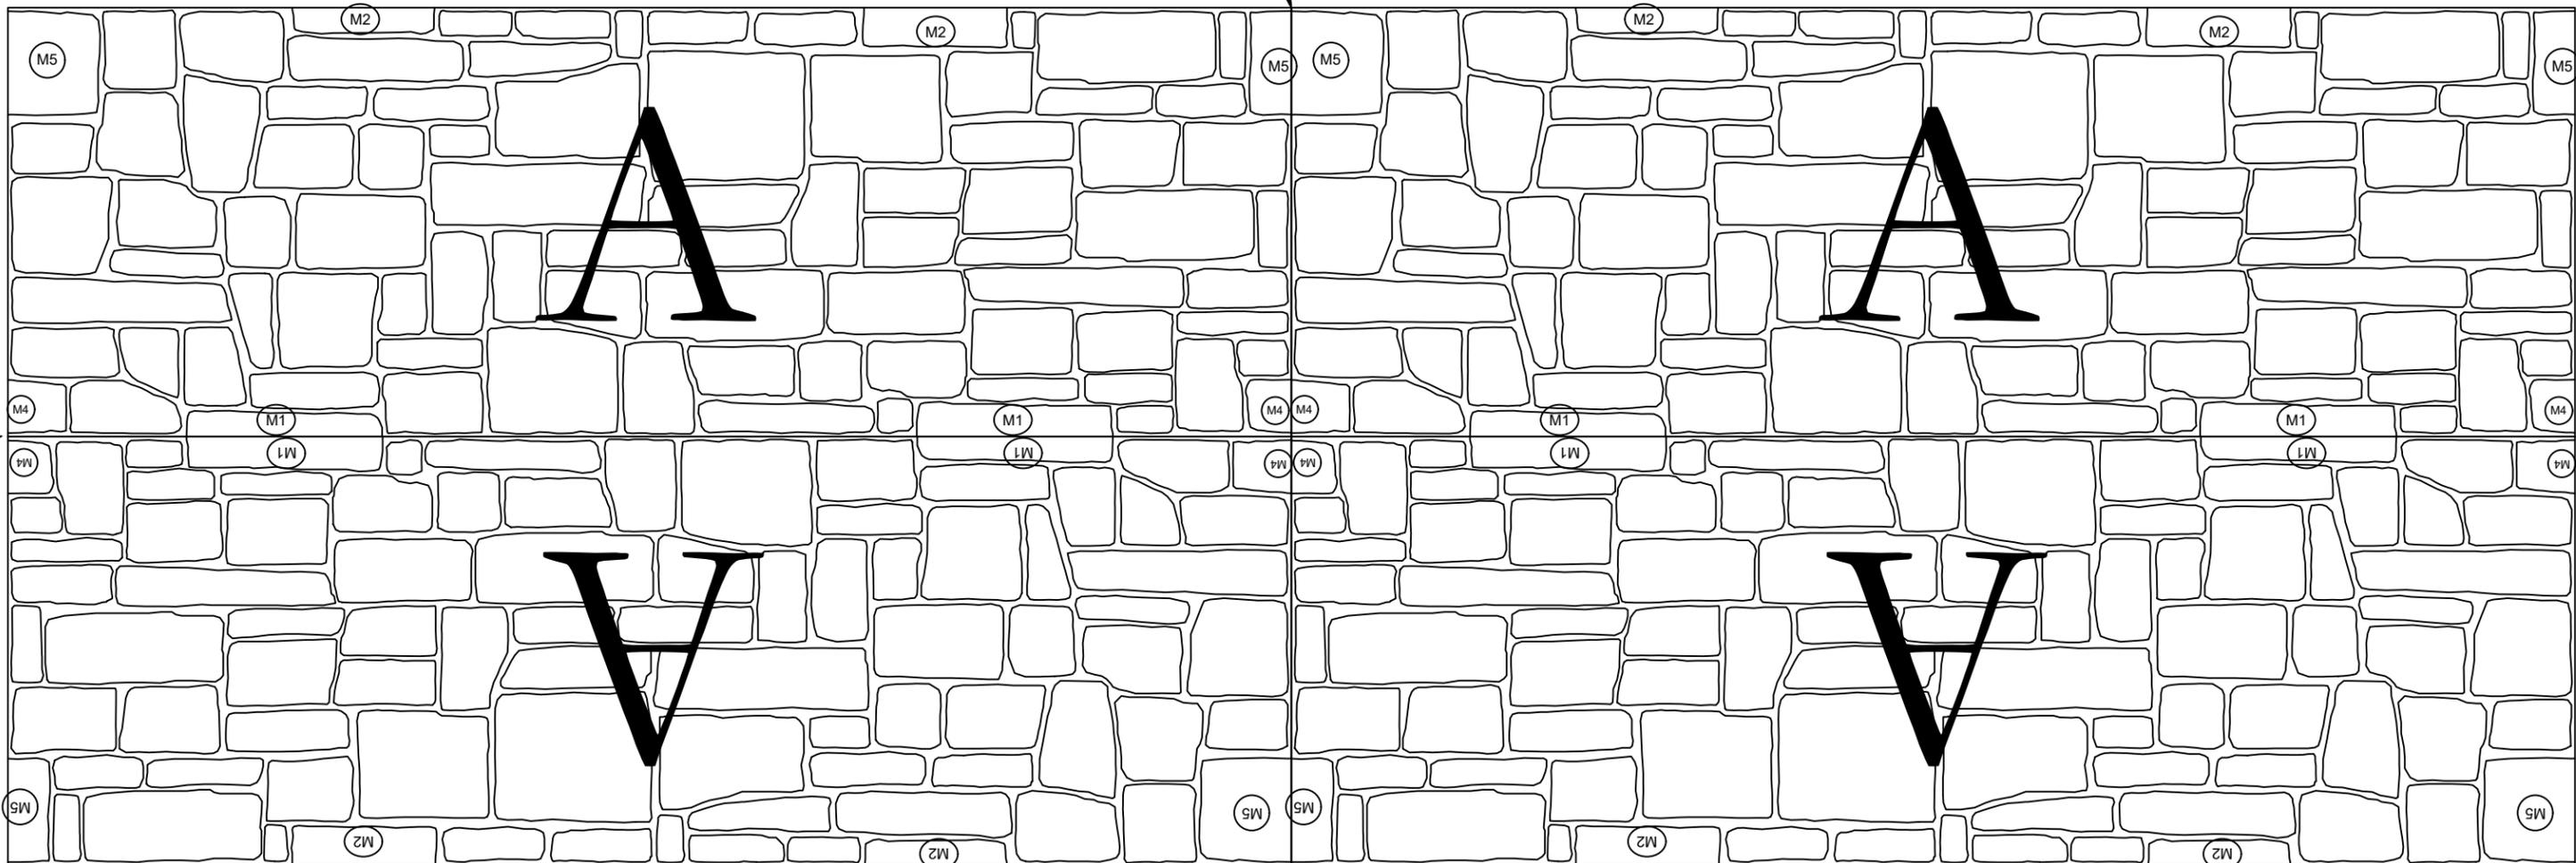
A noticeable seam will occur if not properly sealed when stacking liners.
