Customer:  
 Job Name:  
 Title: #904A Ashlar Stone

Customer: \_\_\_\_\_  
 Job Name: \_\_\_\_\_  
 Title: #904A Ashlar Stone Assembled

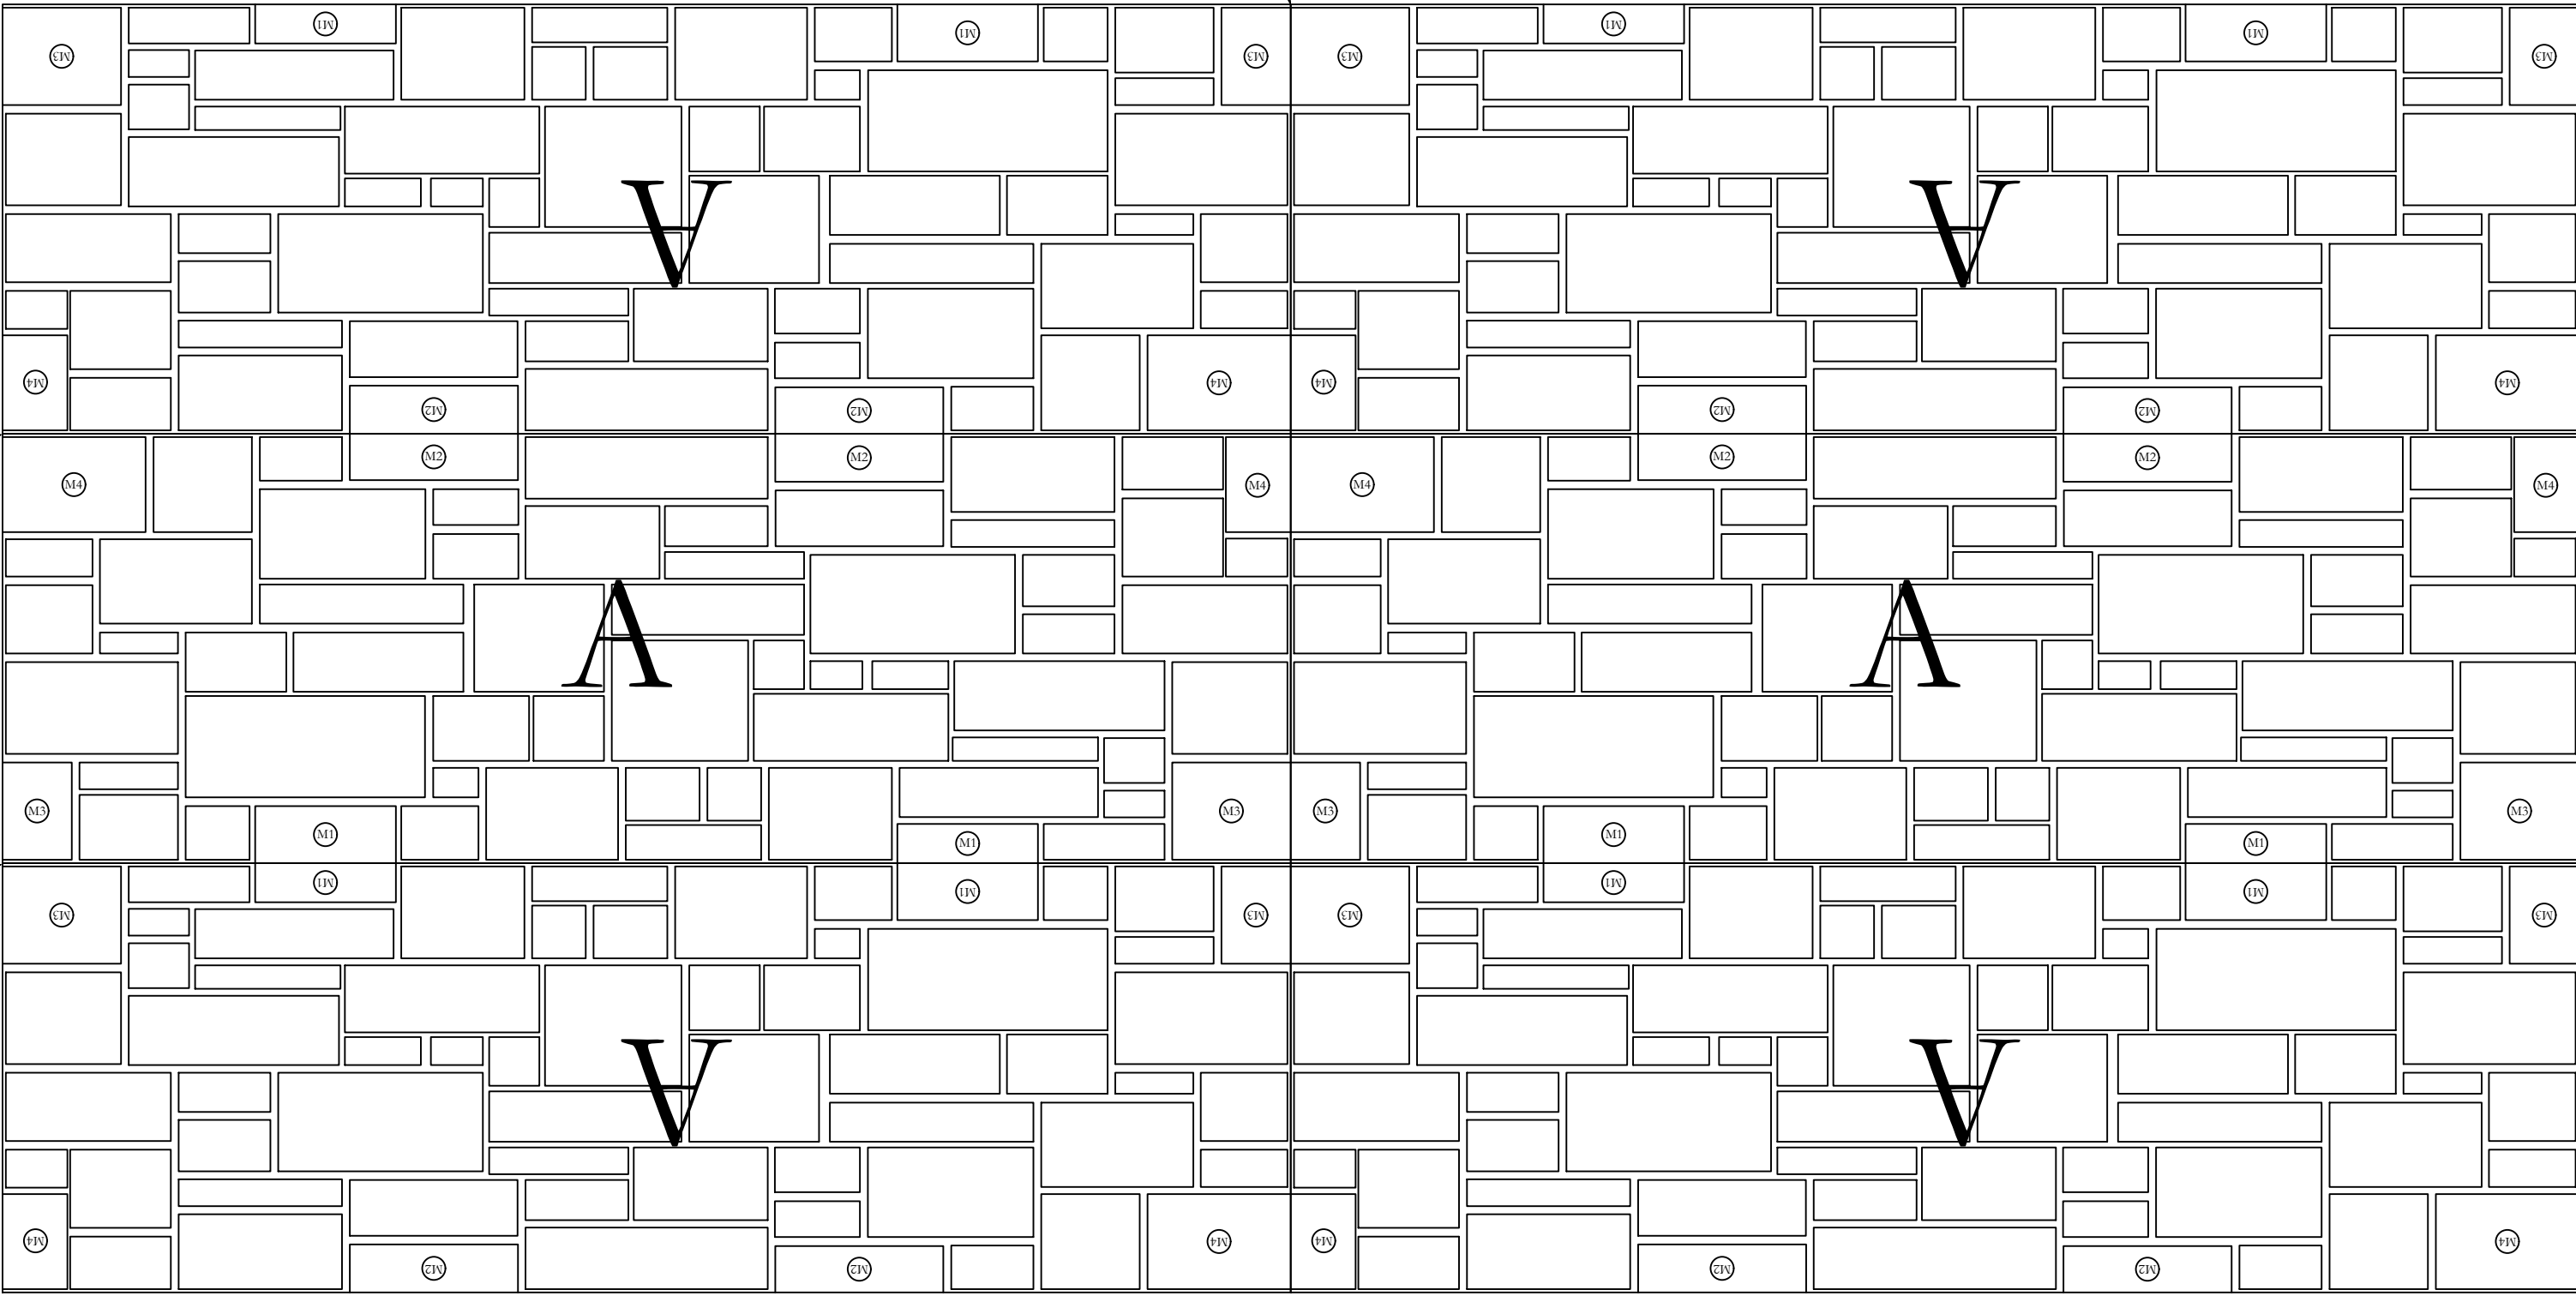
A noticeable seam will occur if not properly sealed when stacking liners.
