Customer:	
Job Name:	
Title:	#9110 Large Stone Ohio Drystack

Customer:
 Job Name:
 Title: #9110 Large Stone Ohio Drystack Assembled

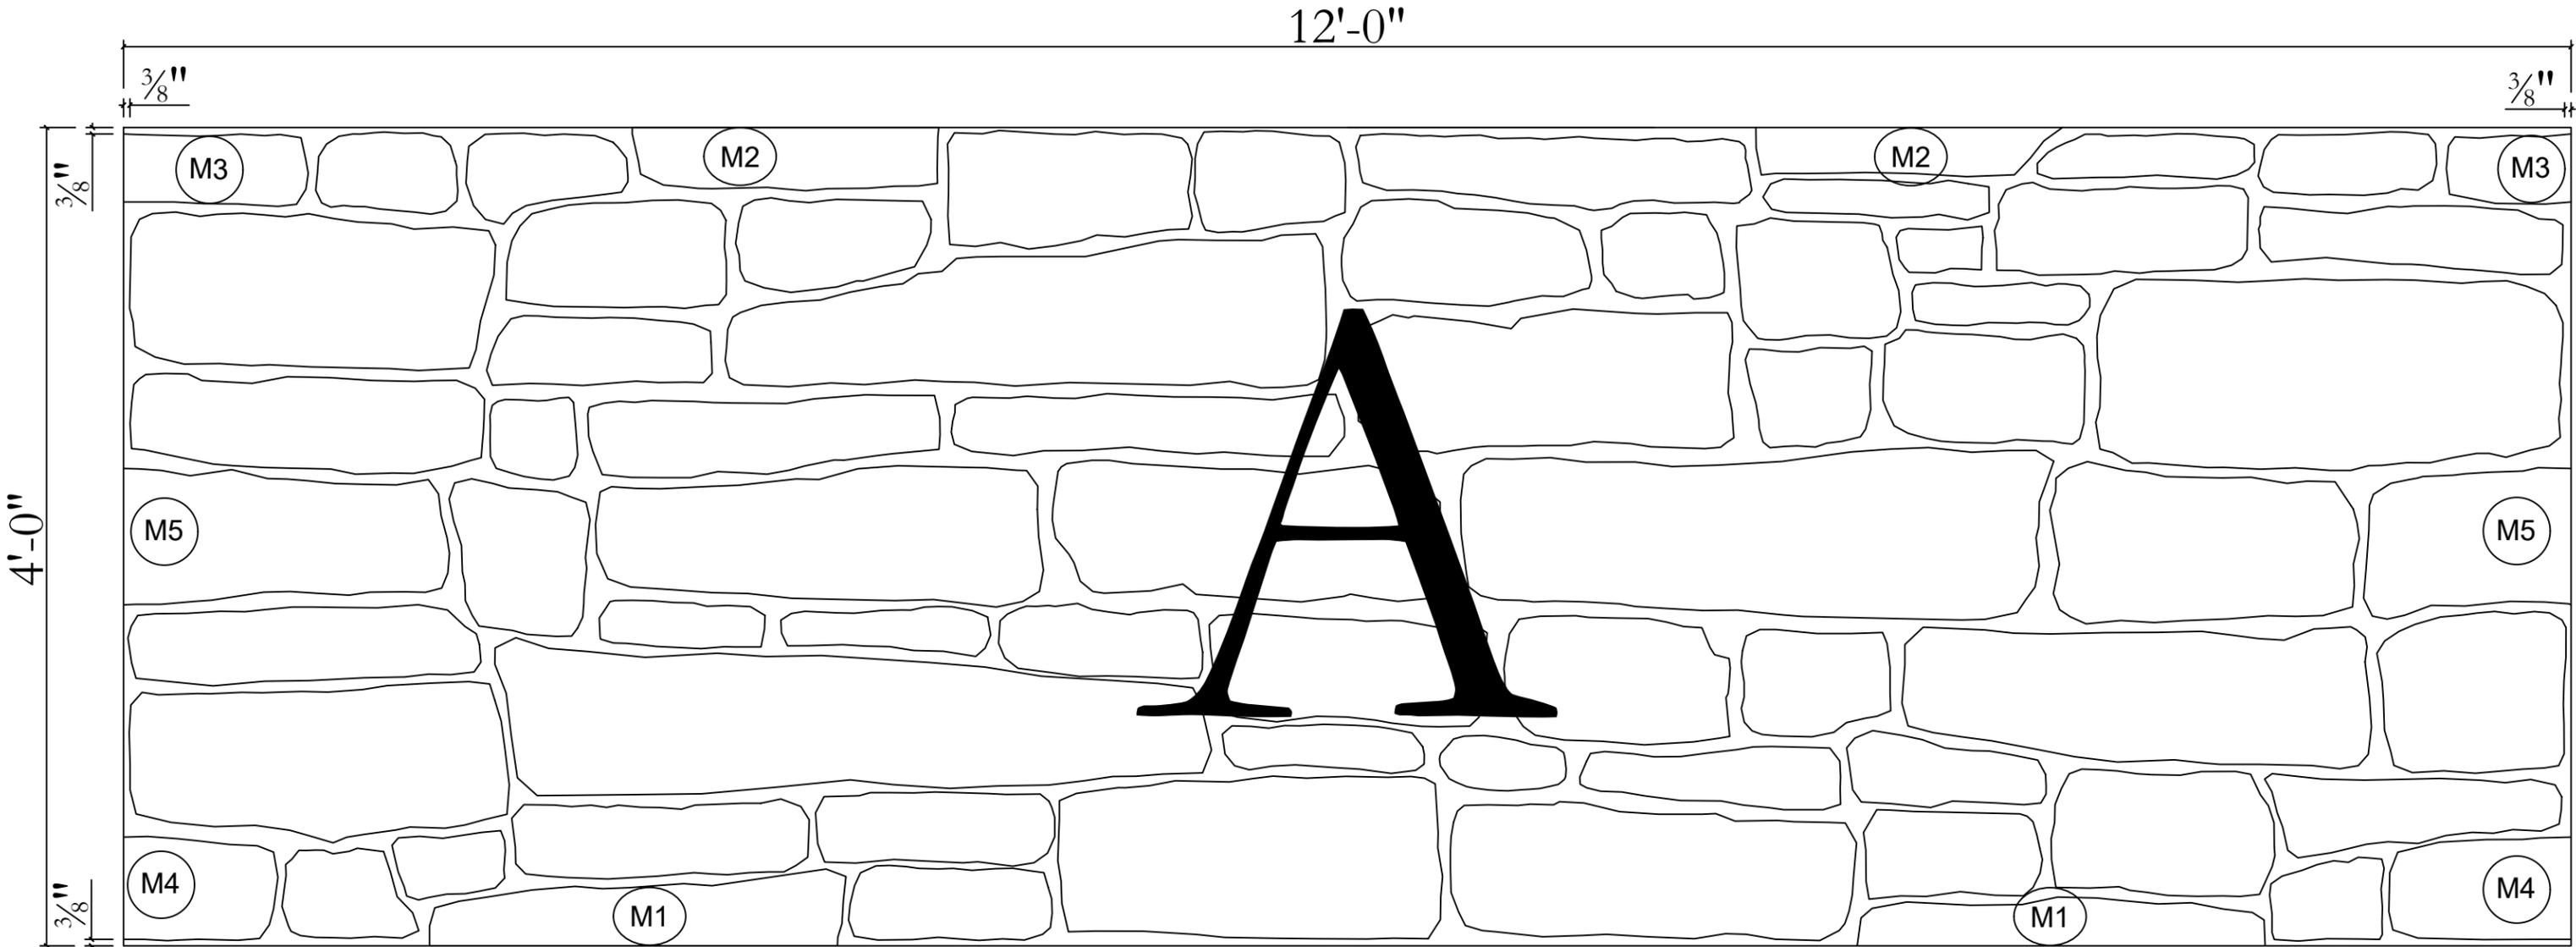
Stone layout for visual reference only. Actual stone layout to be determined by AP

24'-0"

A noticeable seam will occur if not properly sealed when stacking liners.

12'-0"

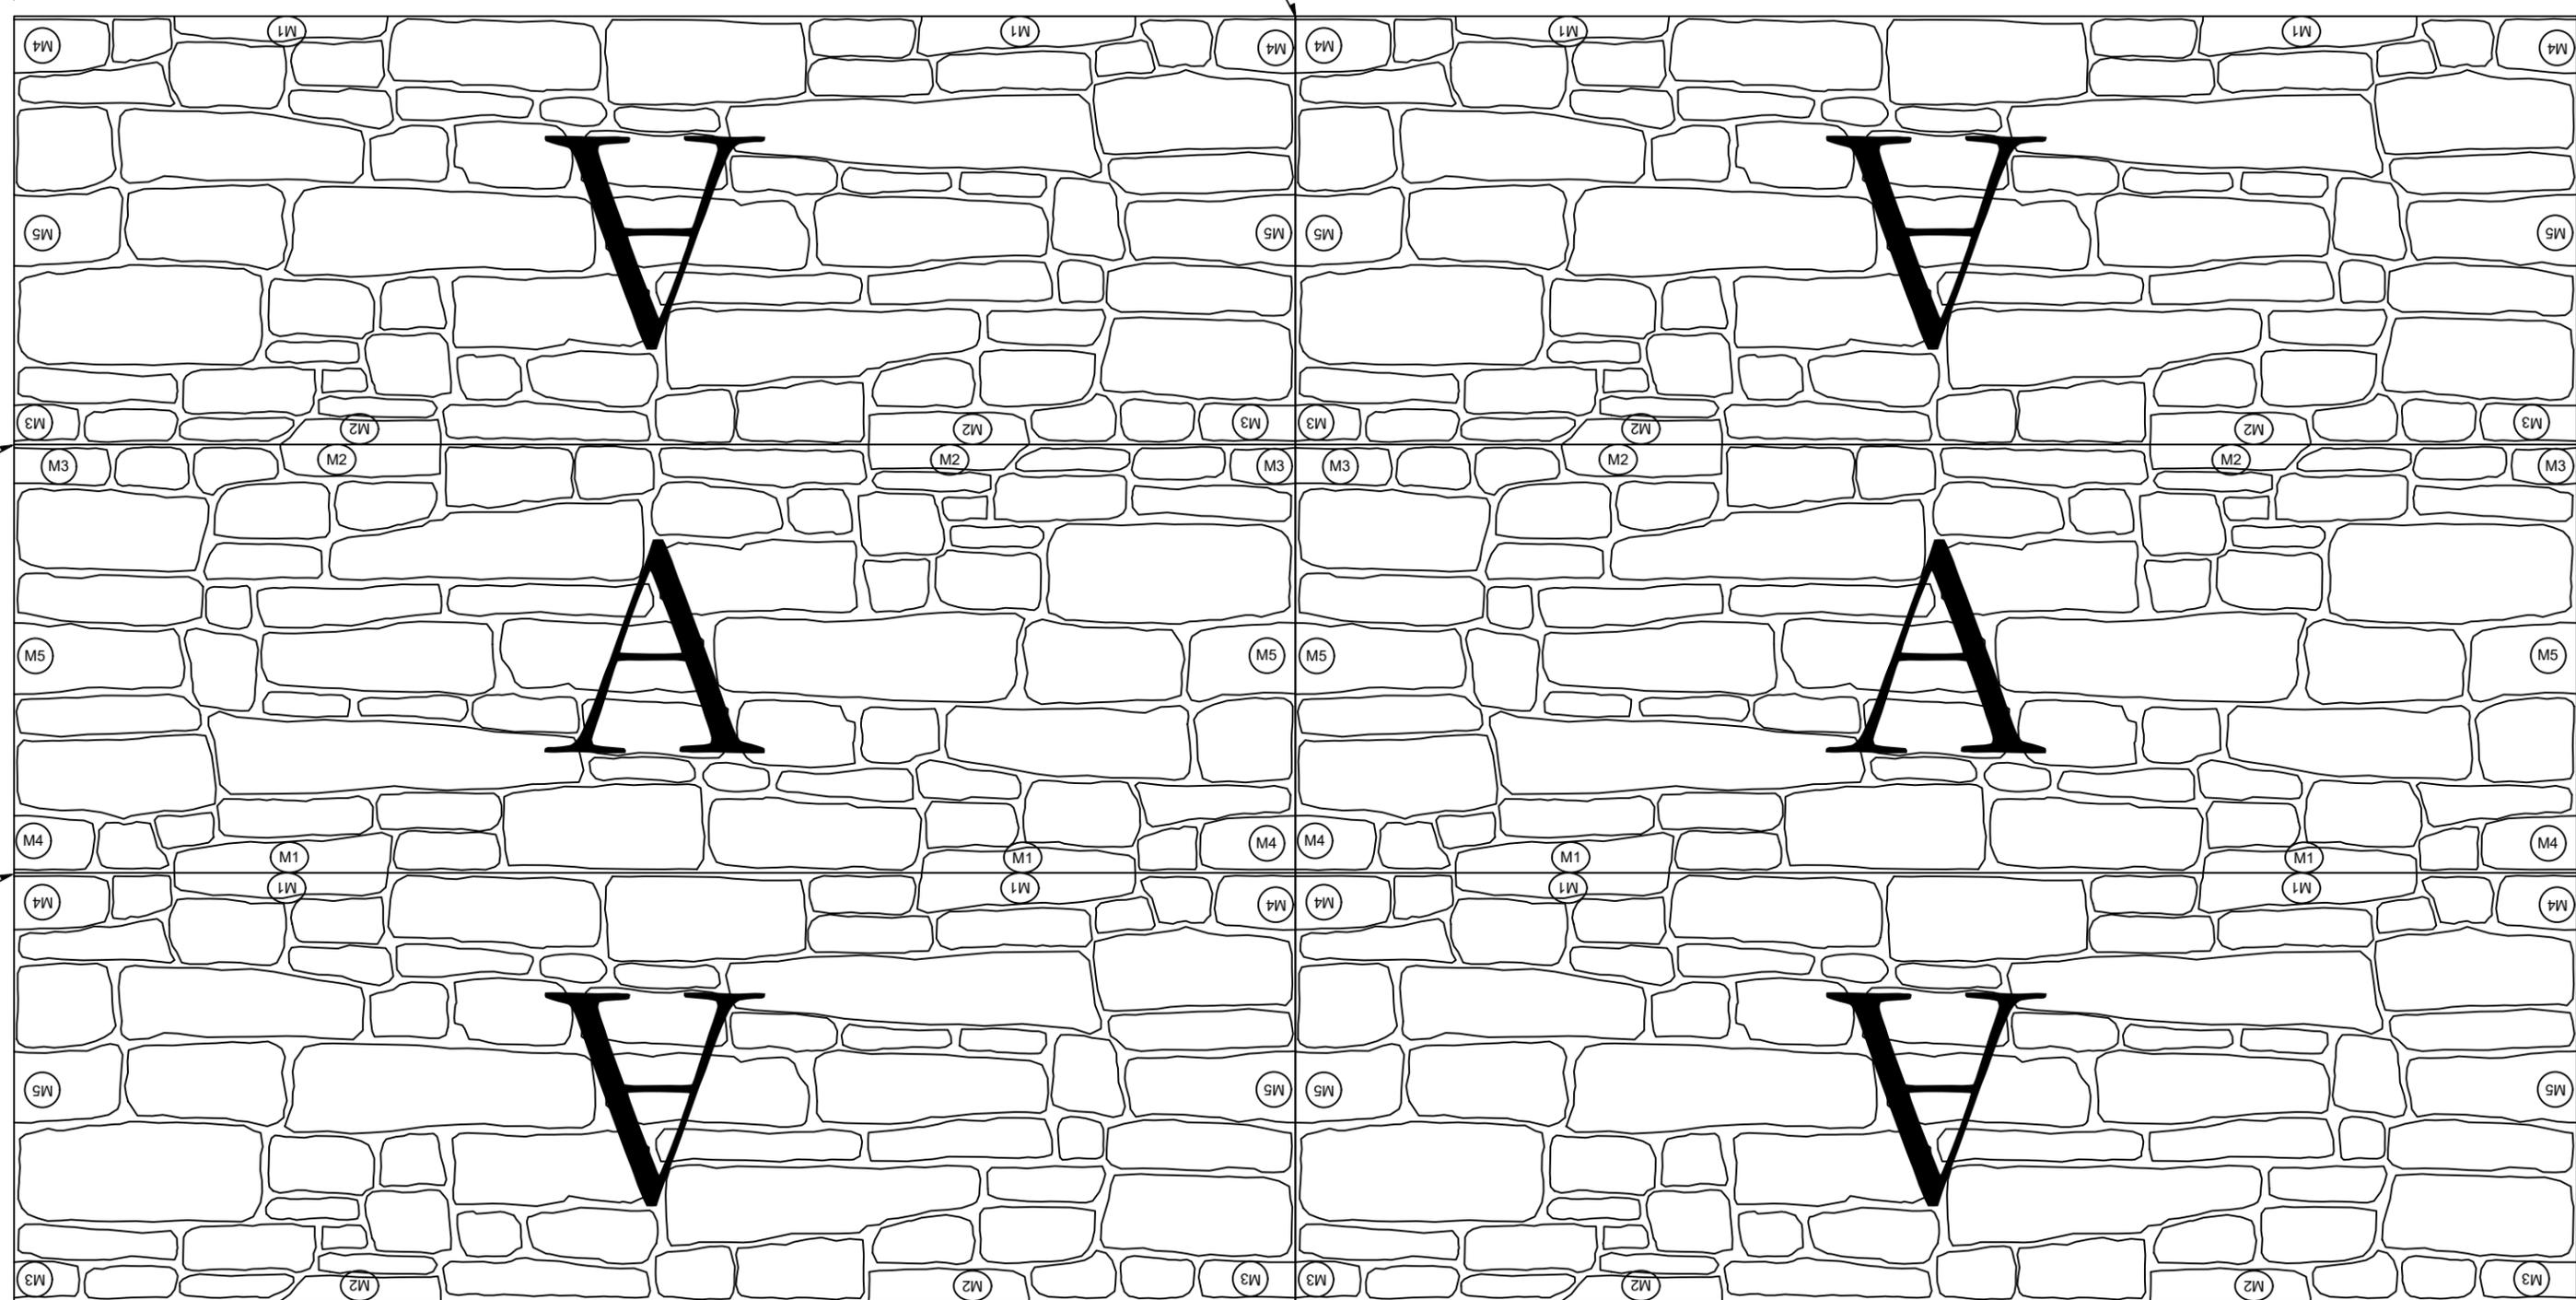
A noticeable seam will occur if not properly sealed when stacking liners.
