Customer:
 Job Name:
 Title: #912 Valley Forge Fieldstone

Customer:
 Job Name:
 Title: #912 Valley Forge Fieldstone Assembled

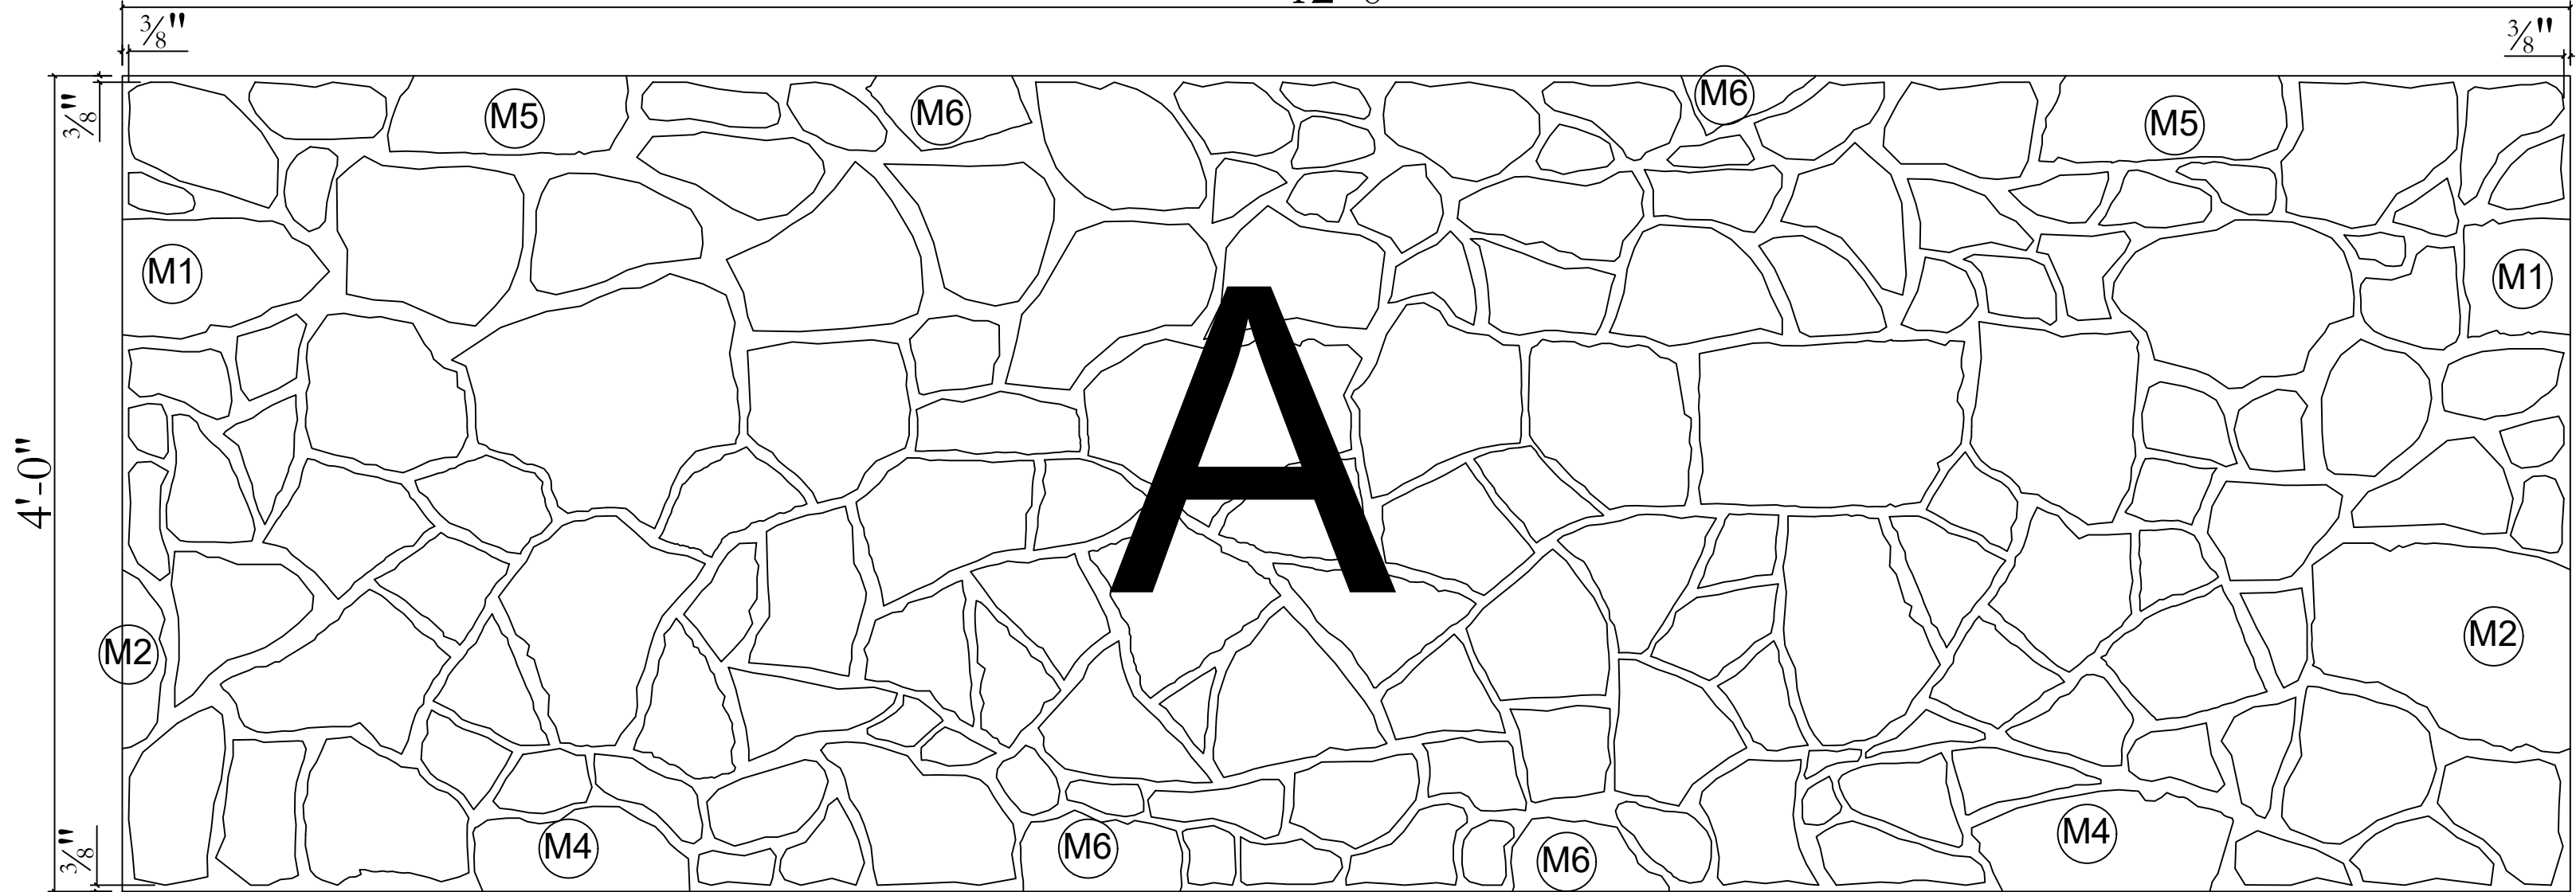
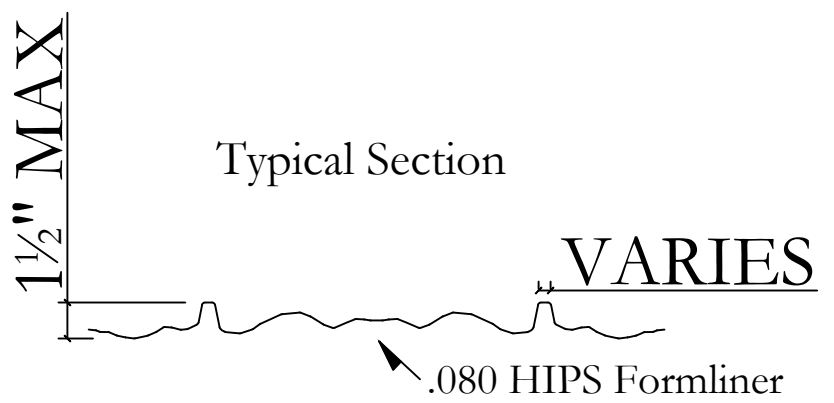
12'-0"

Stone layout for visual reference only. Actual stone layout to be determined by AP

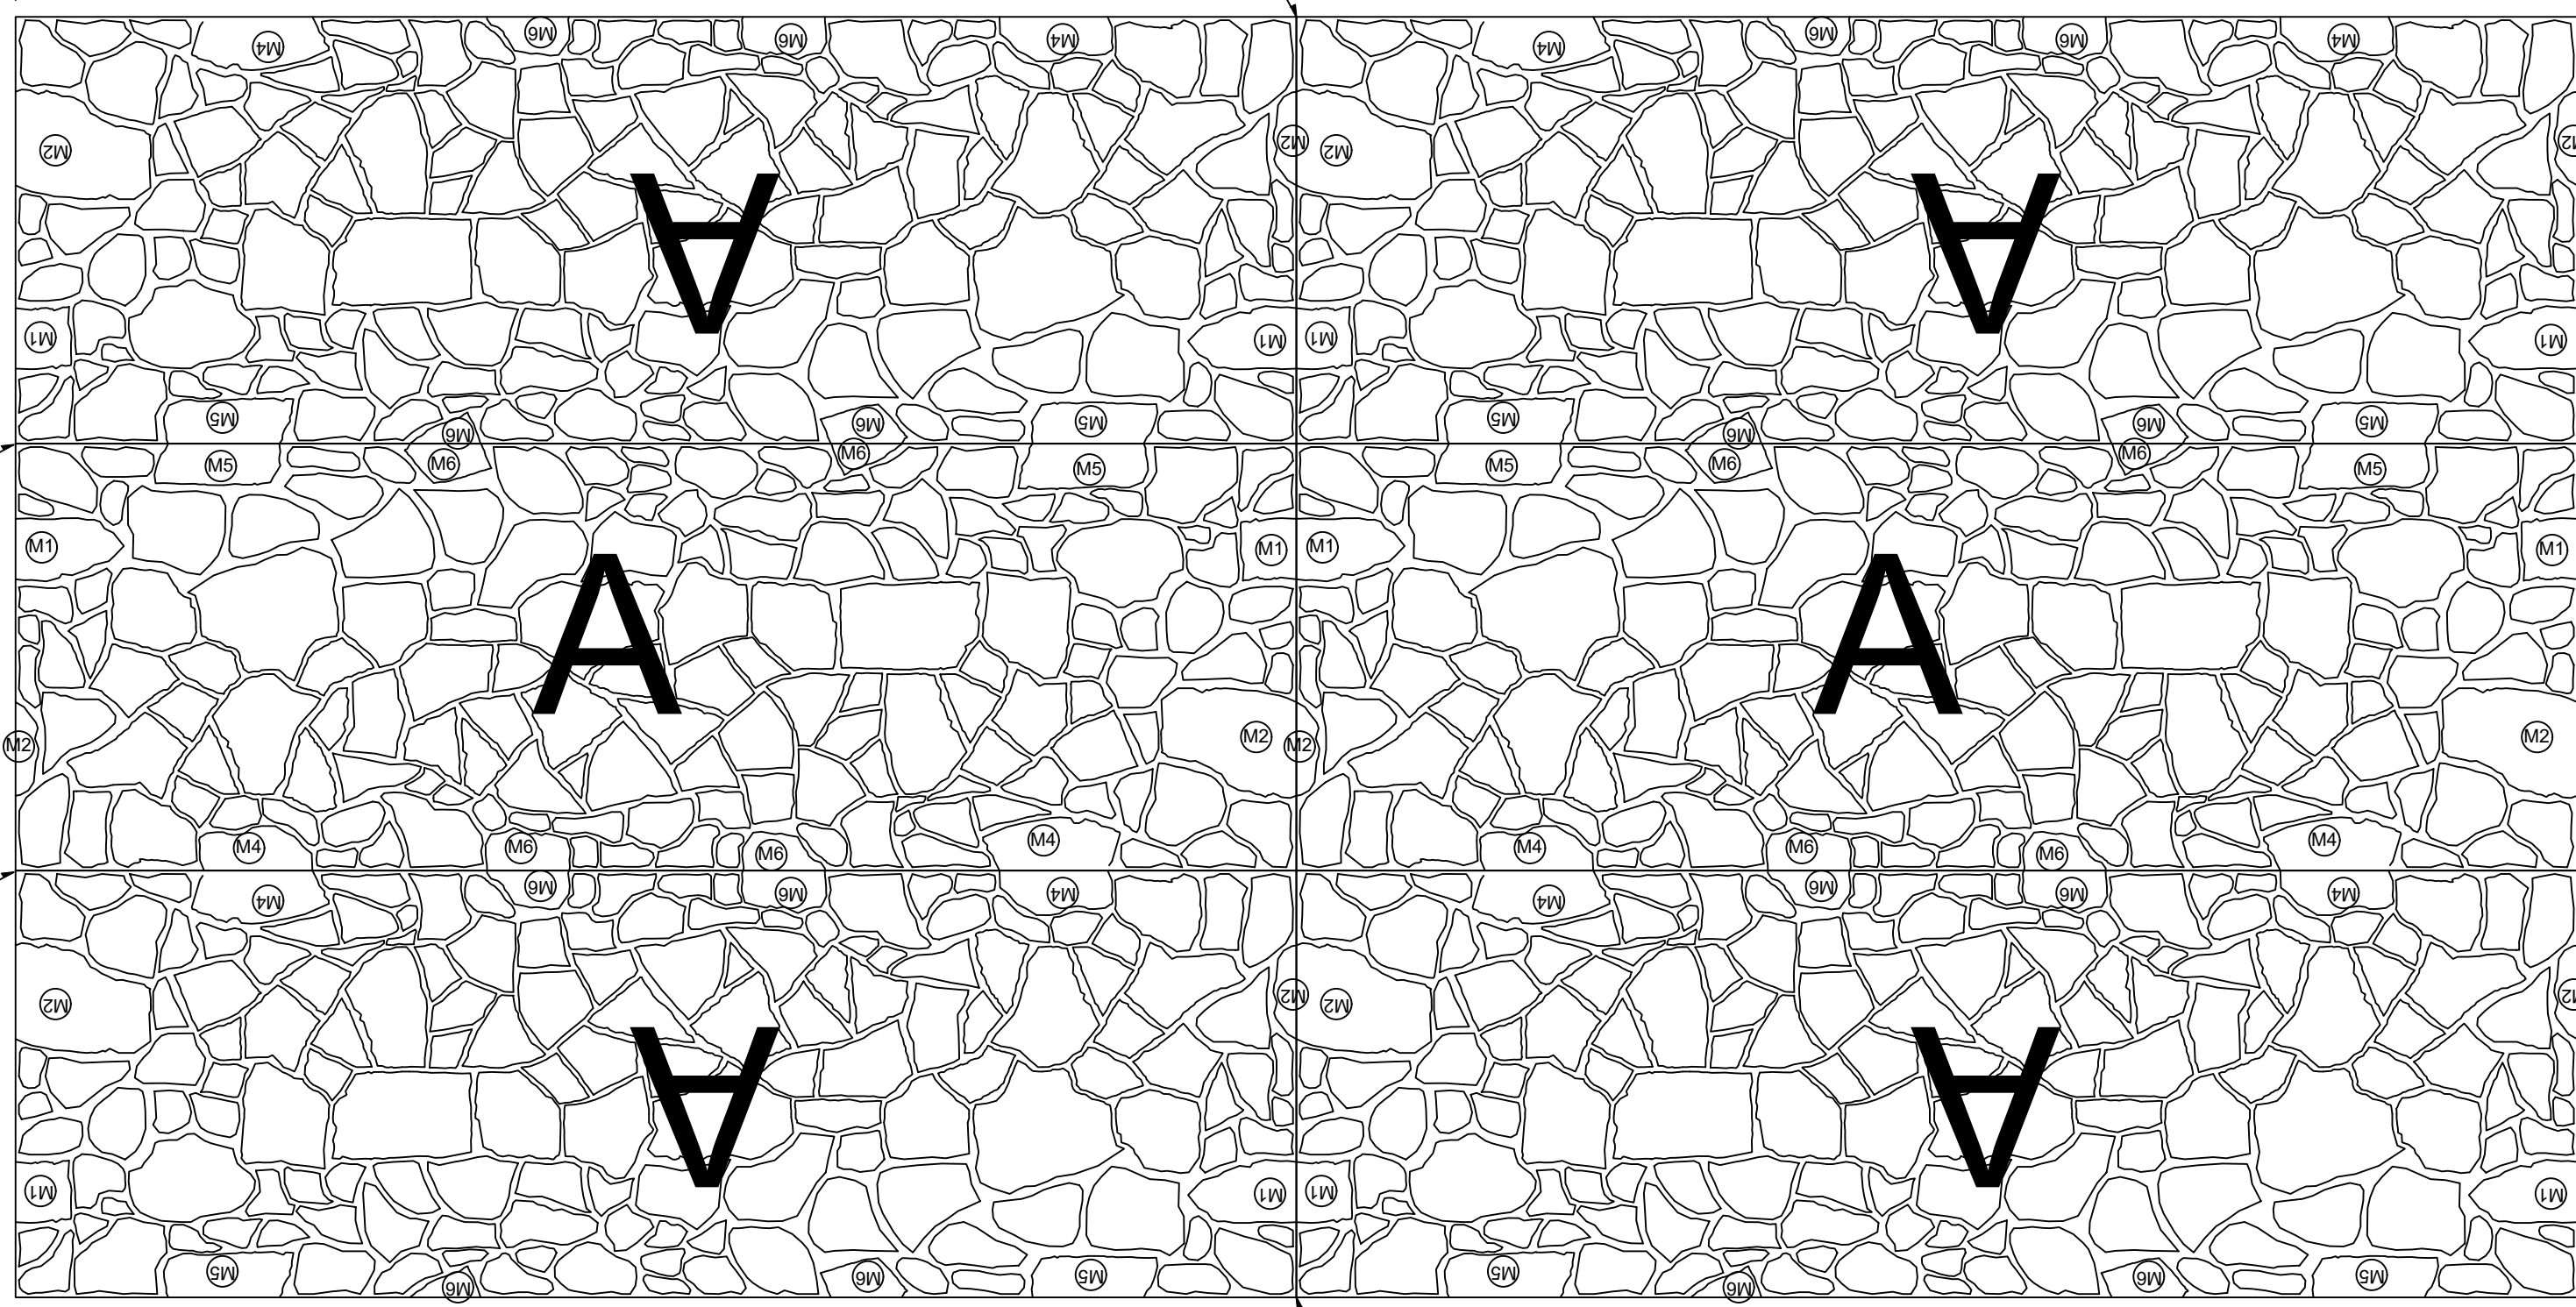
24'-0"

A noticeable seam will occur if not properly sealed when stacking liners.

12'-0"
