Customer:
 Job Name:
 Title: #913 New York Dot Ashlar

Customer:
 Job Name:
 Title: #913 New York DOT Ashlar Assembled

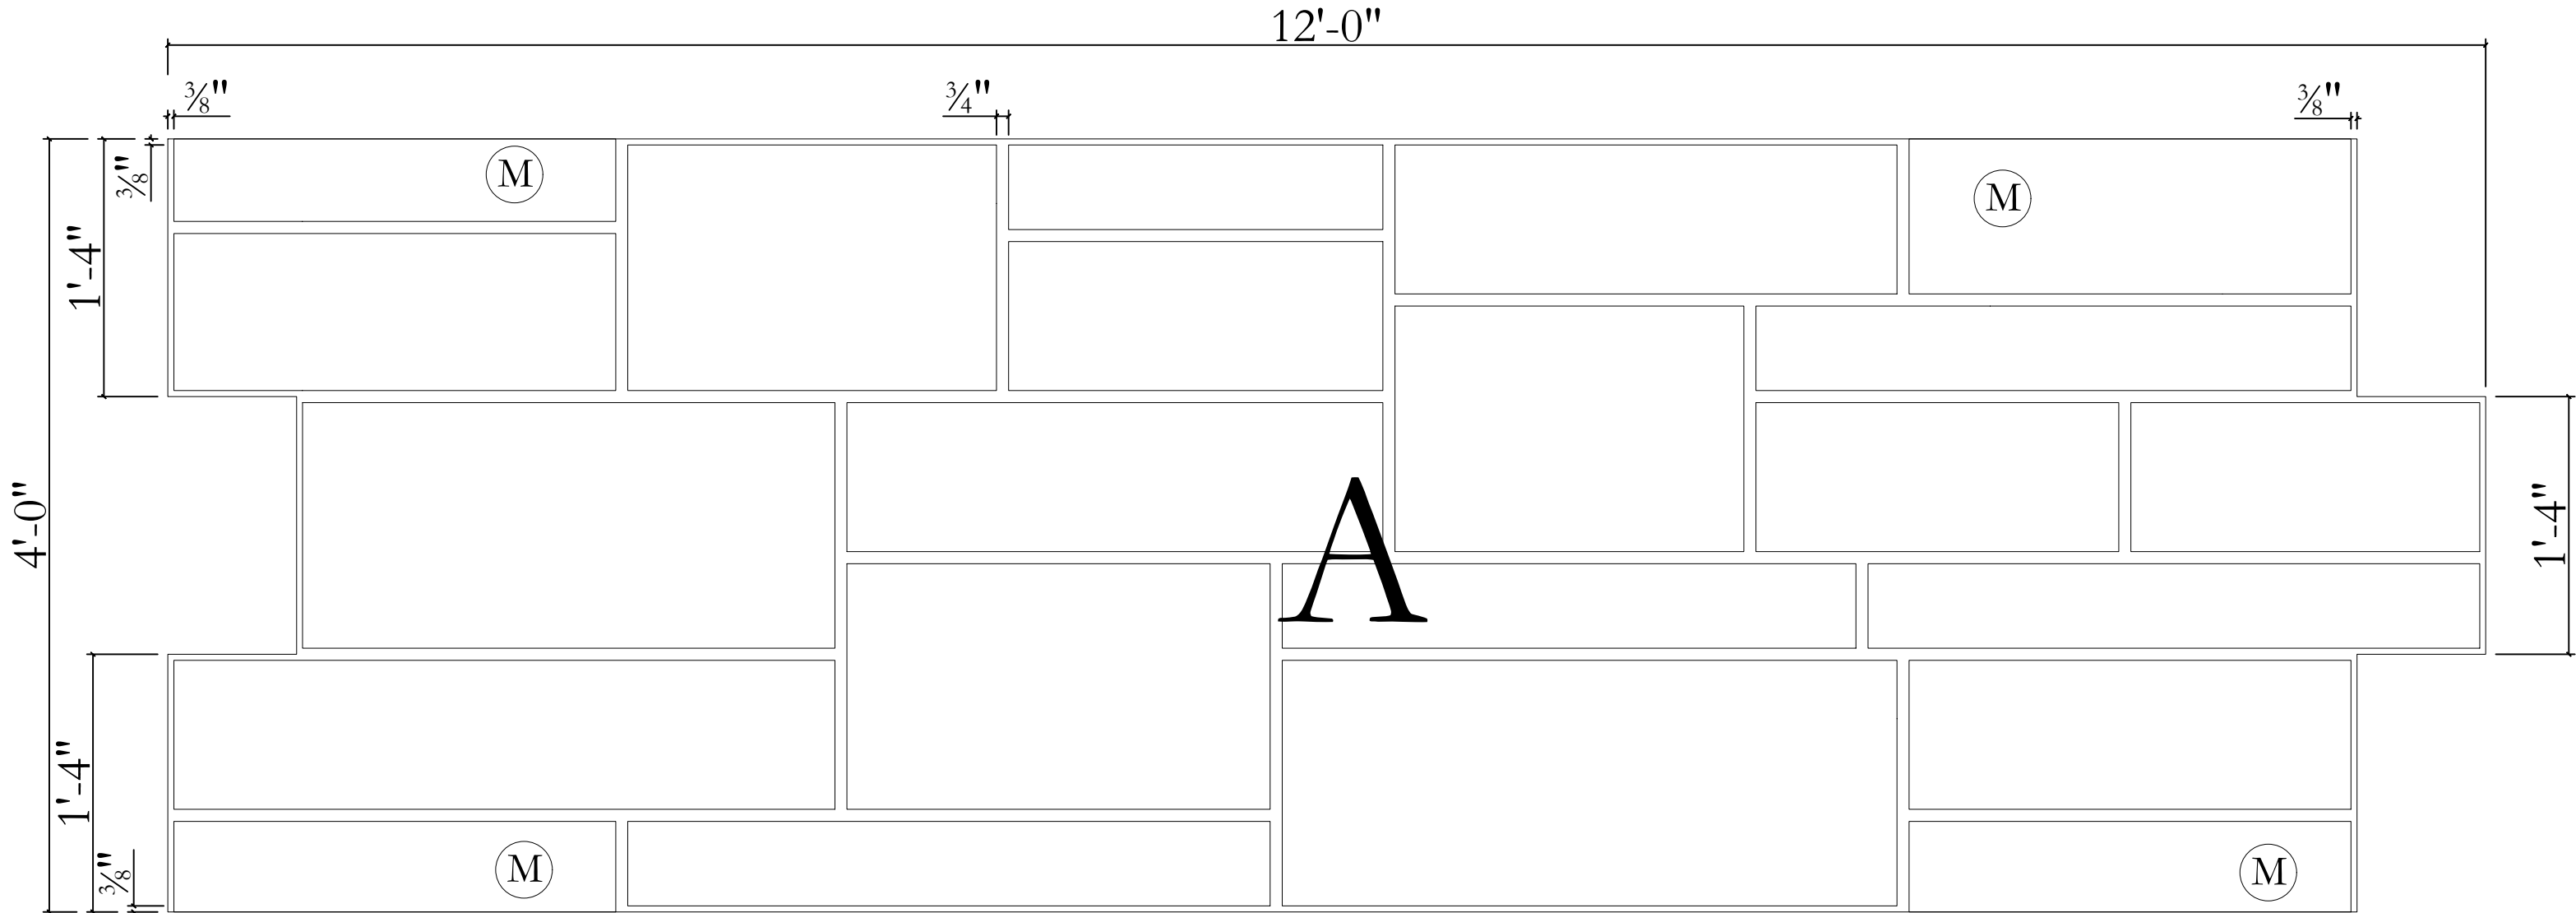
Stone layout for visual reference only. Actual stone layout to be determined by AP

Stone Texture Not Shown For Clarity

22'-0"

A noticeable seam will occur if not properly sealed when stacking liners.

12'-0"
A noticeable seam will occur if not properly sealed when stacking liners.

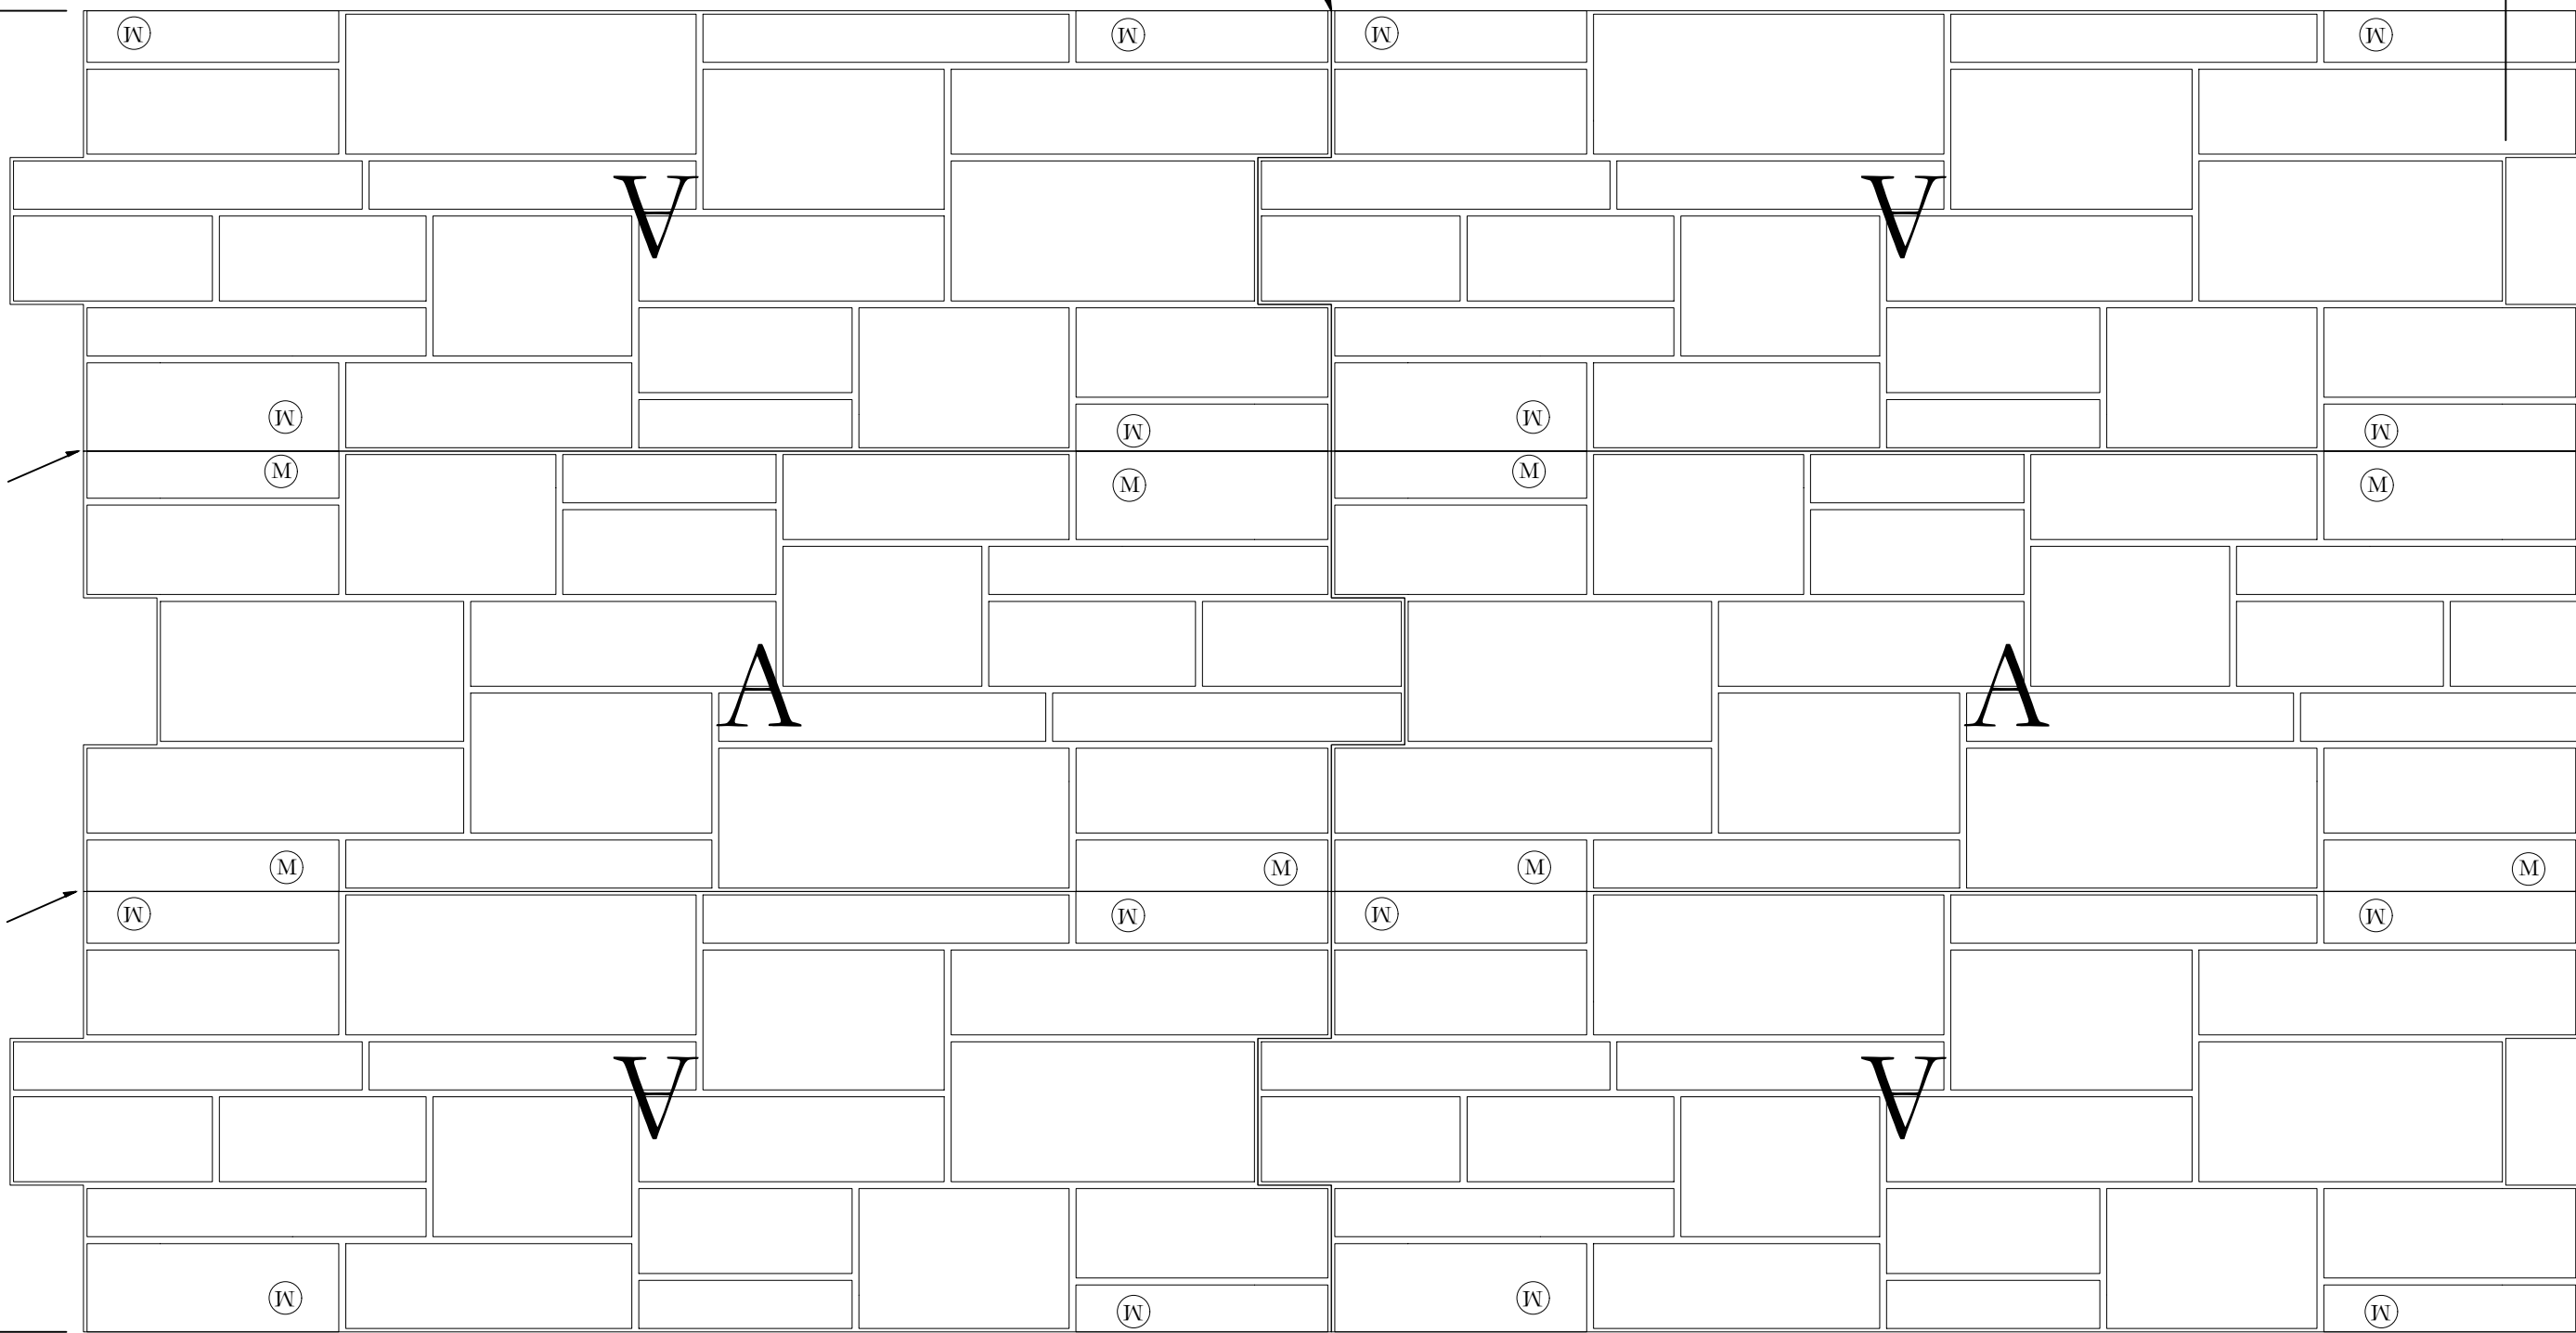
A noticeable seam will occur if not properly sealed when stacking liners.
