Customer:	
Job Name:	
Title:	#932 Random Coursed Ashlar

Customer:
Job Name:
Title: #932 Random Coursed Ashlar Assembled

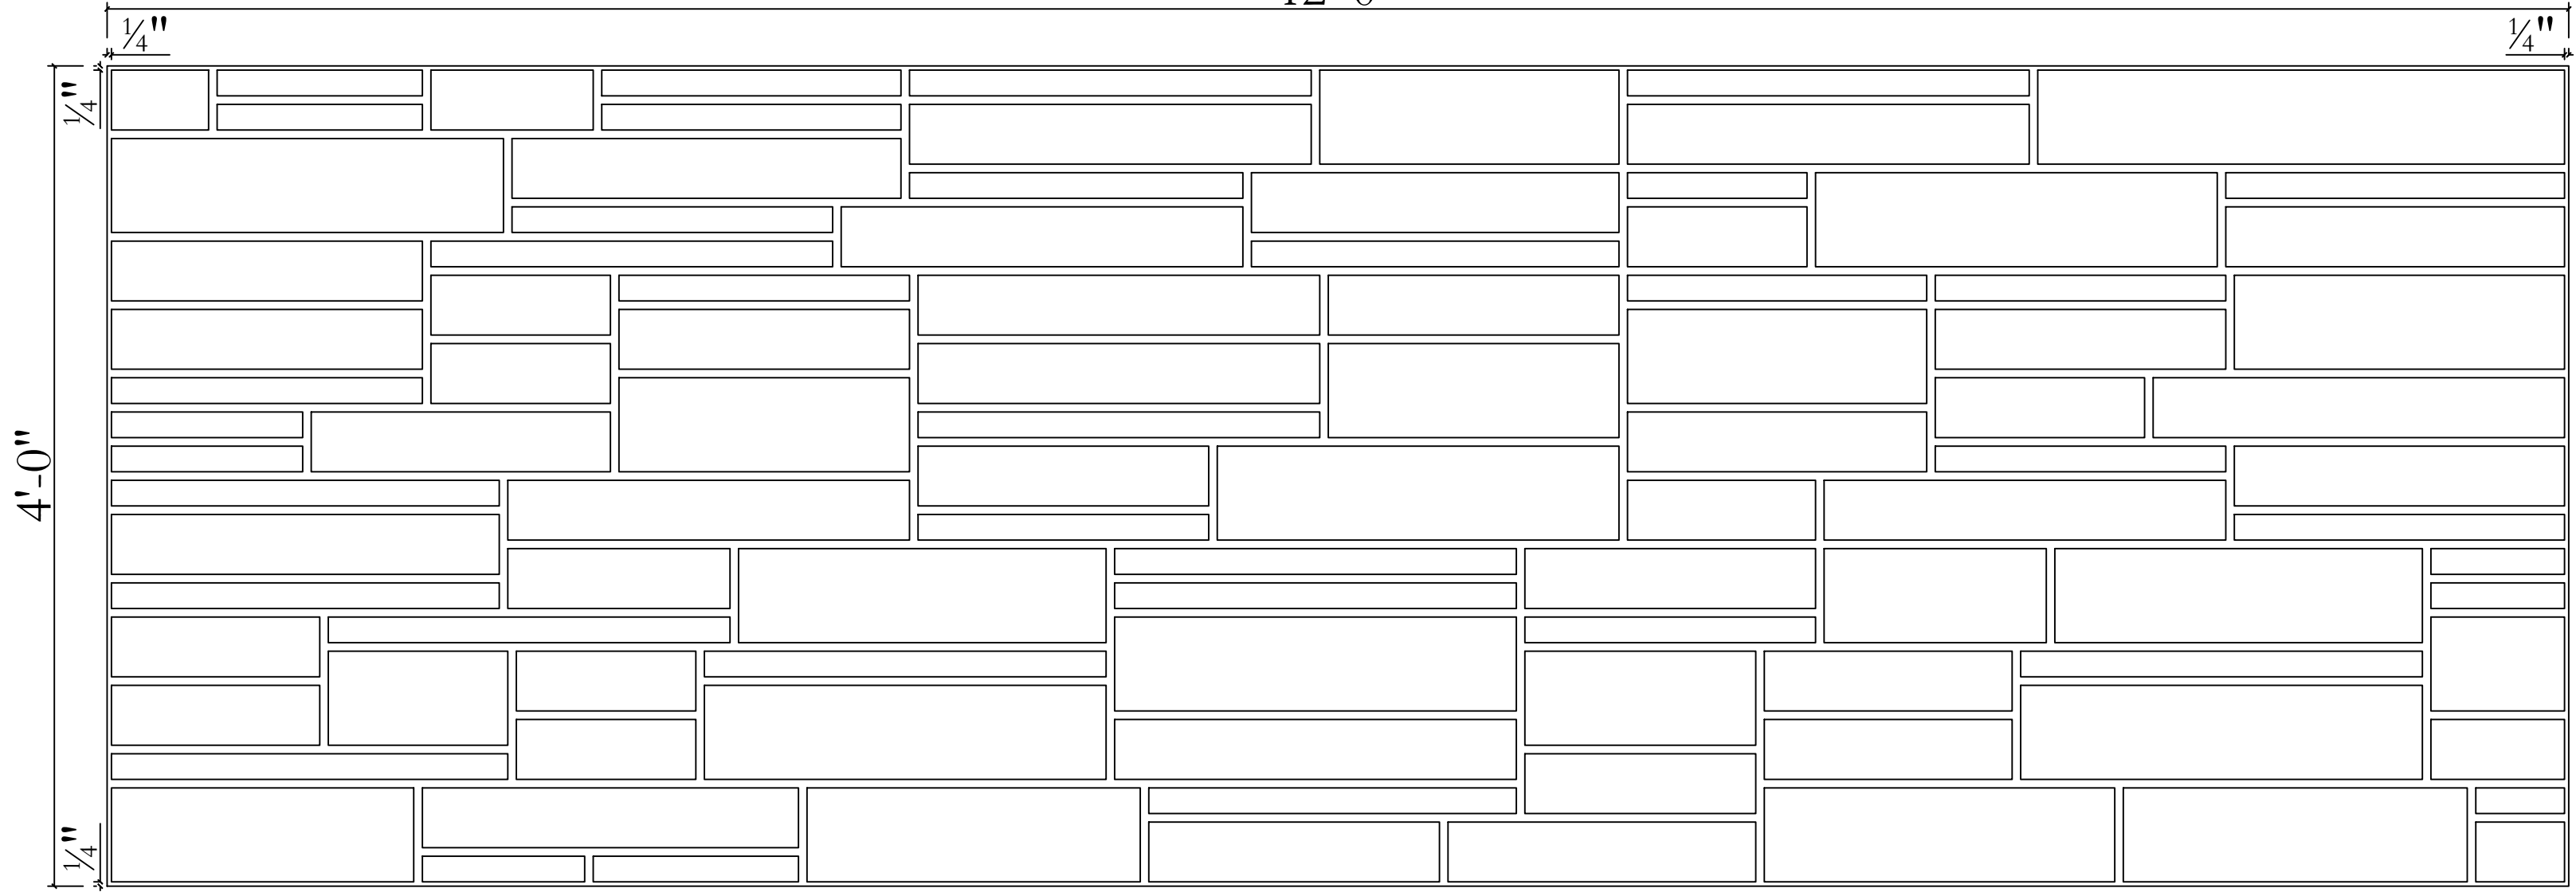
12'-0"

Stone layout for visual reference only. Actual stone layout to be determined by AP

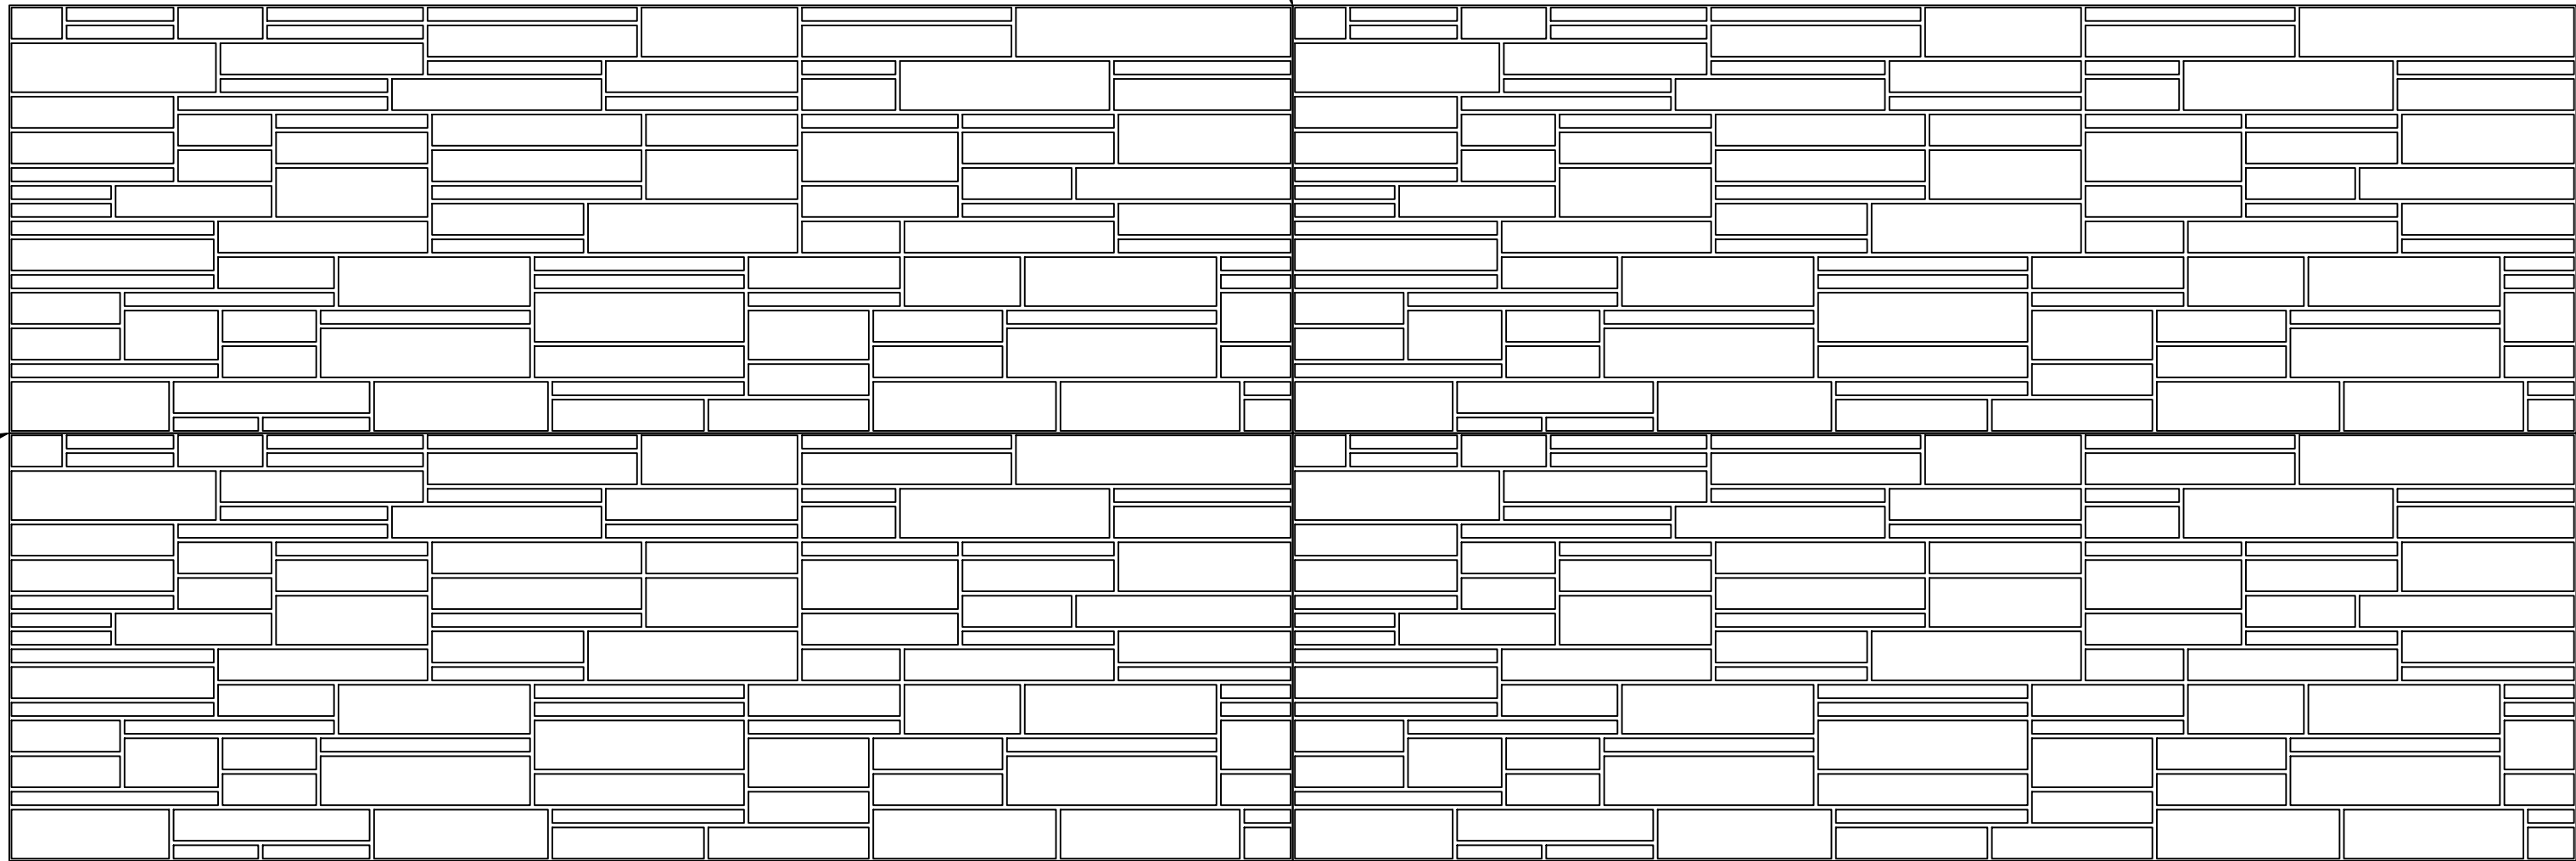
24'-0"

A noticeable seam will occur if not properly sealed when stacking liners.

8'-0"
A noticeable seam will occur if not properly sealed when stacking liners.
