ITEM # 308356

Customer:		Drawn By:		Date:	
Job Name:		Approved By:		Date:	
Title:	#933 LedgeStone Drystack	Scale:	None	Tolerance:	±3/16
		Page:	1	Drawing Number:

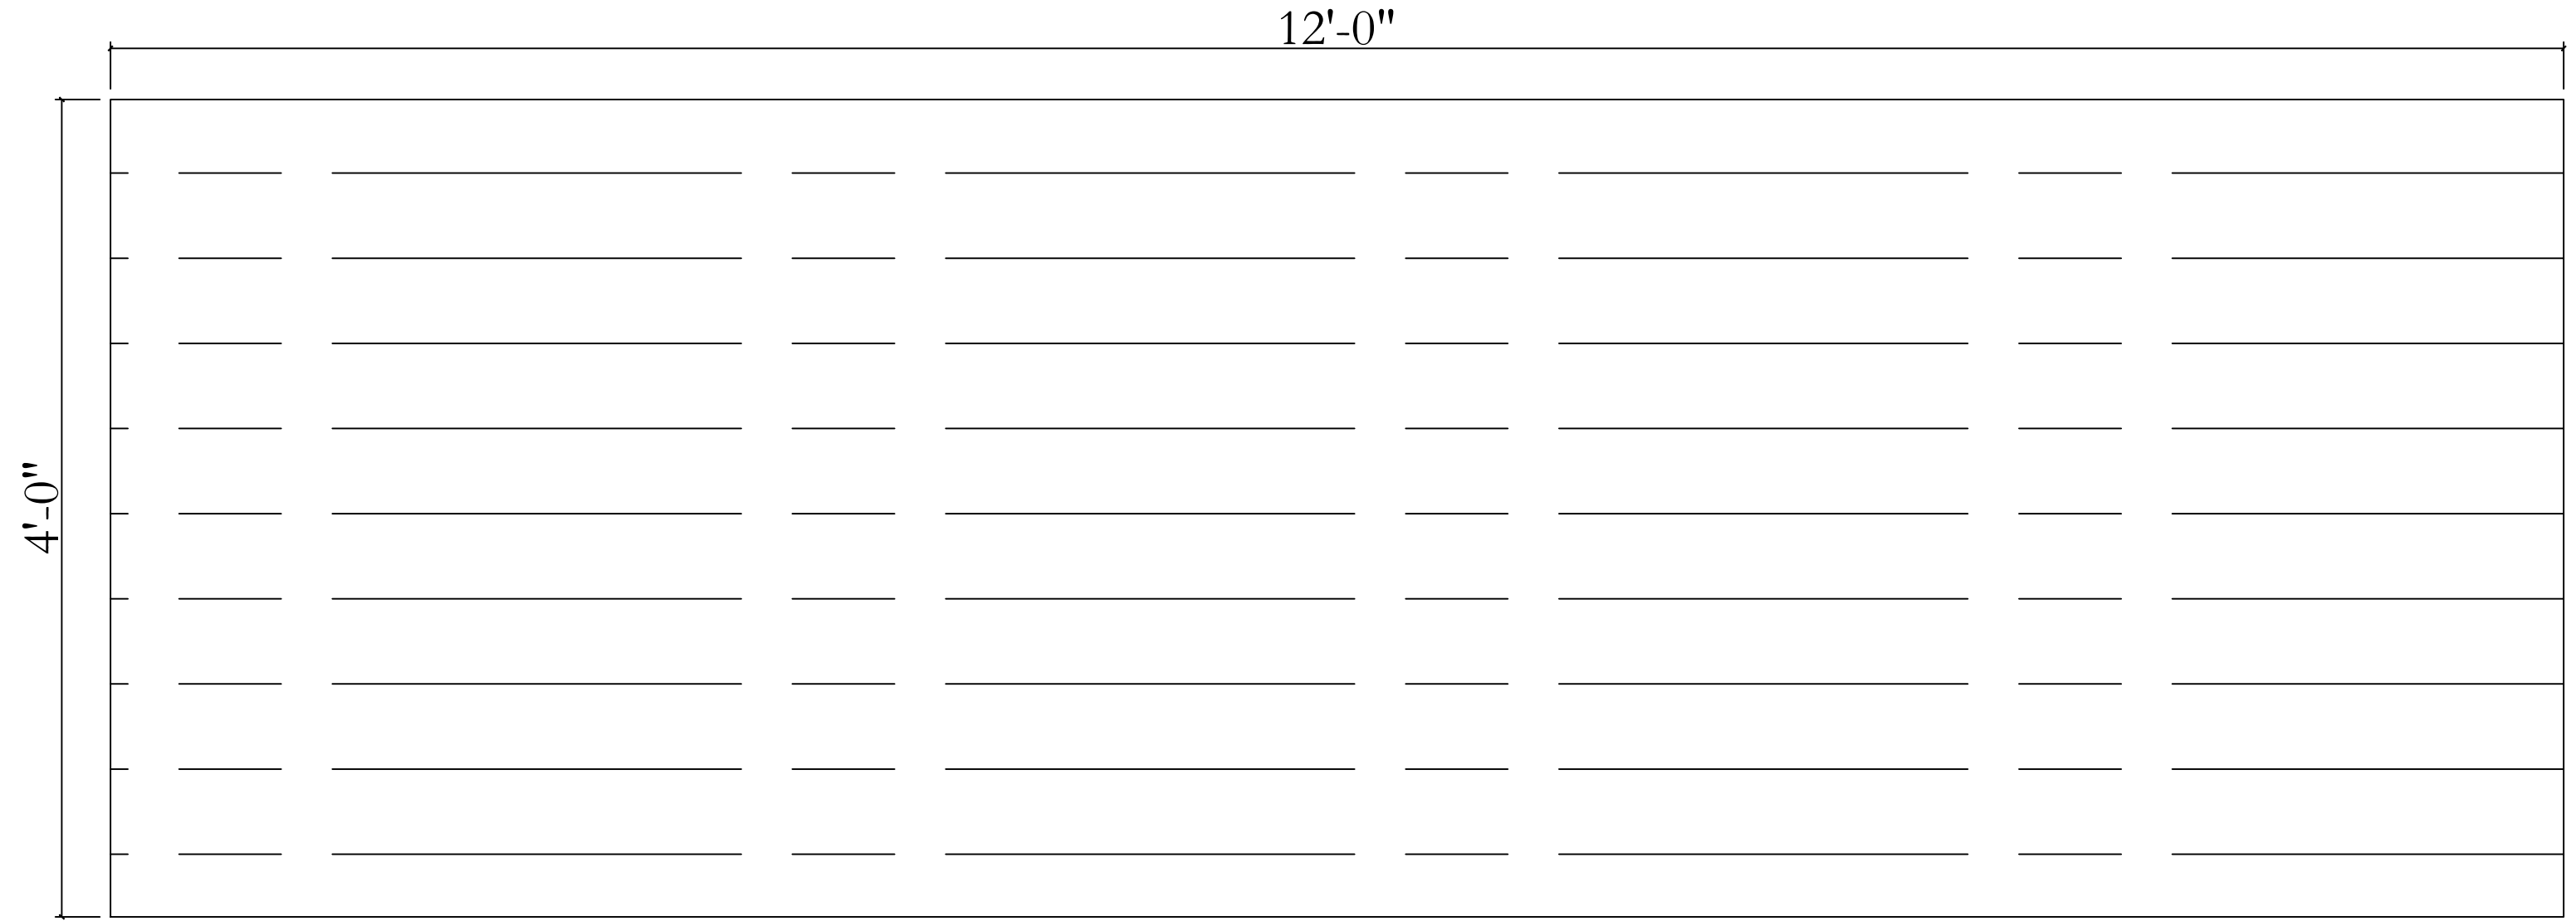
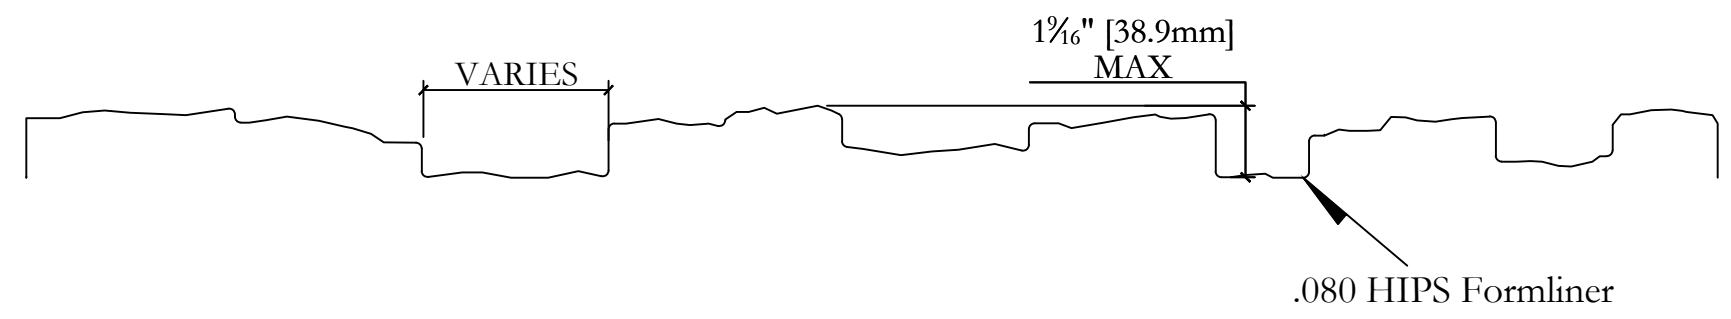
Typical Section

Hatch for visual reference only actual stone layout determined by AP  
 Formliner may require backup provided by customer
