Customer:	
Job Name:	
Title:	#946 Southern Drystack

Customer:
 Job Name:
 Title: #946 Southern Drystack Assembled

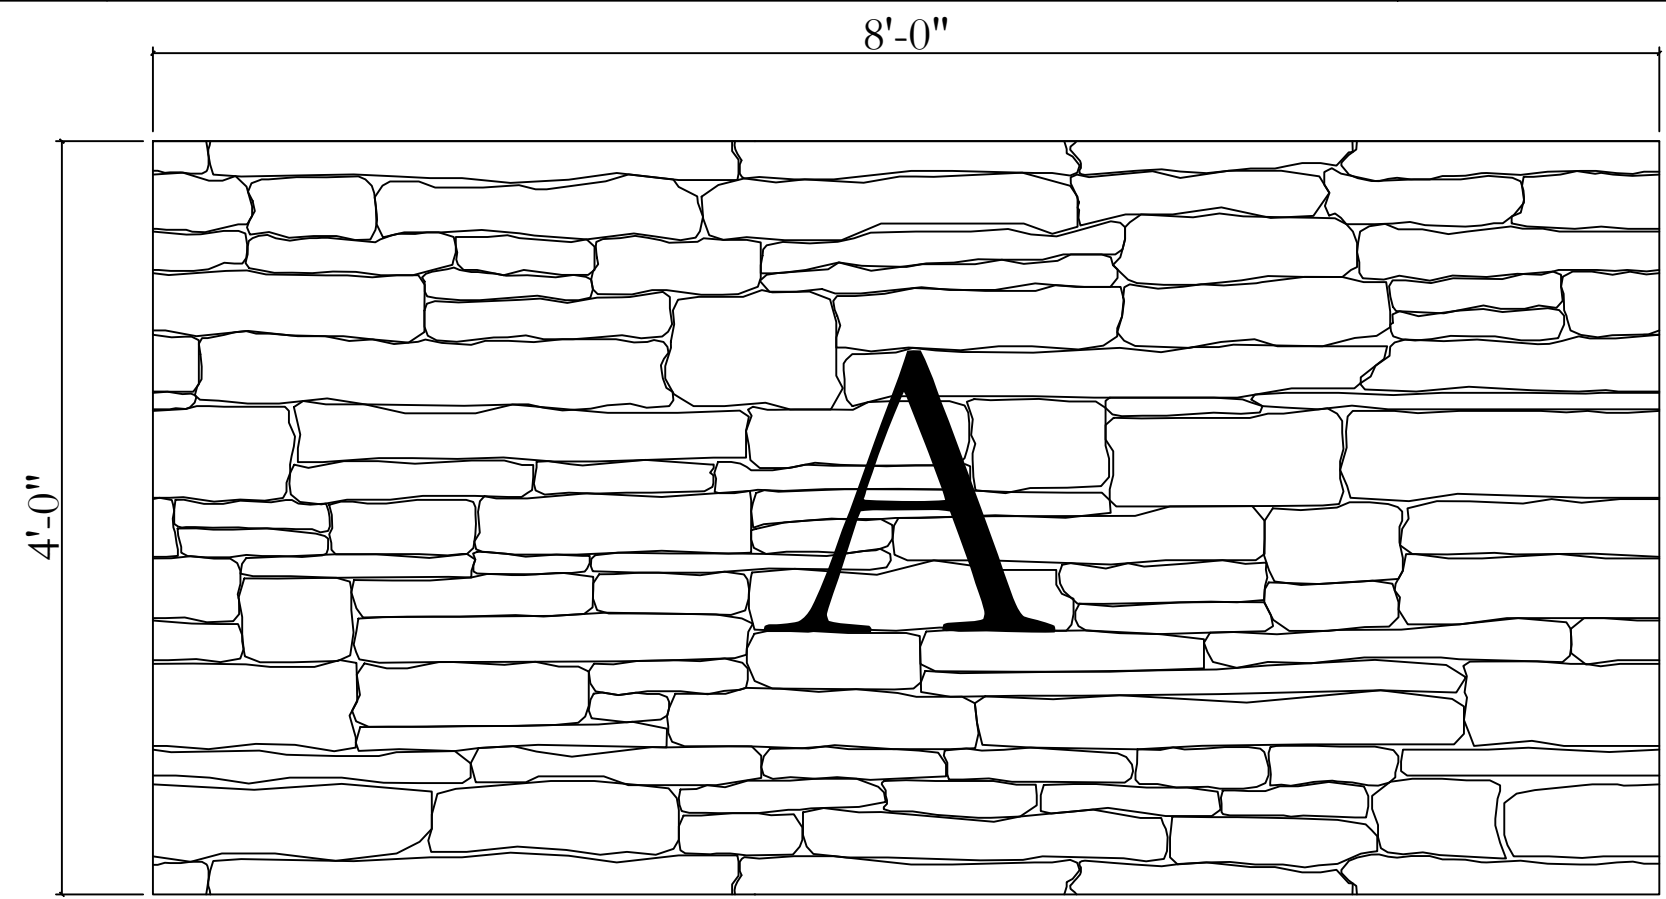
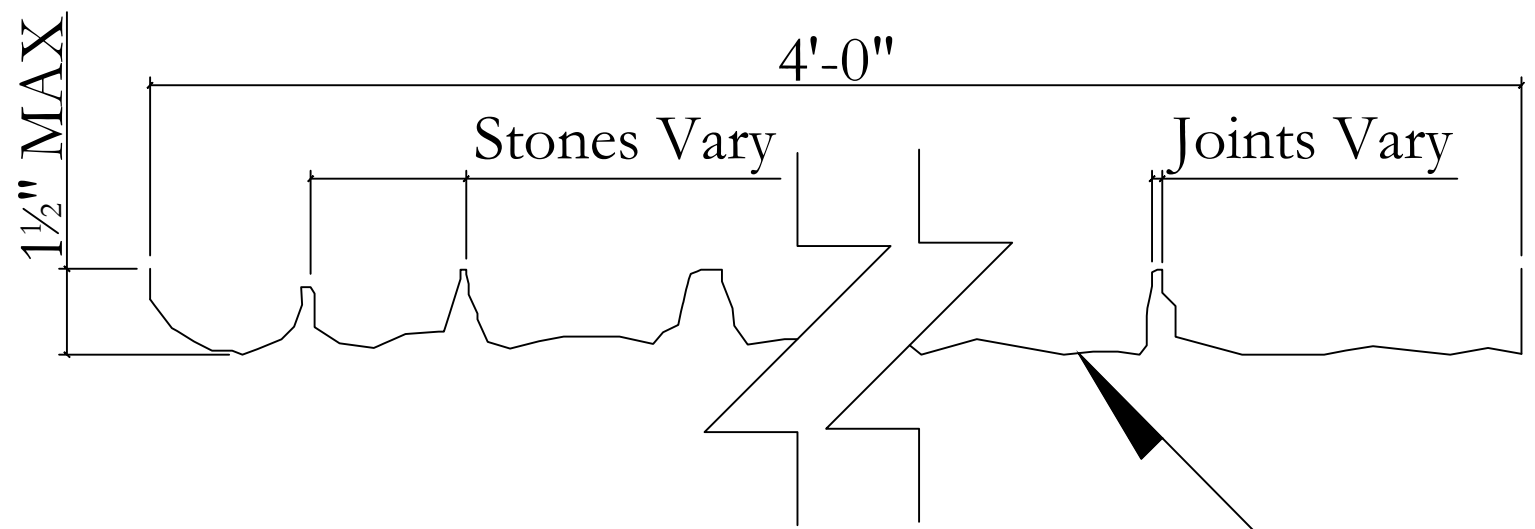
Drystack 1 1/2" Relief. Stone Layout Will Vary

Stone layout for visual reference only. Actual stone layout to be determined by AP

.080 HIPS Formliner

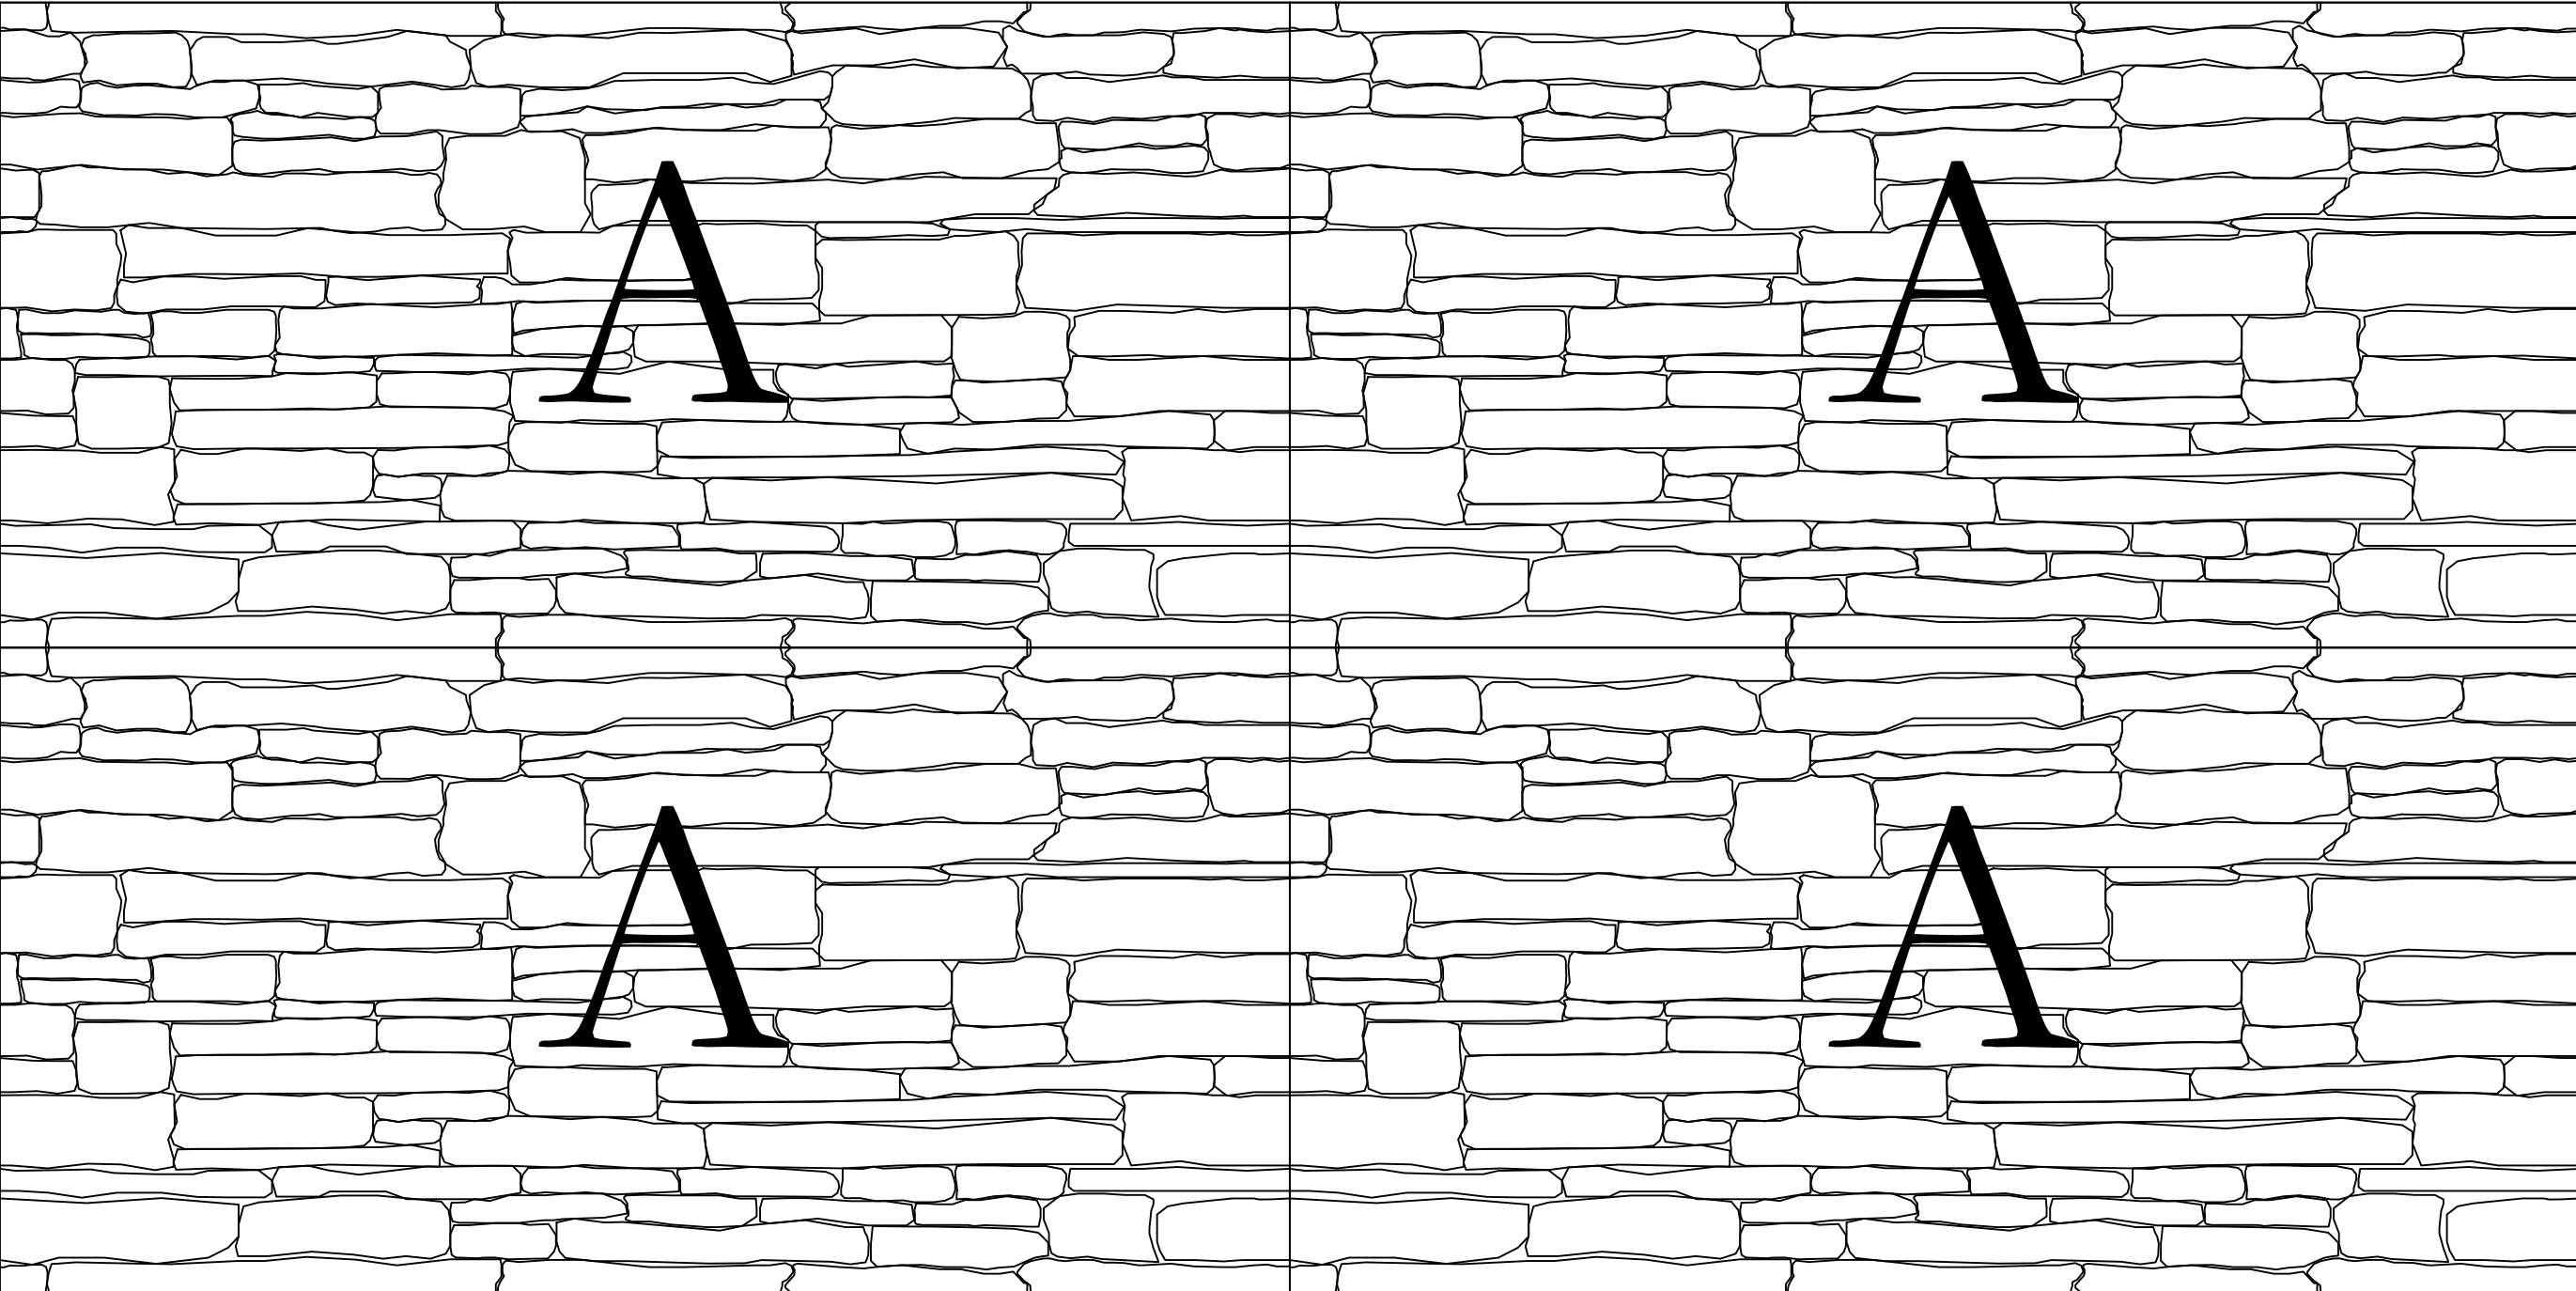
16'-0"

A noticeable seam will occur if not properly sealed when stacking liners.

8'-0"
