Customer:  
 Job Name:  
 Title: #899 Appalachian Ashlar

Customer: \_\_\_\_\_  
 Job Name: \_\_\_\_\_  
 Title: #899 Appalachian Ashlar Assembled

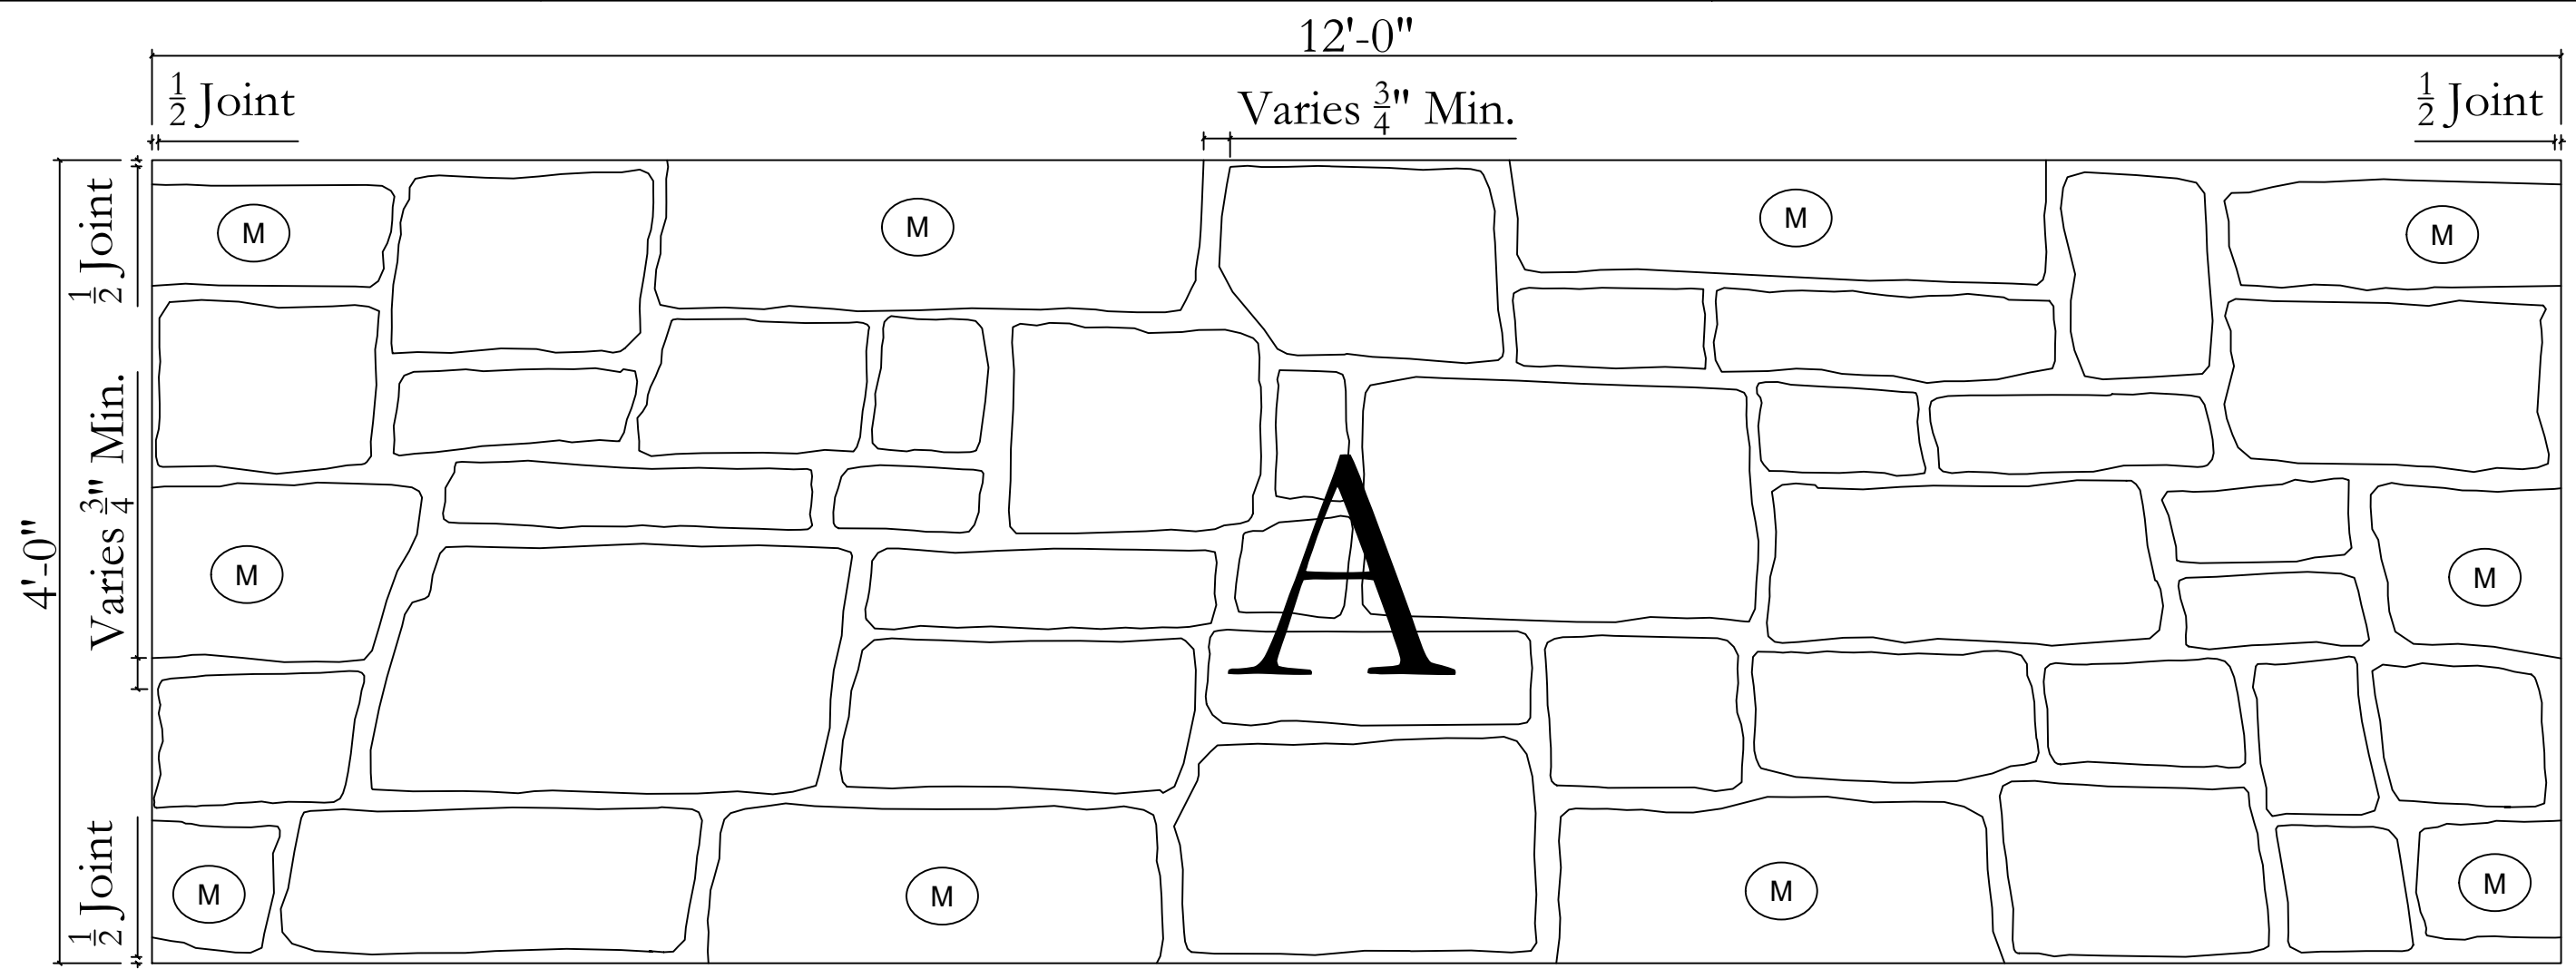
(M) Matched Stone

\*\*\*Stone layout for visual reference only. Actual stone layout to be determined by AP\*\*\*

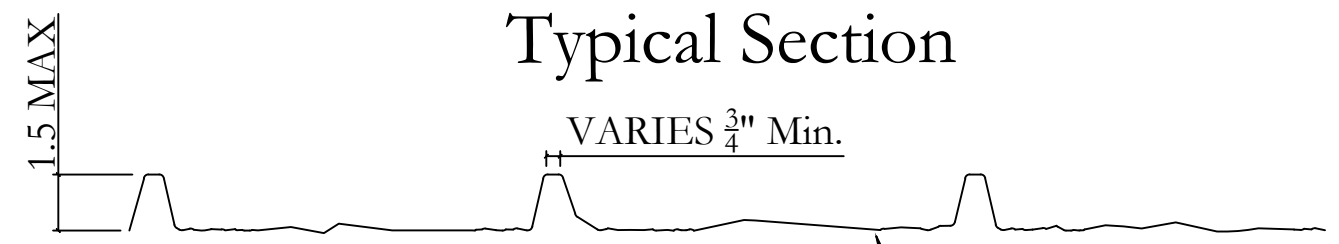
Typical Section

.080 HIPS Formliner

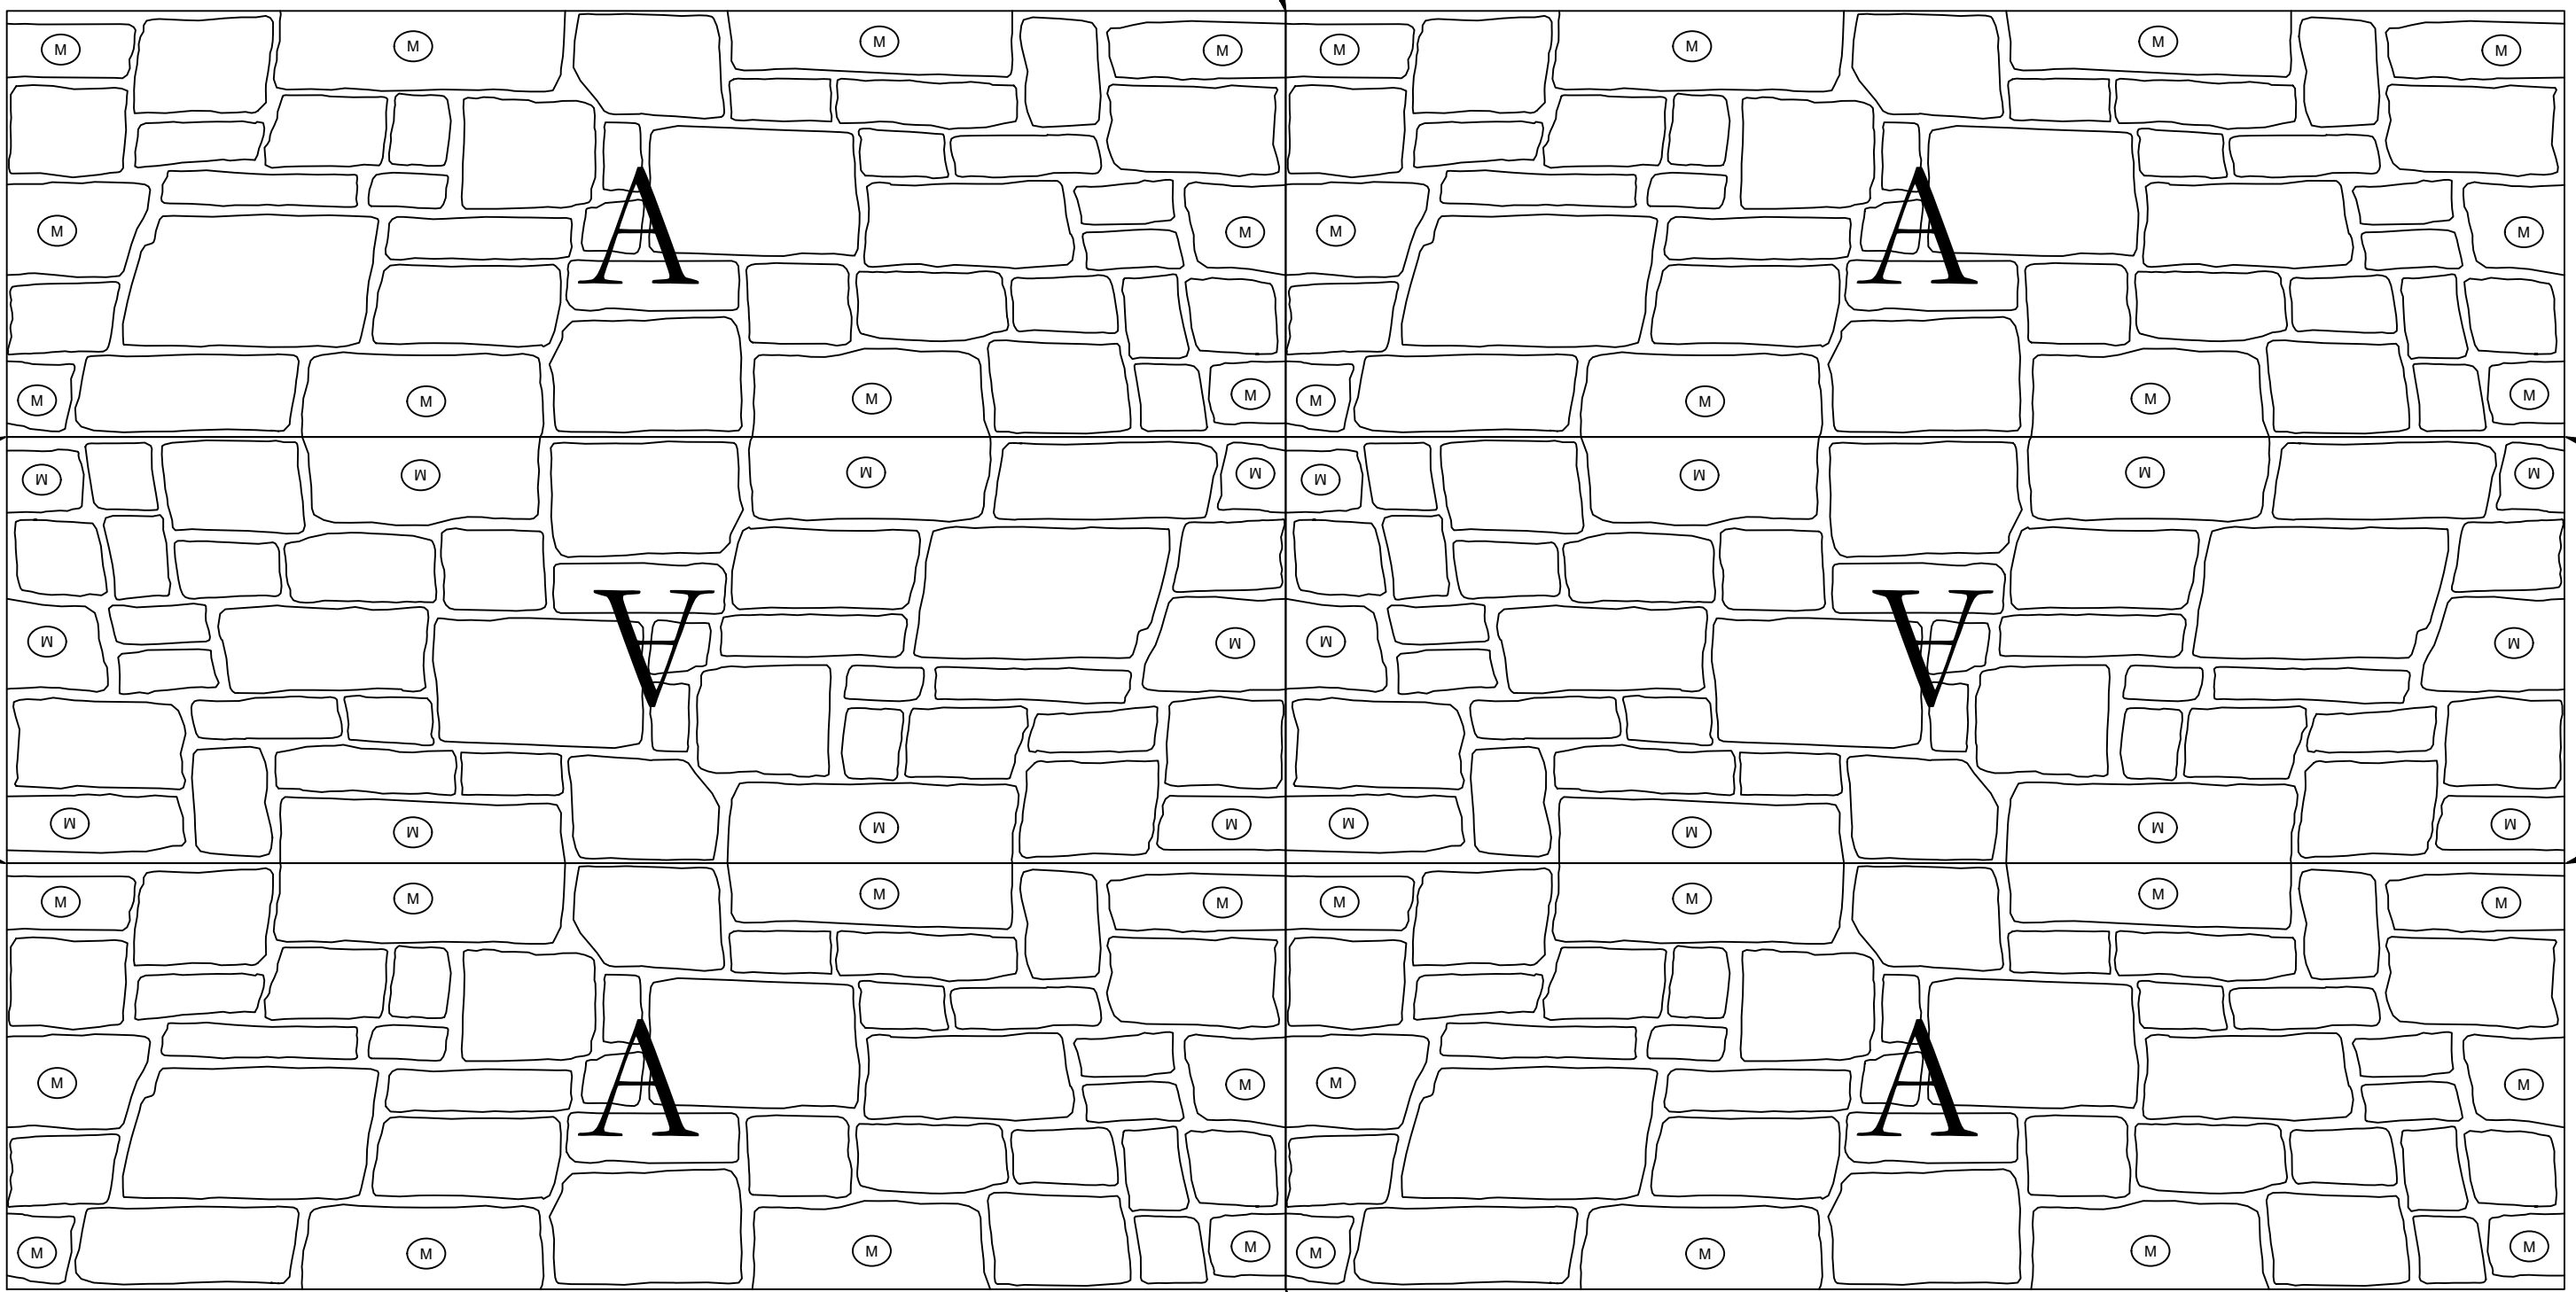
24'-0"

A noticeable seam will occur if not properly sealed when stacking liners.

12'-0"
