ITEM # 310154

Customer:
 Job Name:
 Title: #337 1 1/2" V Groove 3" O/C

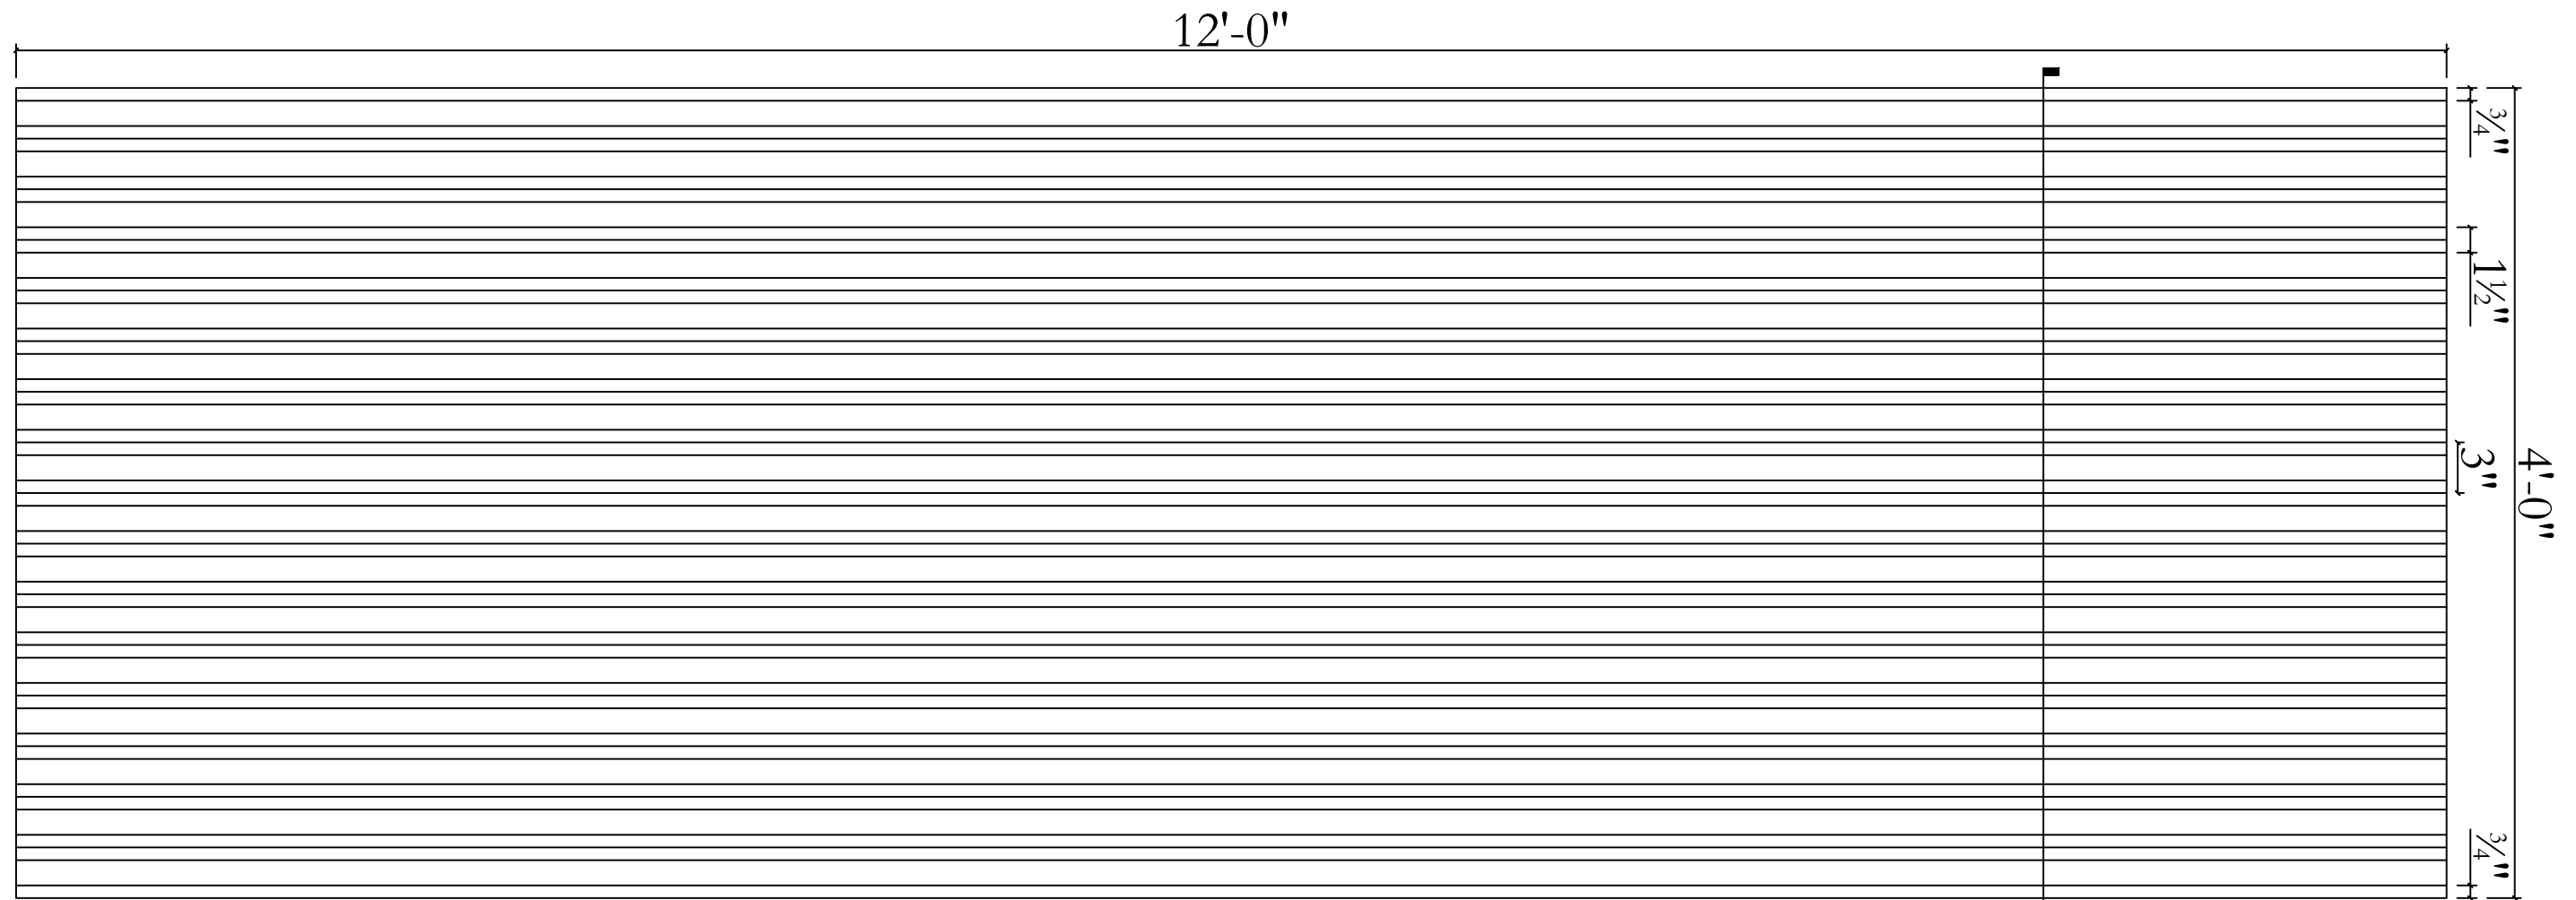
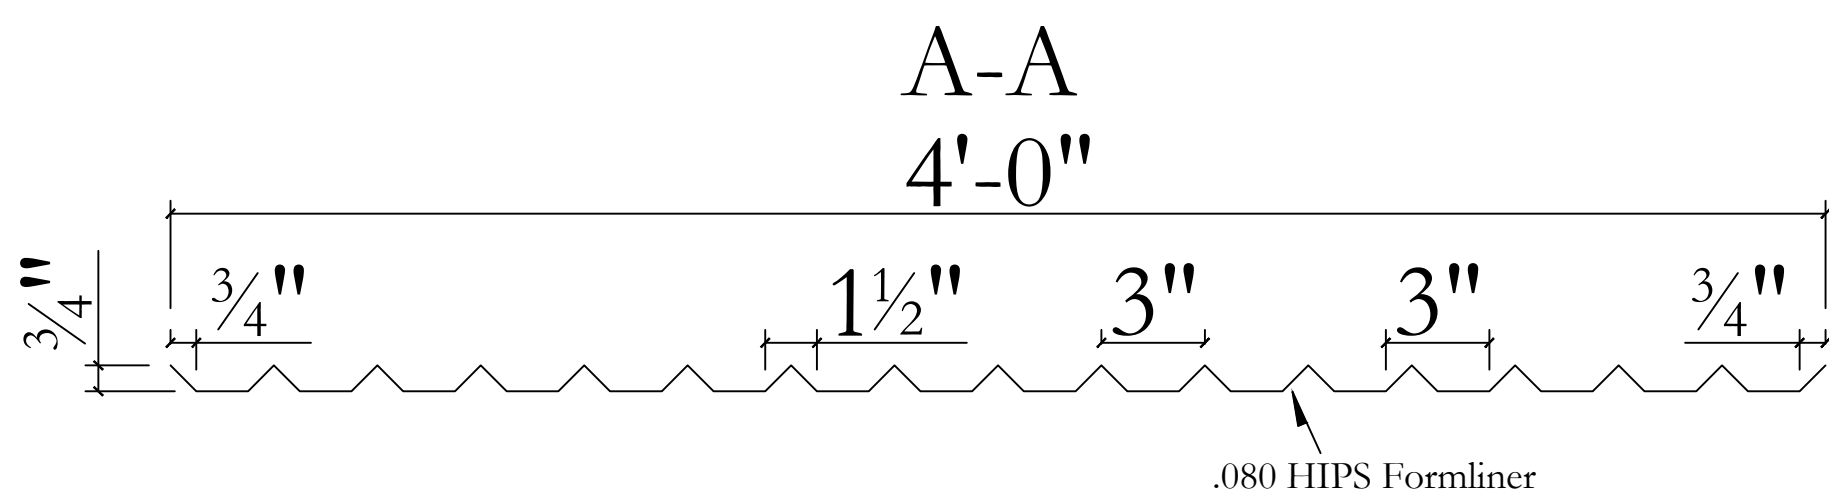
24'-0"

Pattern not designed to stack in 12' direction. A noticeable seam will occur if stacking the liners in 12' direction

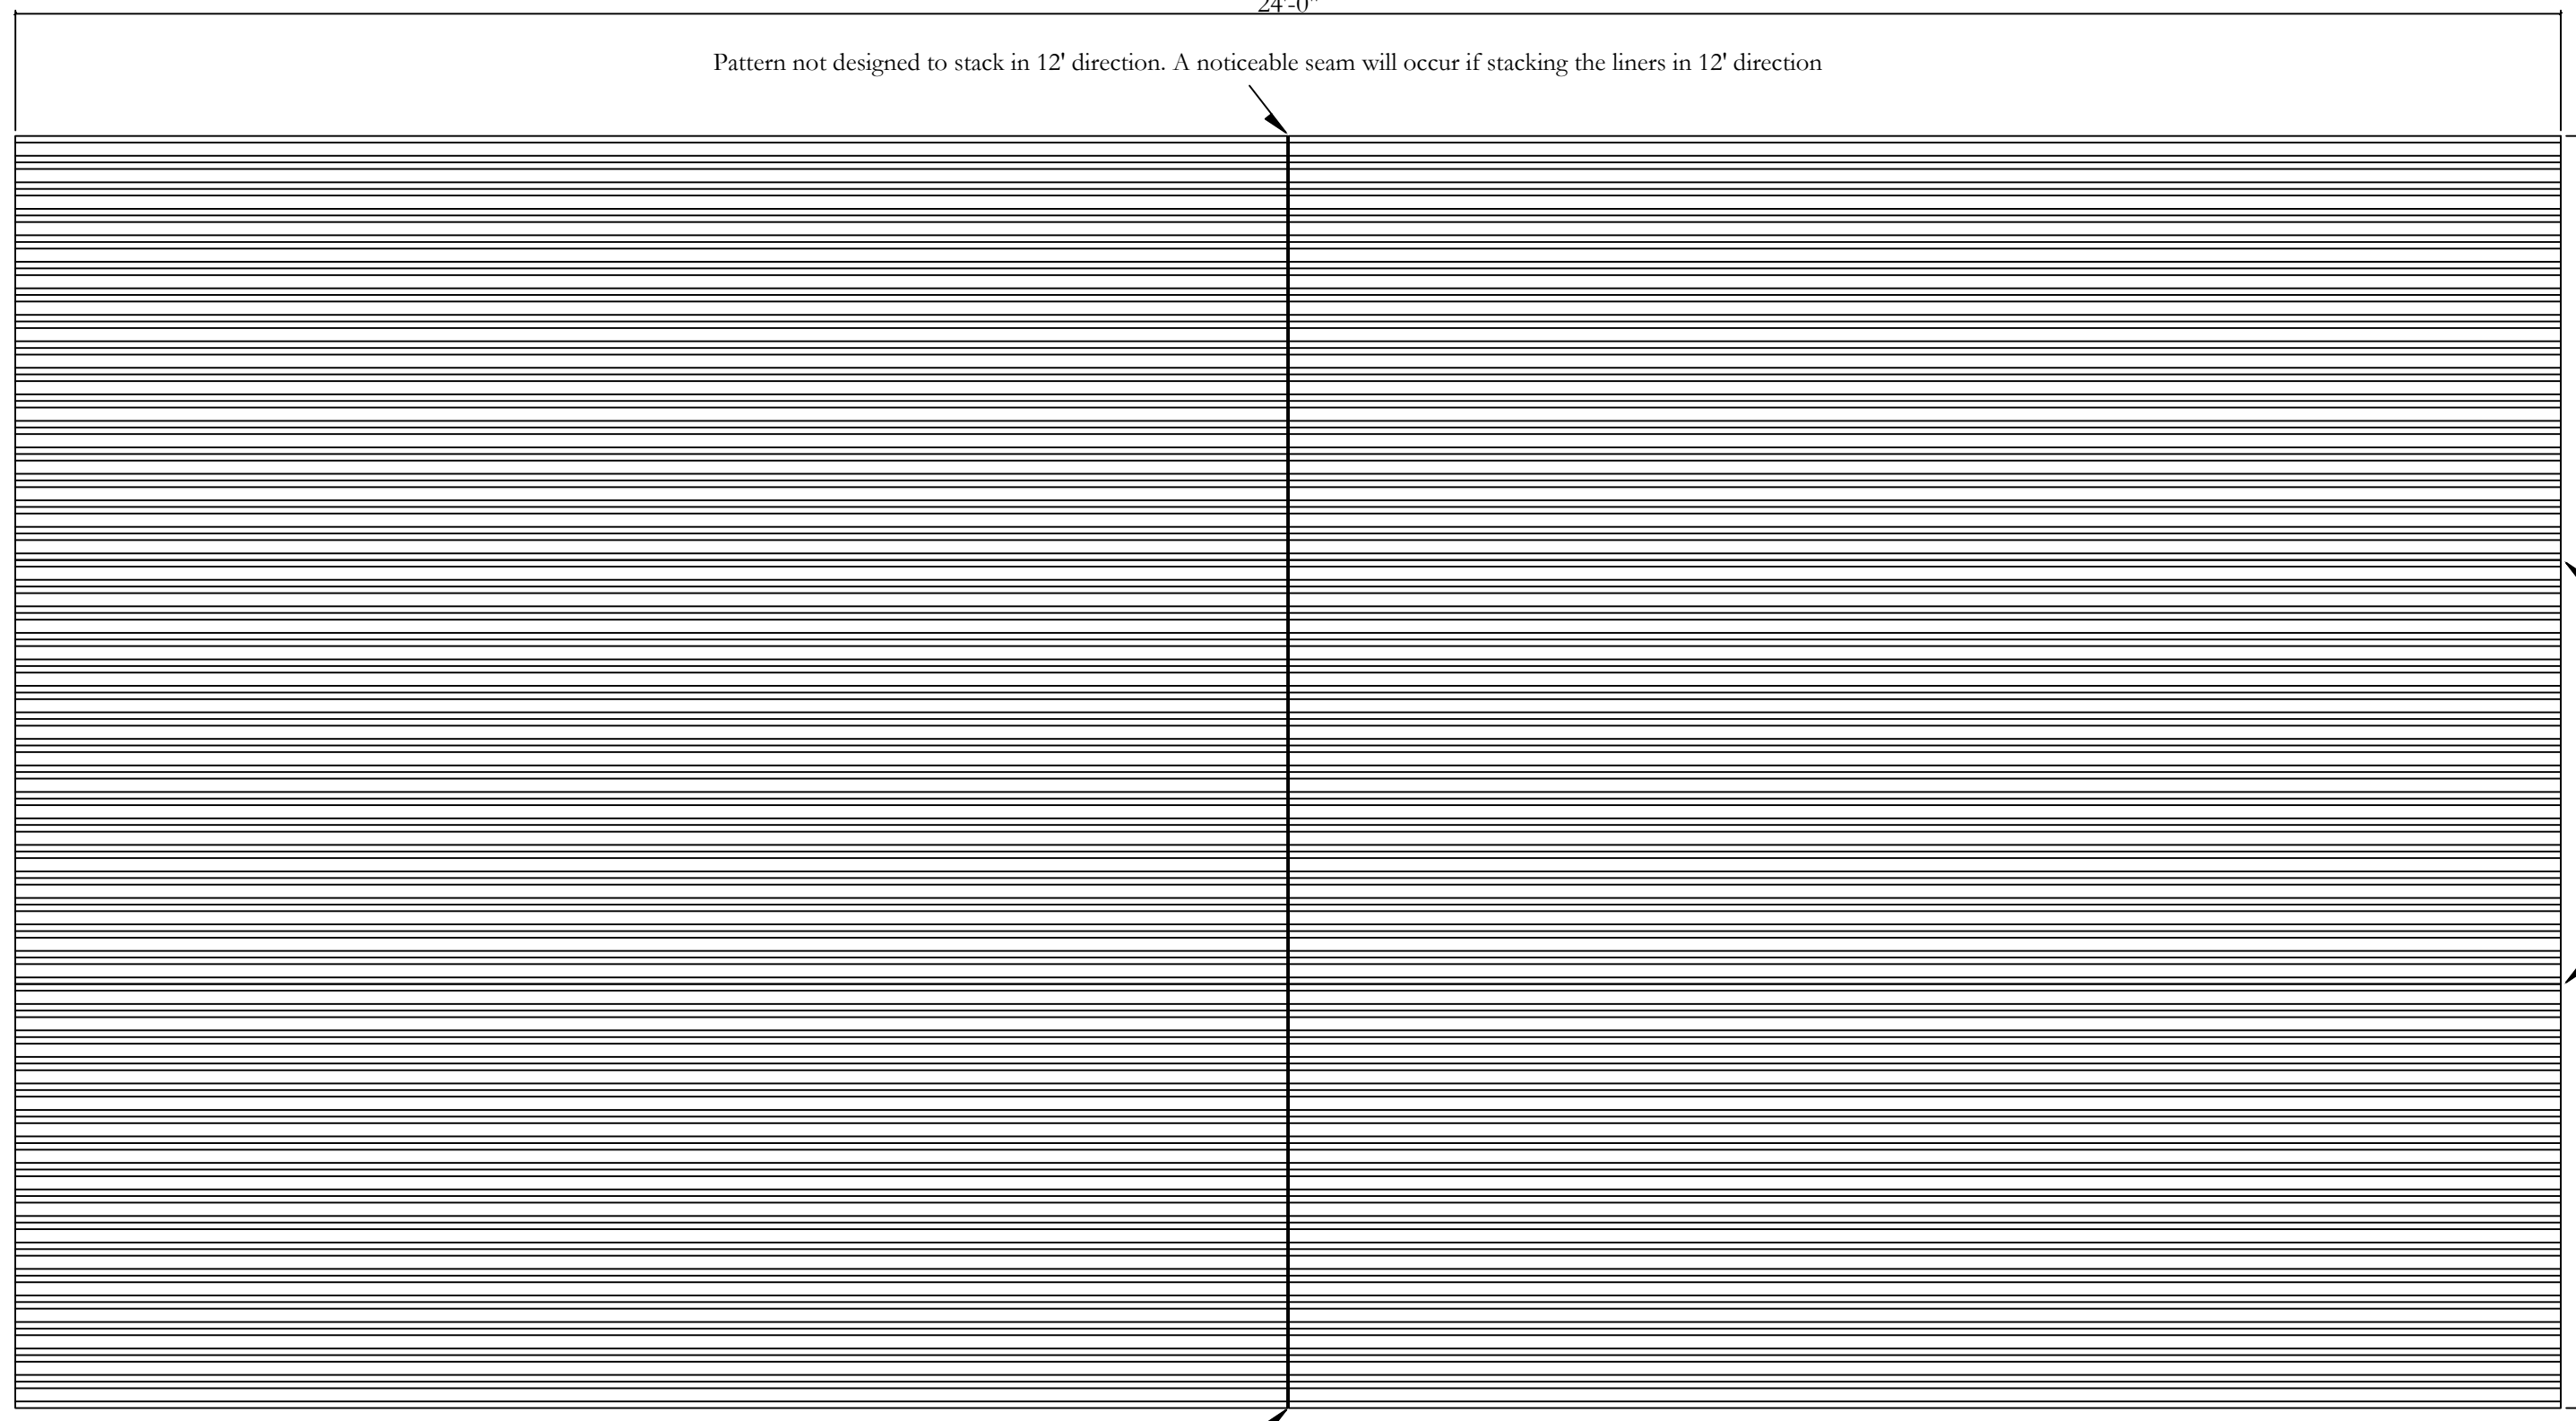
A noticeable seam will occur if not properly sealed before pouring

12'-0"

Pattern not designed to stack in 12' direction. A noticeable seam will occur if stacking the liners in 12' direction
