# #101A Velour Modular Running Bond Zipper

Customer:  
 Job Name:  
 Title:  
 #101A Velour Modular RB - 3'-0 3/8"x 2'-8 3/8" Zipper

Customer: \_\_\_\_\_  
 Job Name: \_\_\_\_\_  
 Title: #101A Velour Modular RB - 3'-0 3/8"x 2'-8 3/8" Zipper Assembled

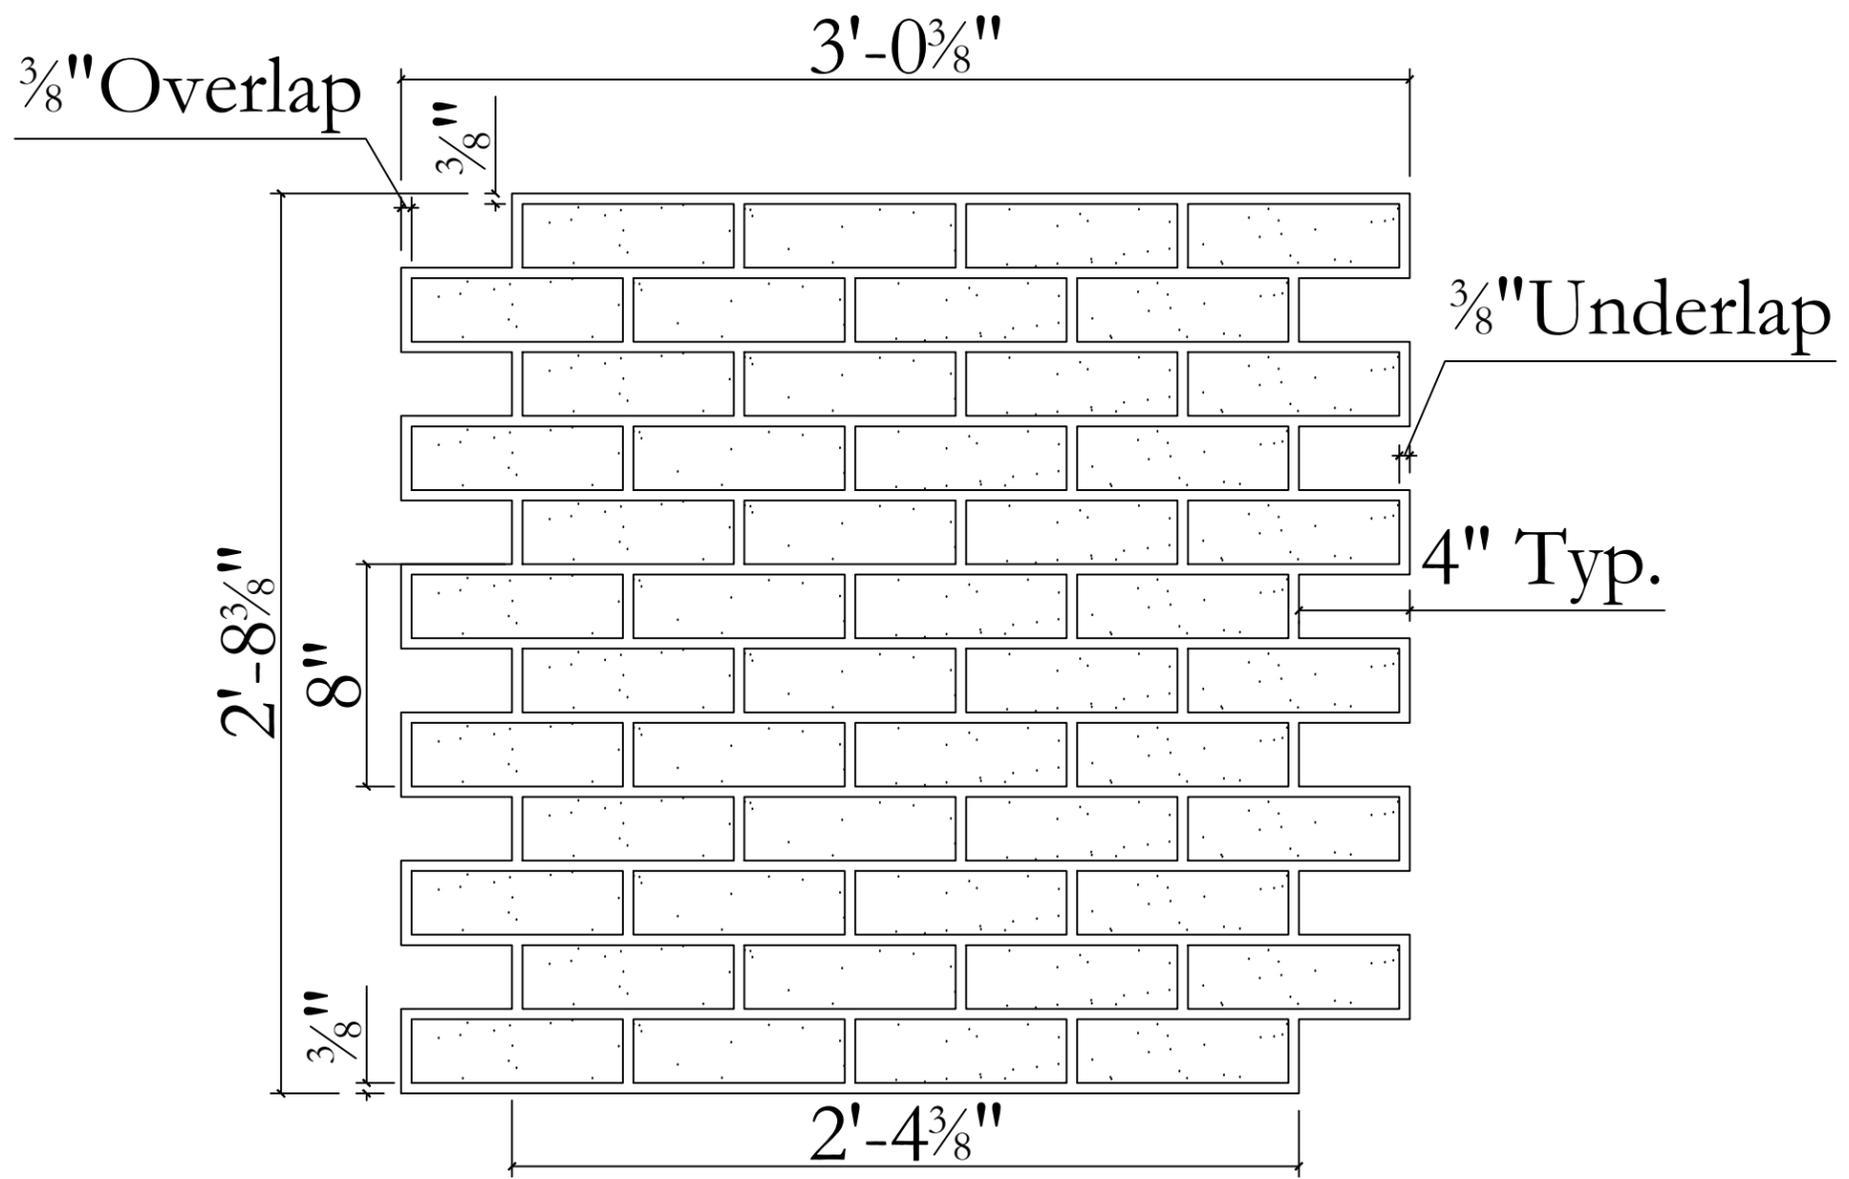
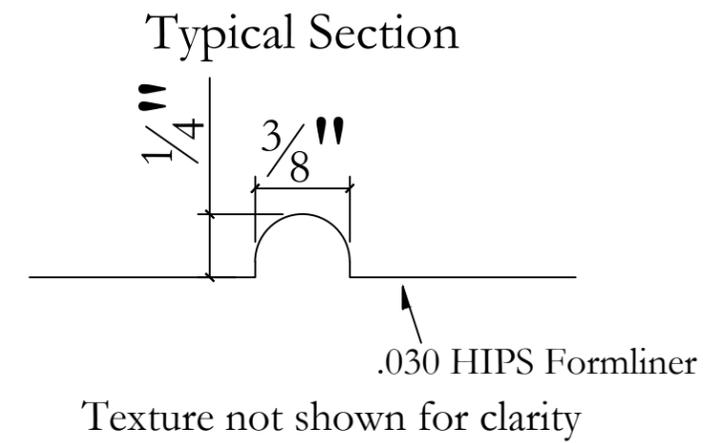
7.39 SF

6.37 SF Coverage

Hatch texture for visual reference only. Actual texture will vary

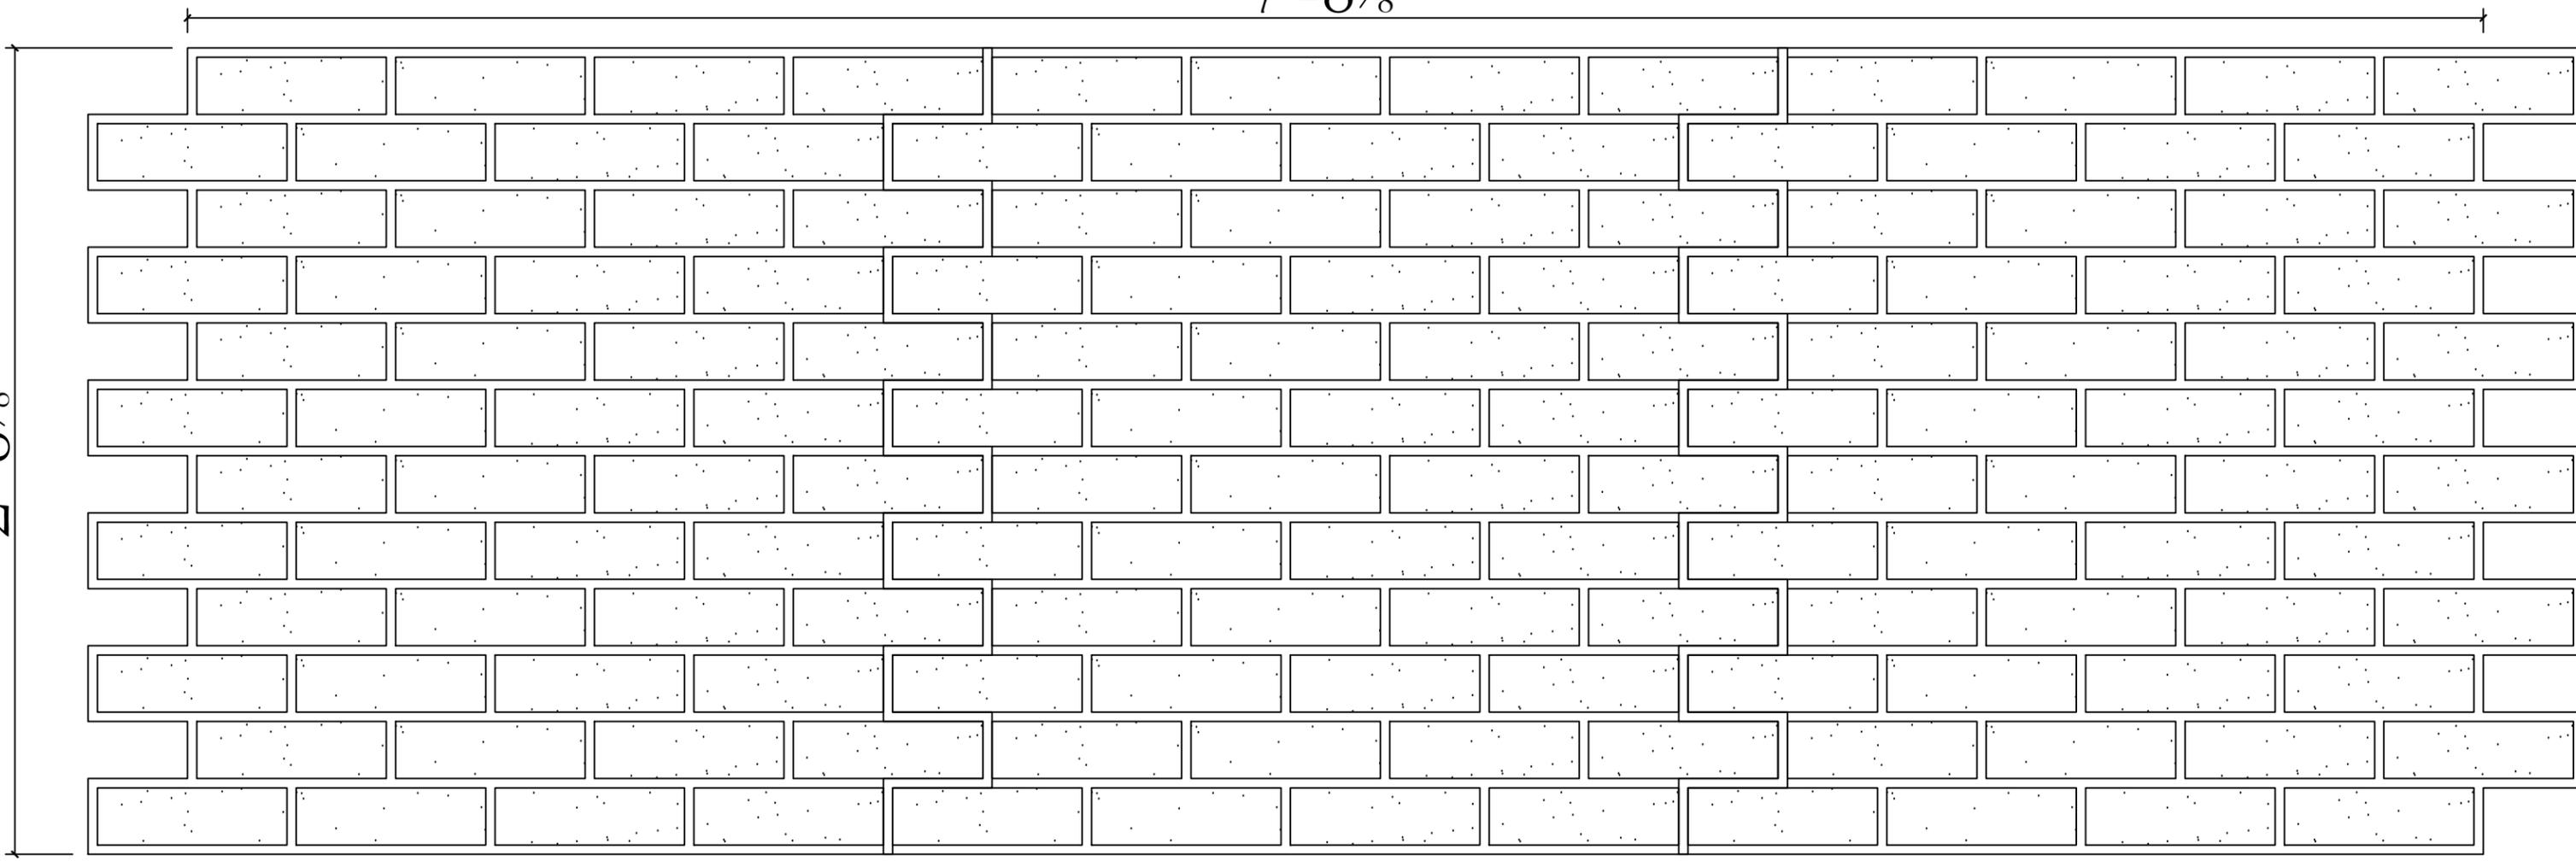
# Assembled

## 7'-8<sup>3</sup>/<sub>8</sub>"

2'-8<sup>3</sup>/<sub>8</sub>"

**Lapping Seam Location**
