Customer:  
Job Name:  
Title: #897A 15" Rustic Quarried Random Lengths

Customer:  
 Job Name:  
 Title: #897A 15" Rustic Quarried Random Lengths Assembled

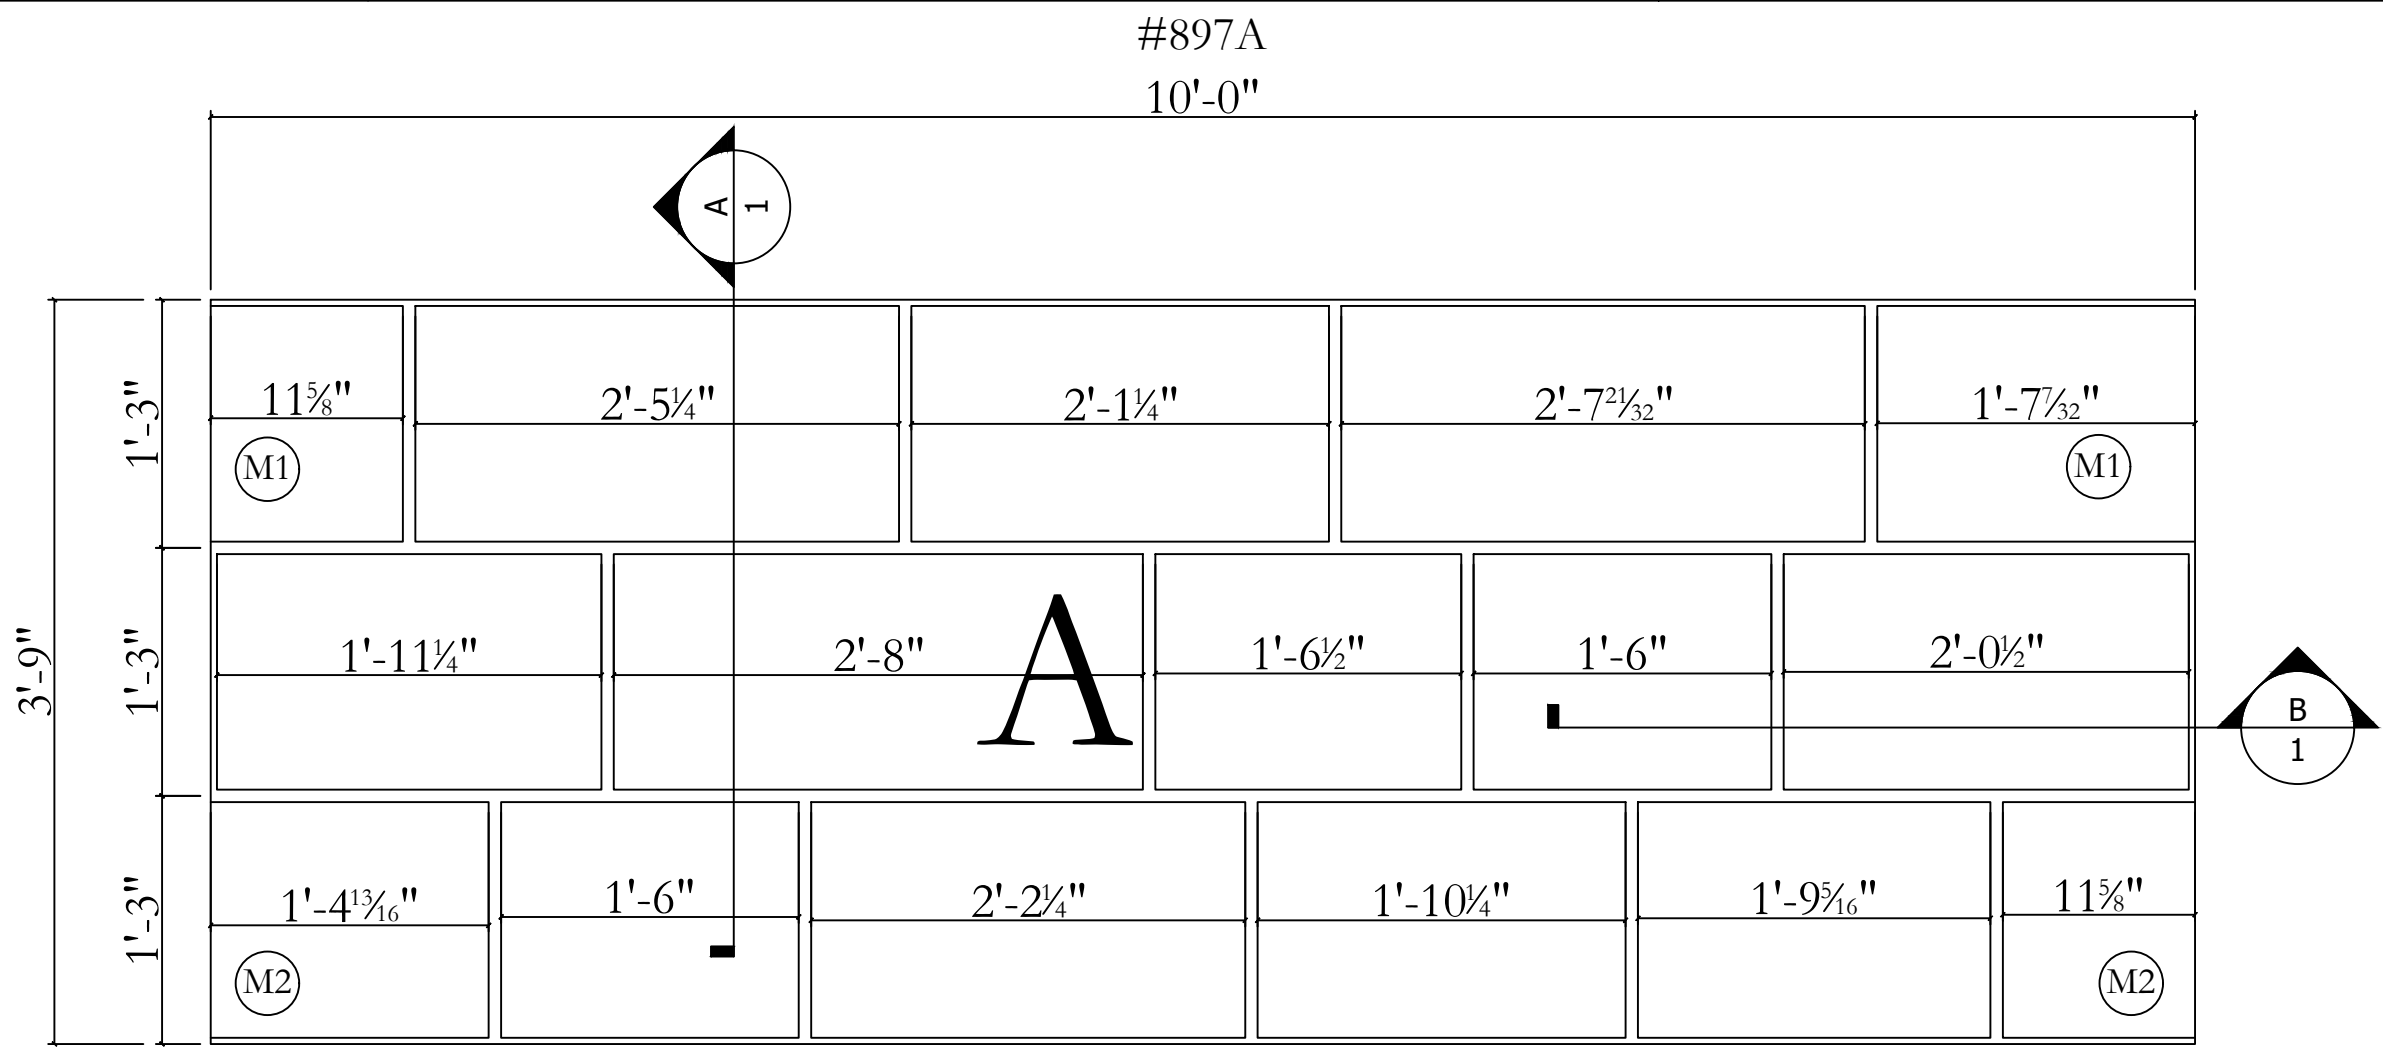
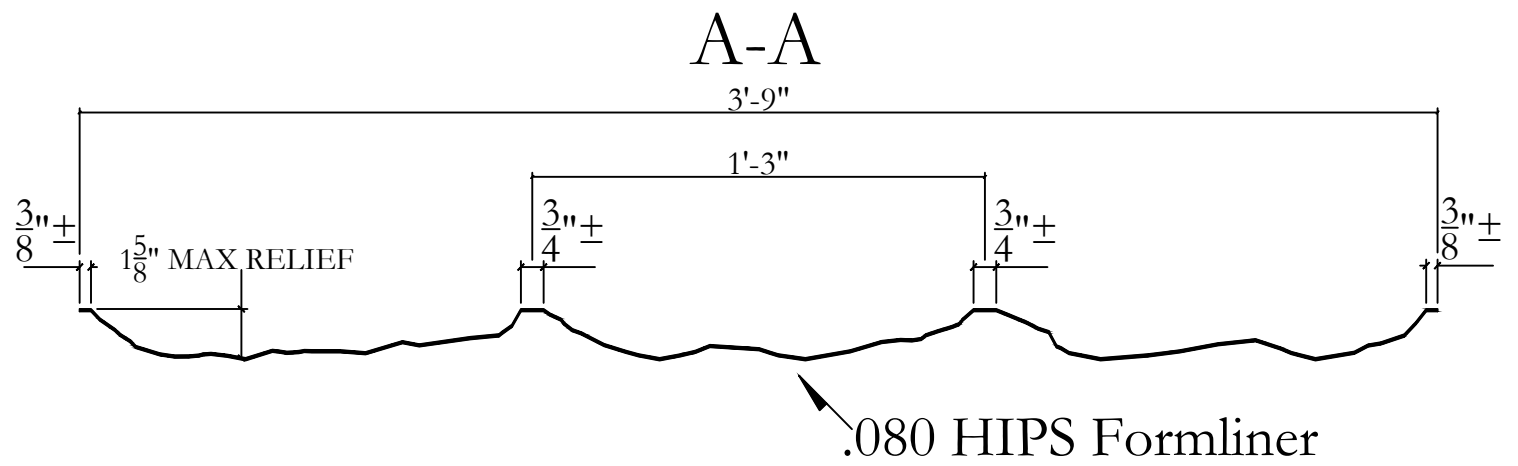
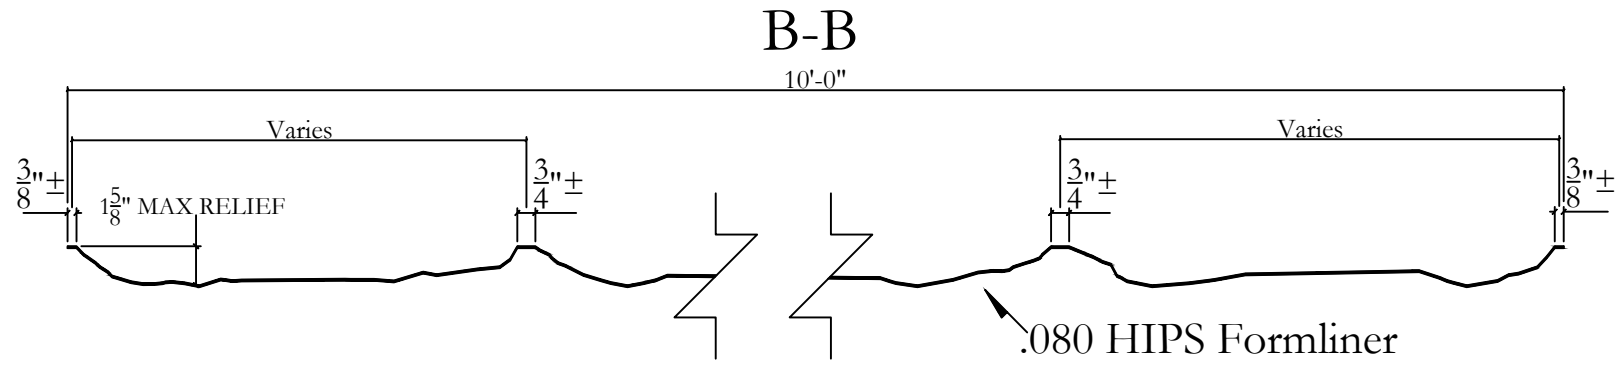
Stone Layout and Dimensions For Visual Reference Only  
Actual Stone Layout and Sizes May Vary

20'-0"

7'-6"

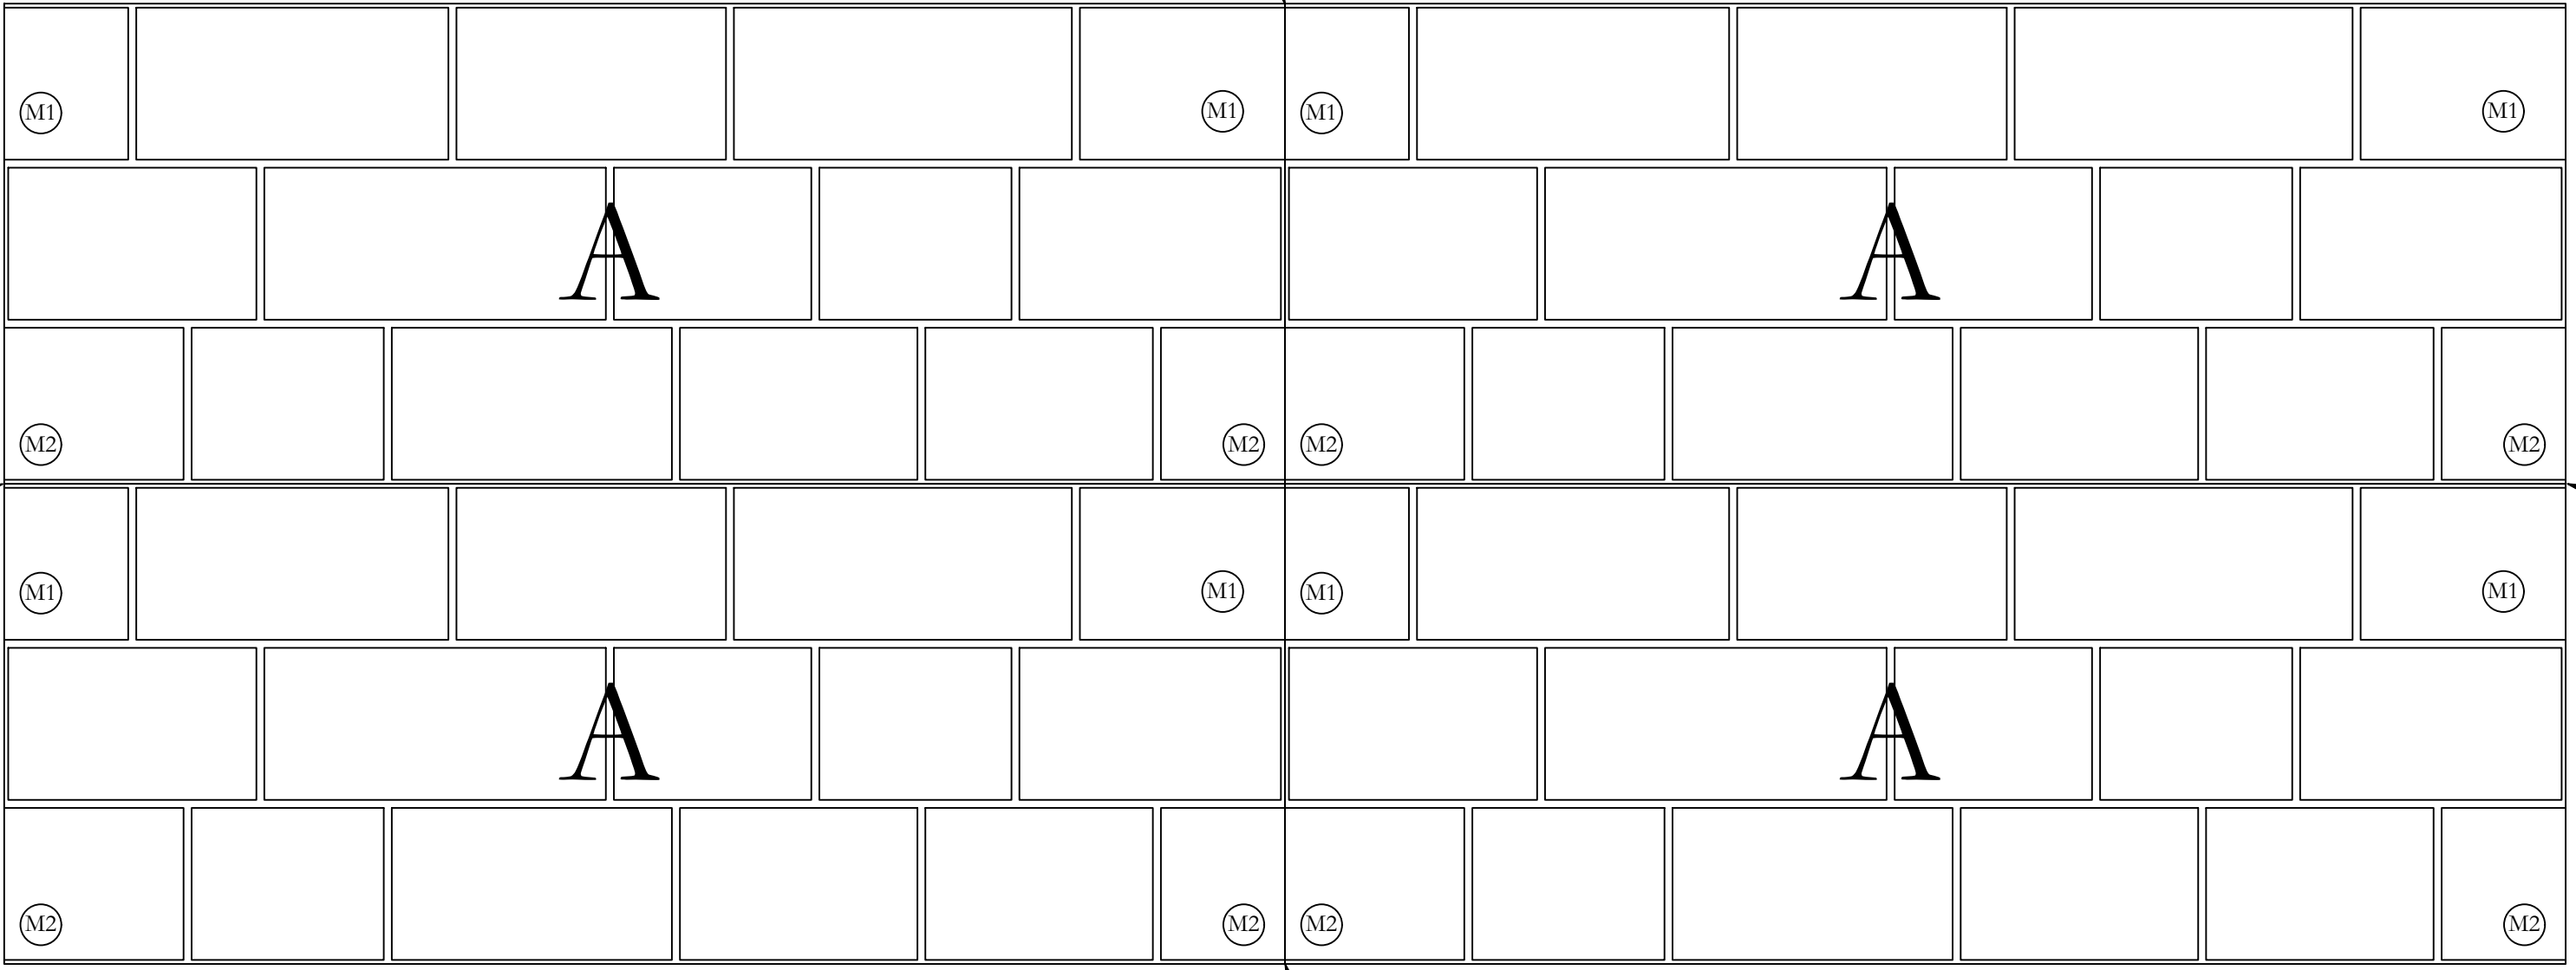
A noticeable seam will occur if not properly sealed when stacking liners.
