Customer:
 Job Name:
 Title: #900 2"x8" Split Block

Customer:
Job Name:
Title: #900 2"x8" Split Block Assembled

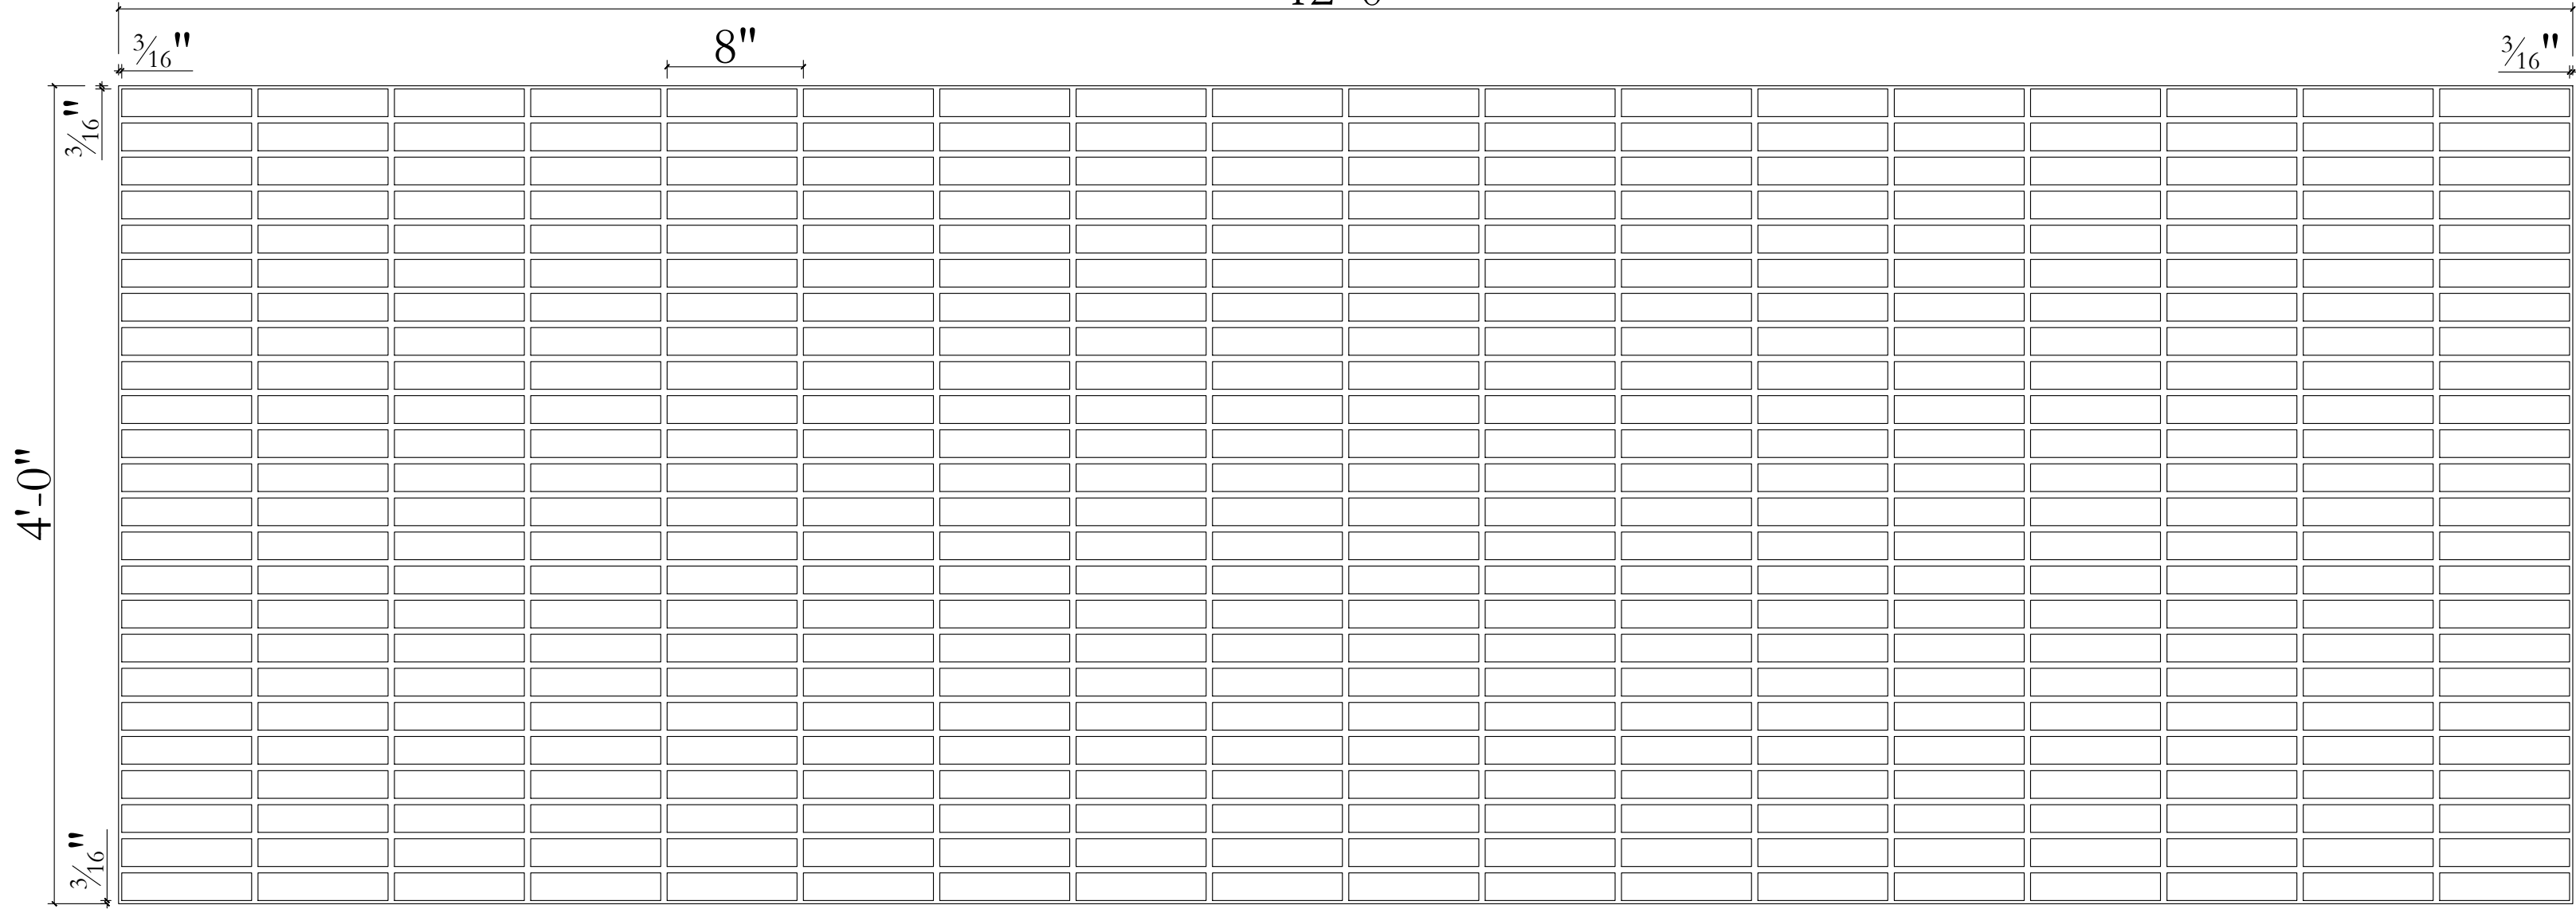
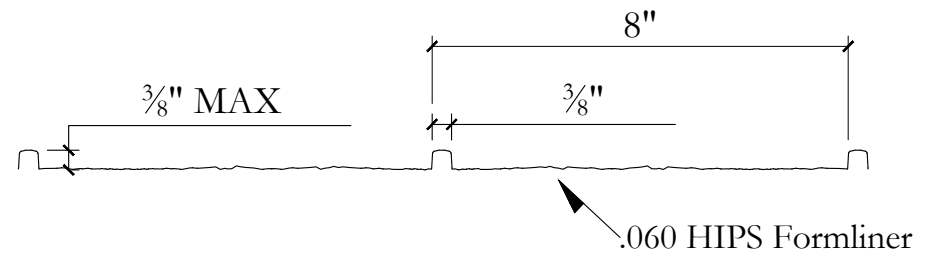
Typical Section

12'-0"

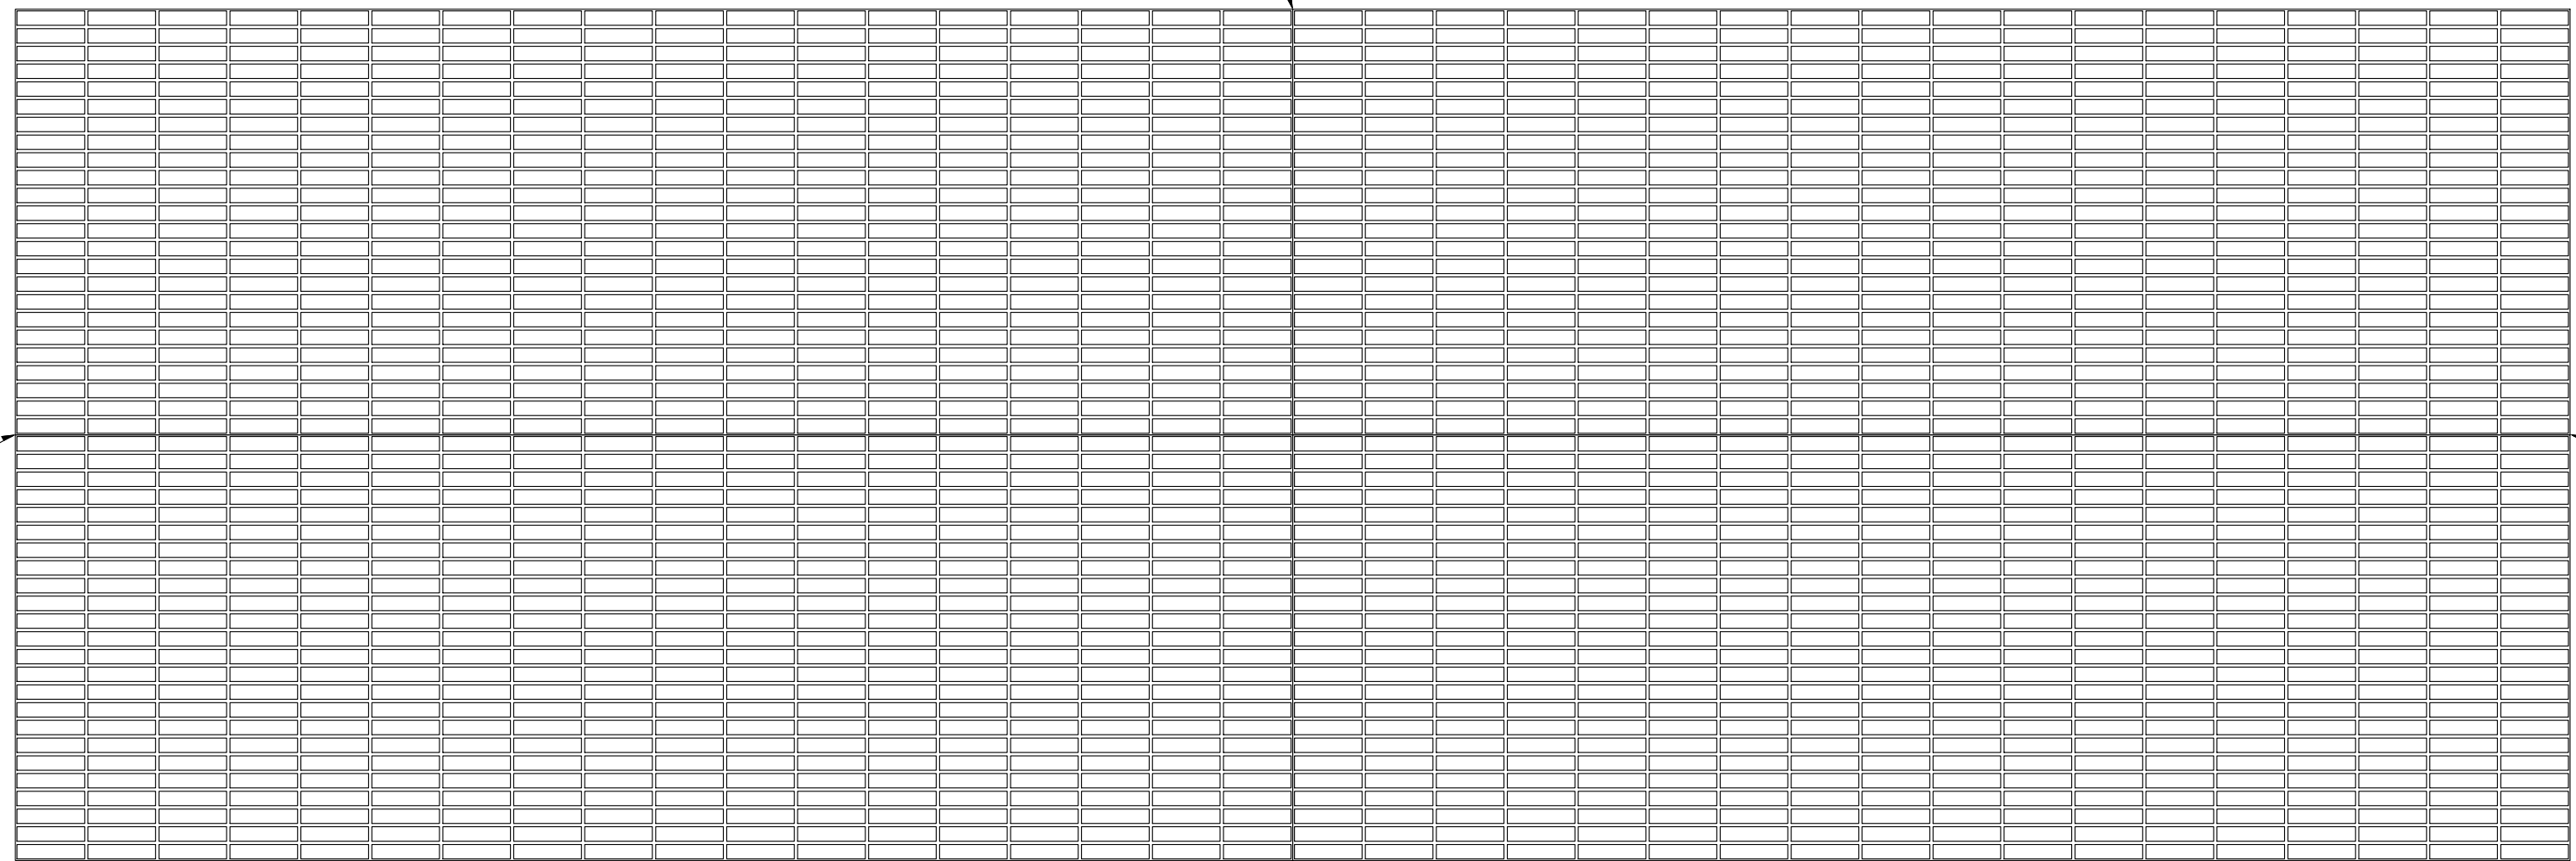
24'-0"

A noticeable seam will occur if not properly sealed when stacking liners.

8'-0"
