ITEM # 300027

Customer:	
Job Name:	
Title:	#904A Ashlar Stone

Customer:  
 Job Name:  
 Title: #904A Ashlar Stone Assembled

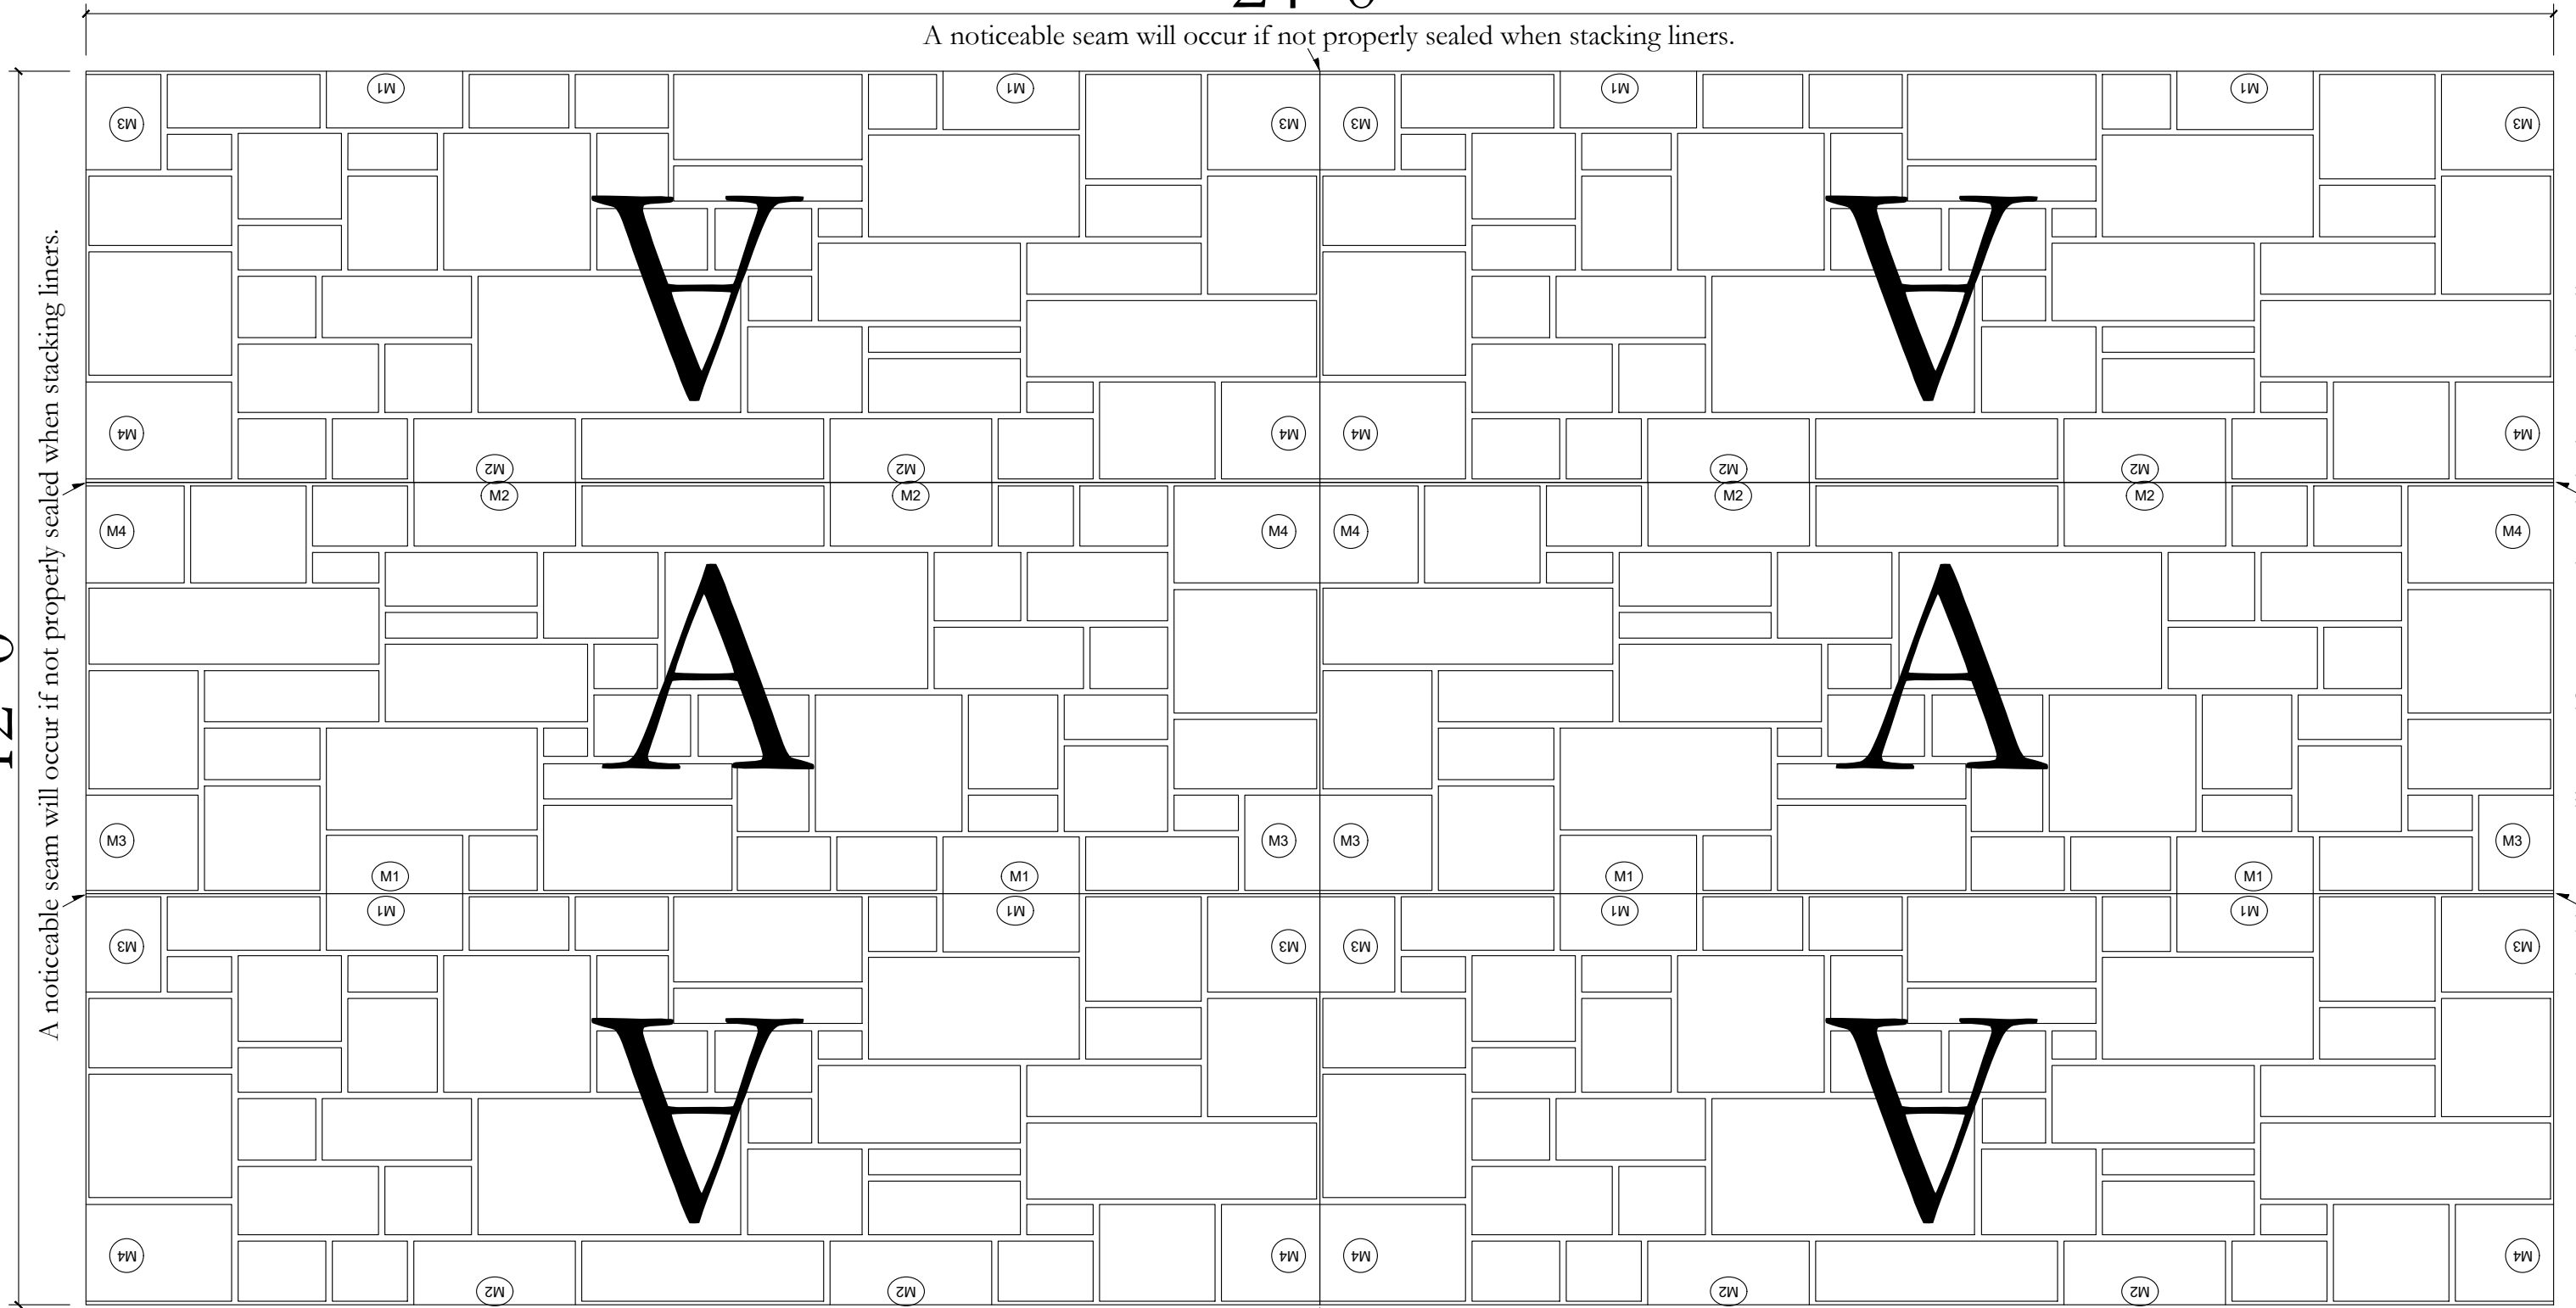
24'-0"

12'-0"  
A noticeable seam will occur if not properly sealed when stacking liners.

A noticeable seam will occur if not properly sealed when stacking liners.
