Customer:	
Job Name:	
Title:	#905 Small Aged Ashlar Stone

Customer:  
 Job Name:  
 Title: #905 Snall Aged Ashlar Stone Assembled

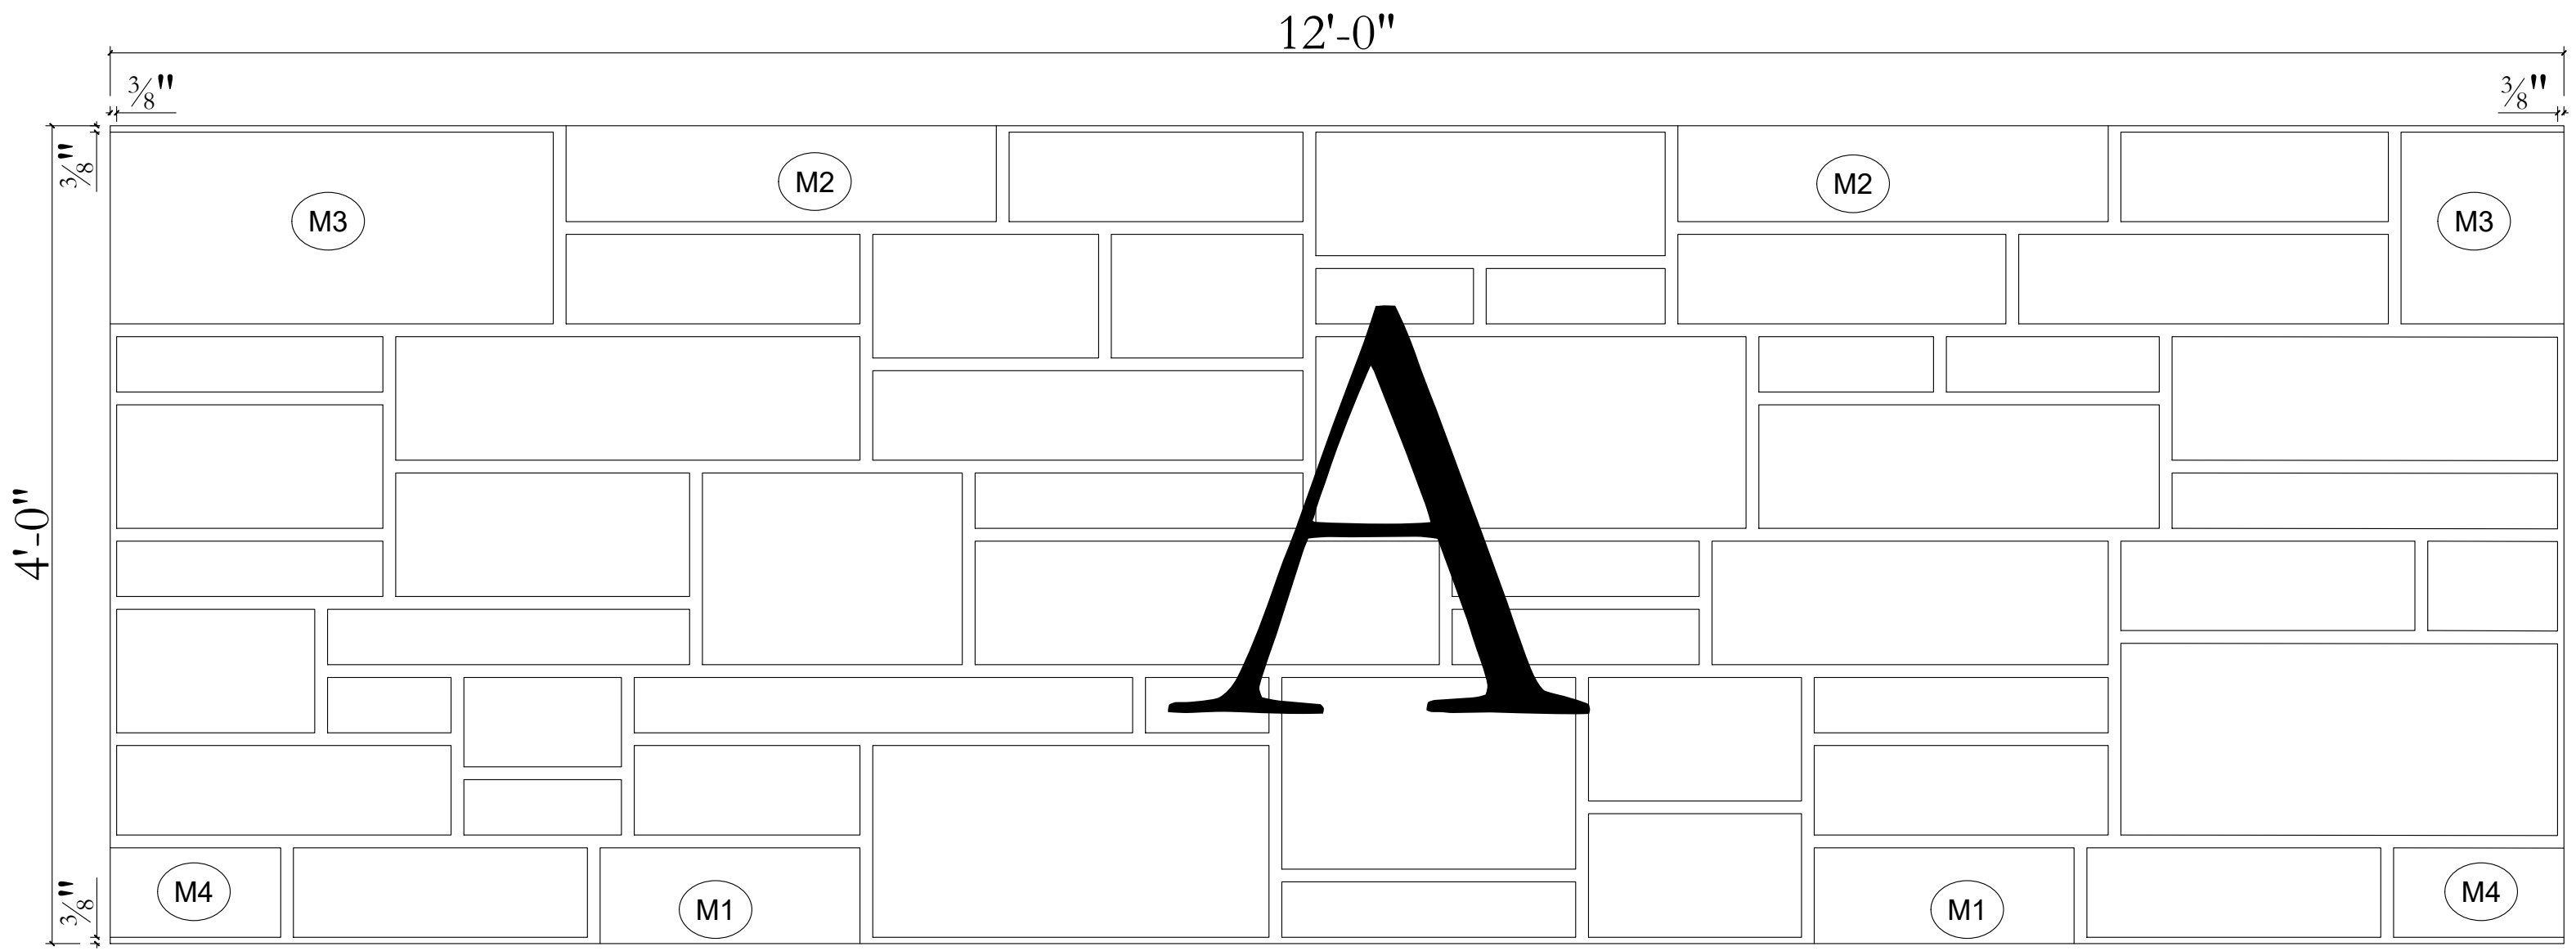
STONE LAYOUT FOR CONCEPT ONLY ACTUAL LAYOUT WILL VARY

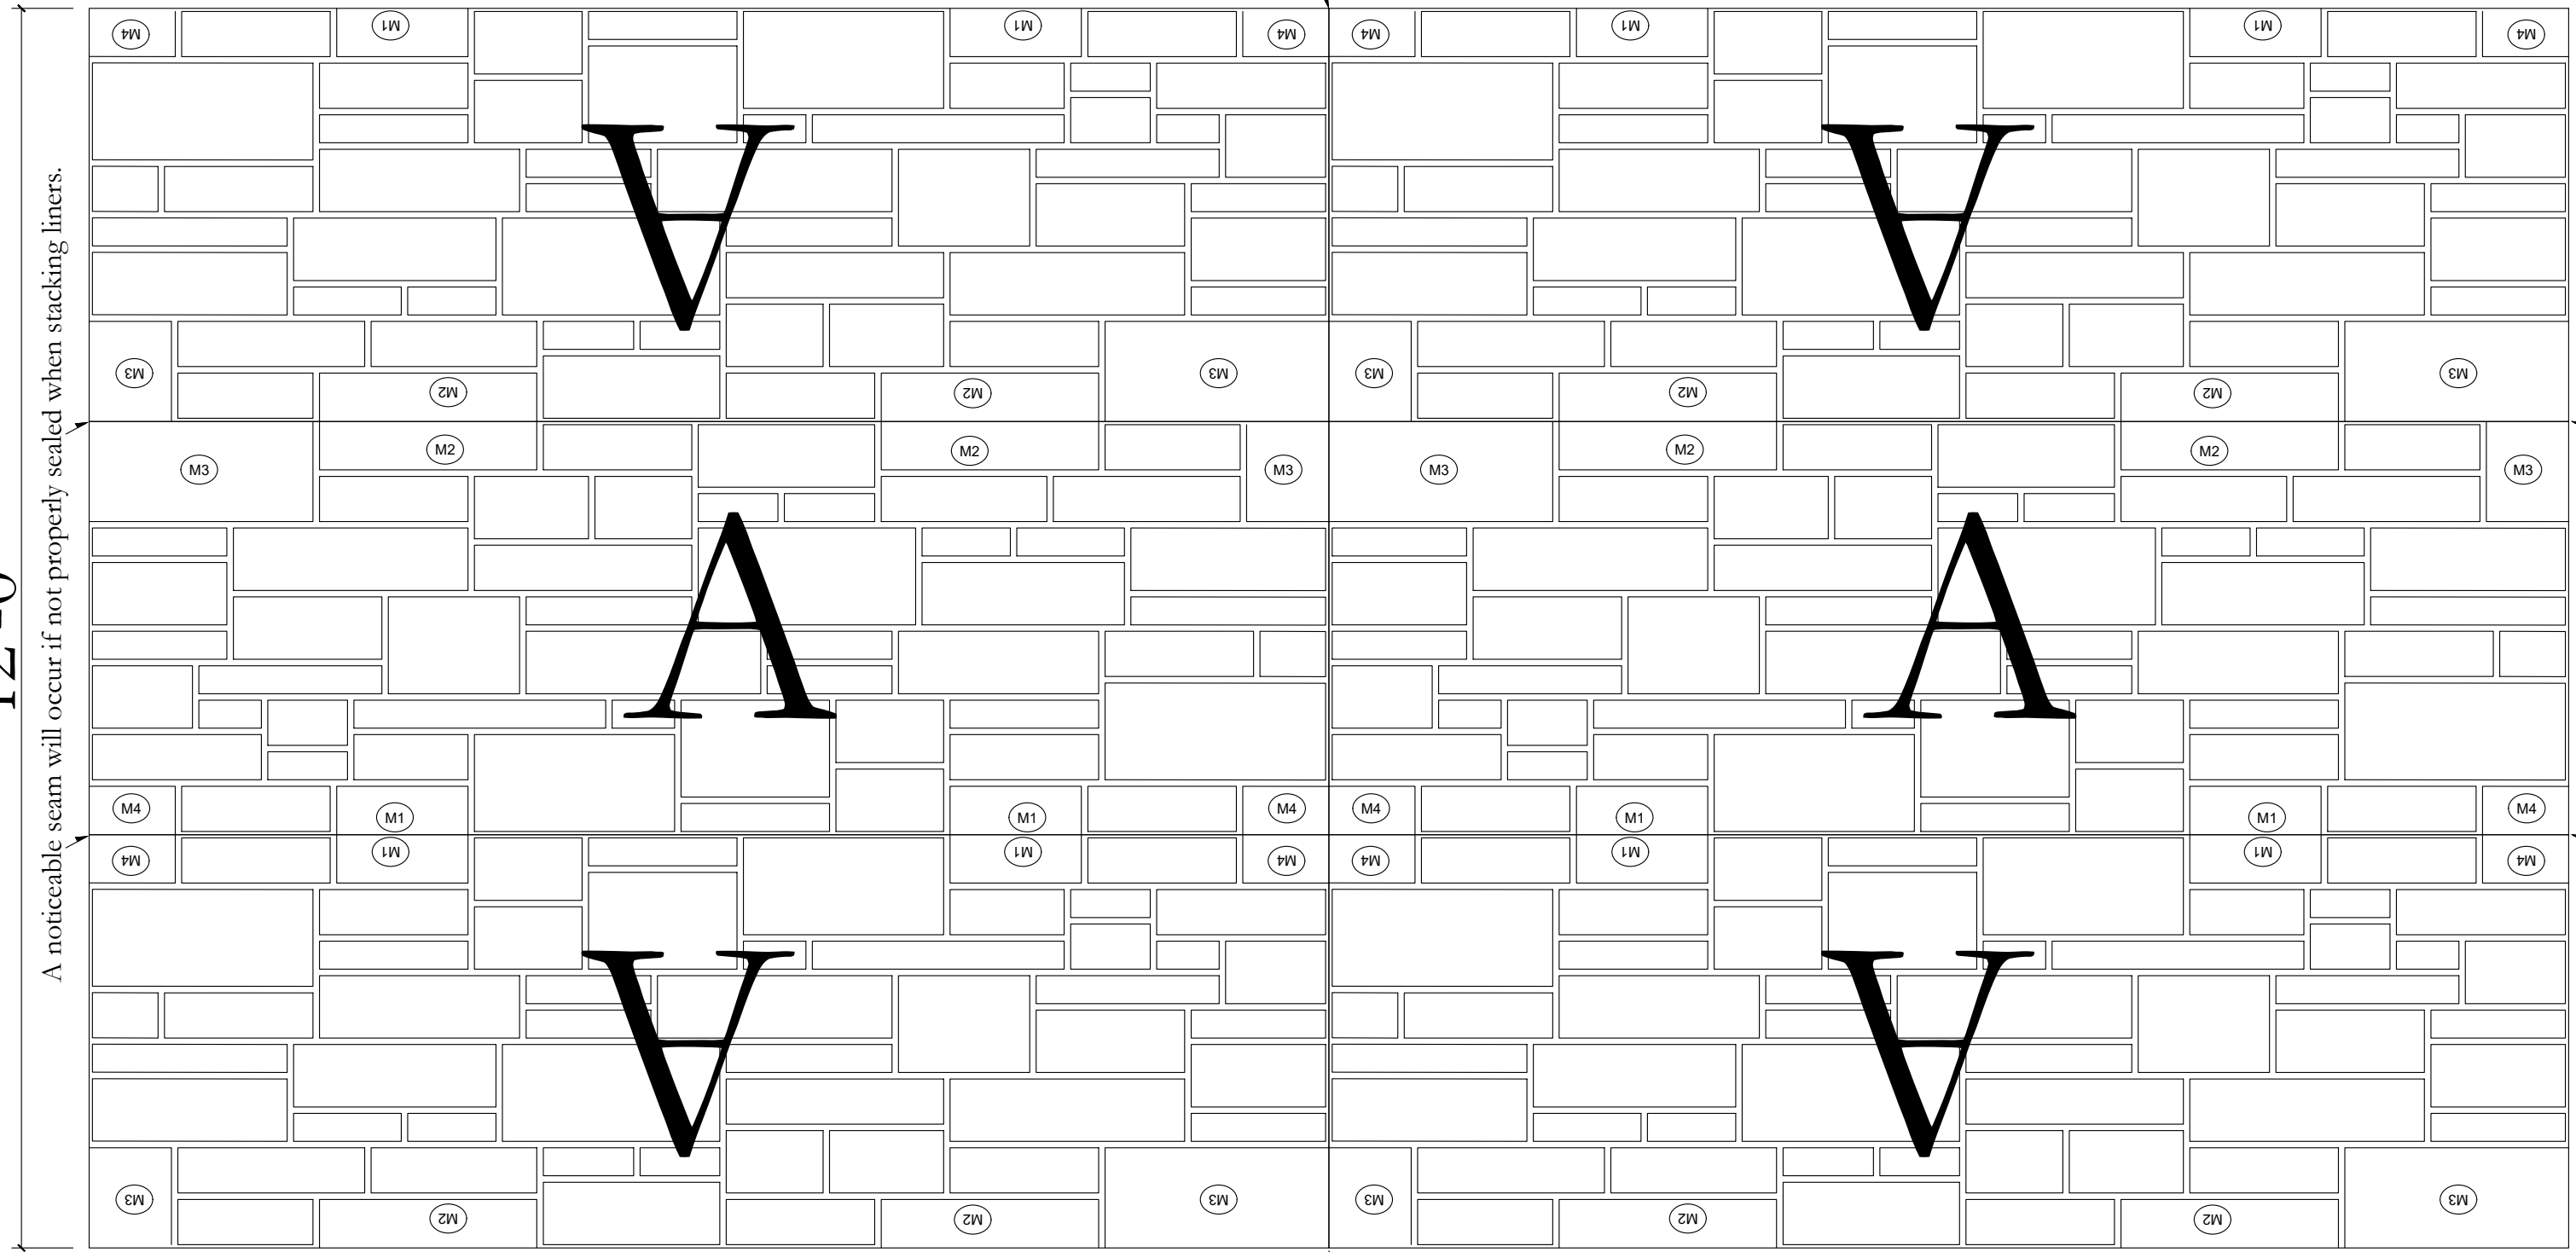
24'-0"

A noticeable seam will occur if not properly sealed when stacking liners.

12'-0"  
A noticeable seam will occur if not properly sealed when stacking liners.
