Customer:
 Job Name:
 Title: #906 Ashlar Stone Heavy Cut

Customer: _____
 Job Name: _____
 Title: #906 Ashlar Stone Heavy Cut Assembled

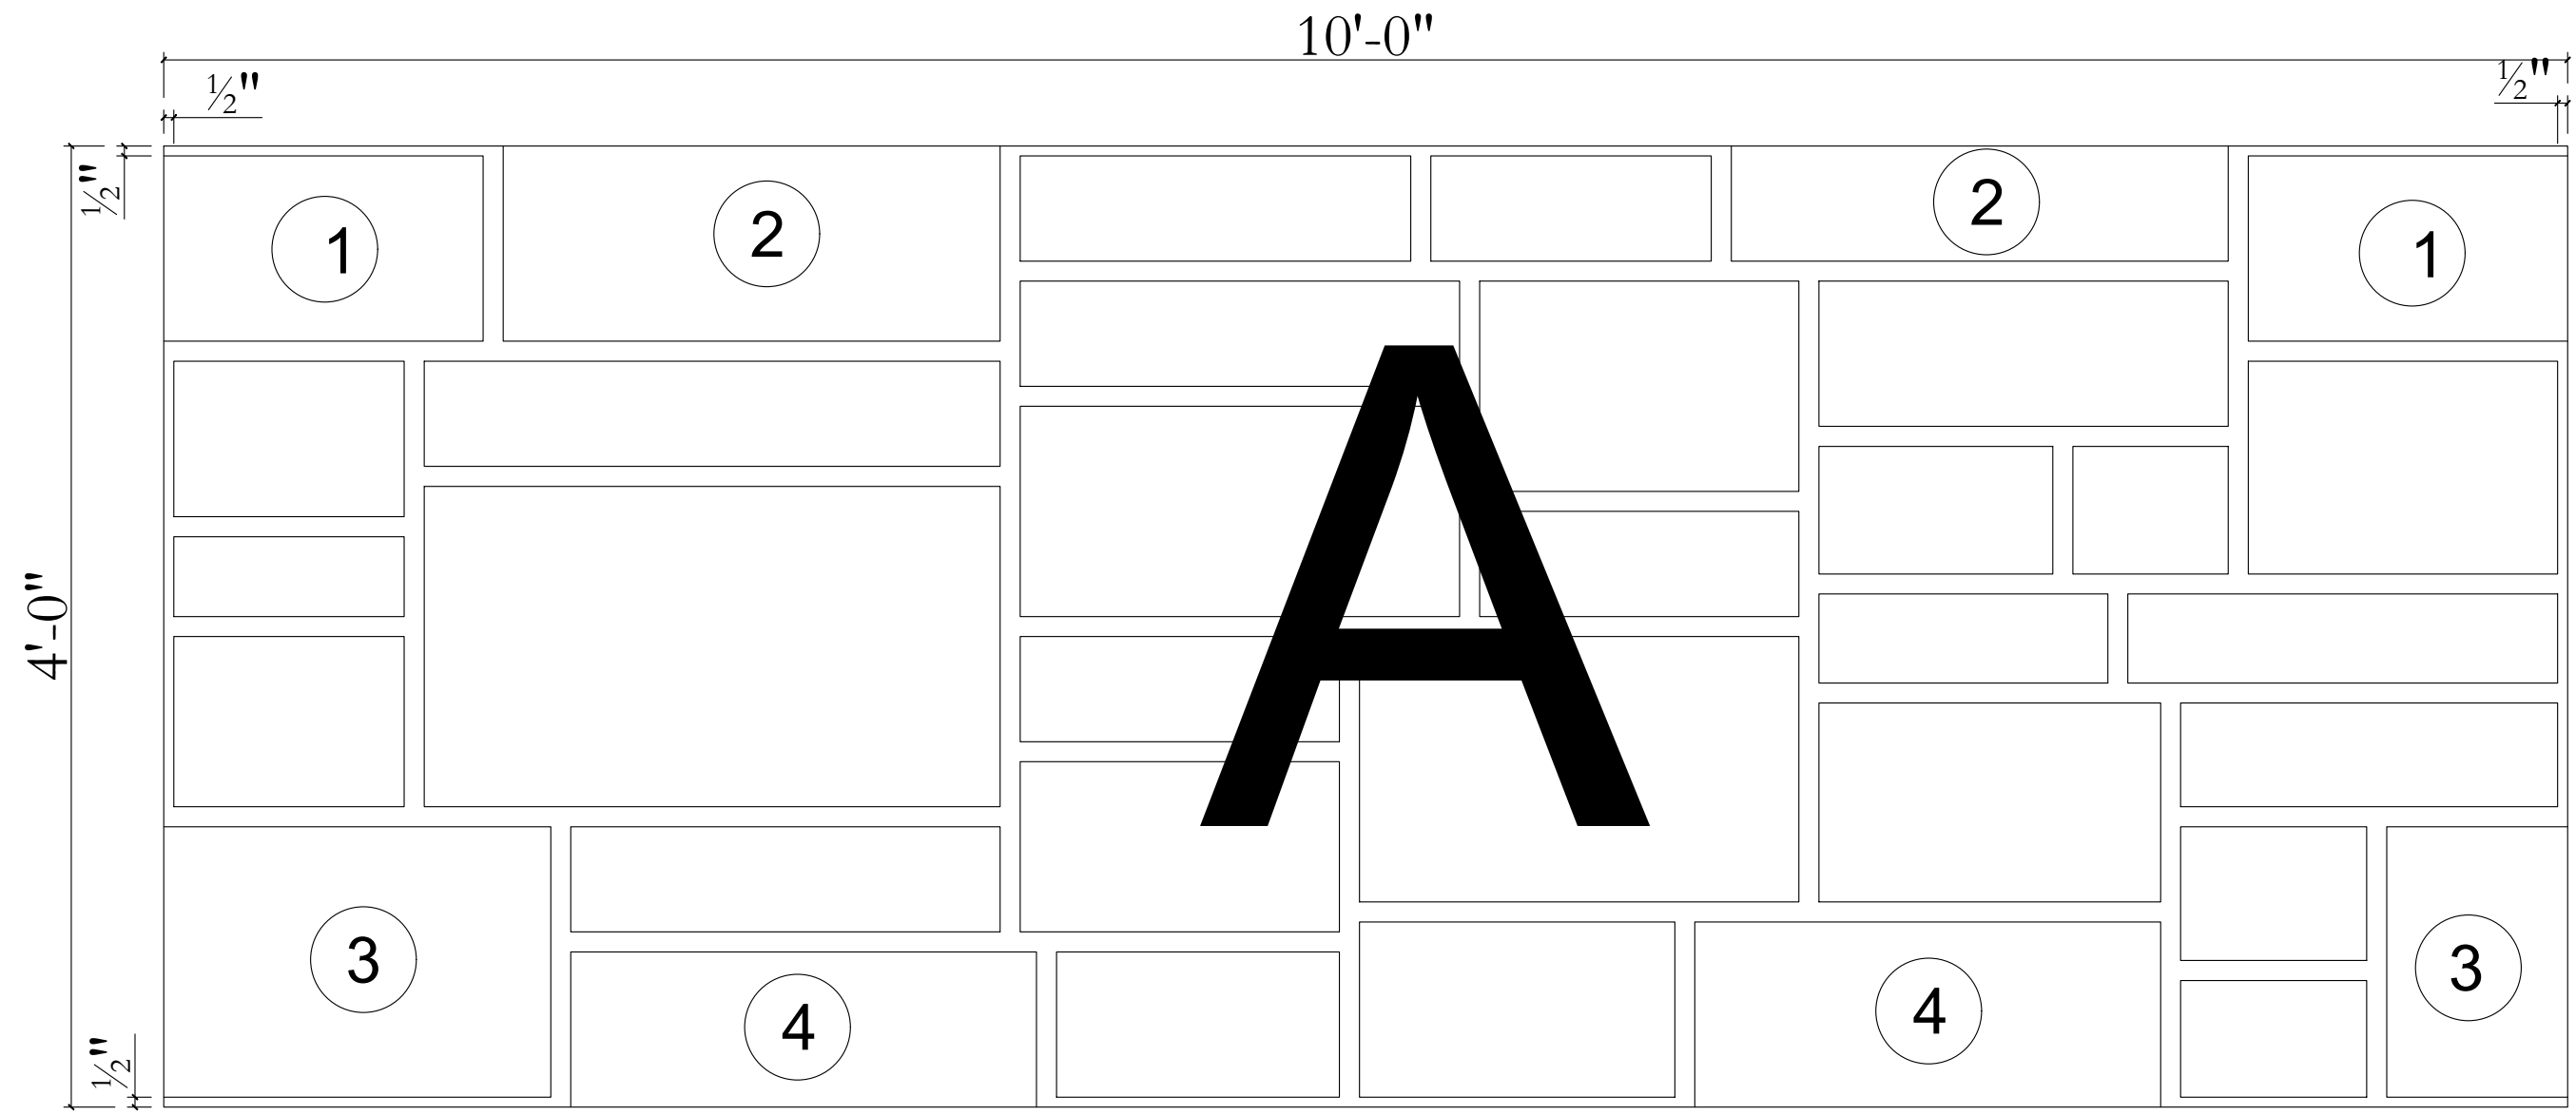
STONE LAYOUT FOR CONCEPT ONLY ACTUAL LAYOUT WILL VARY

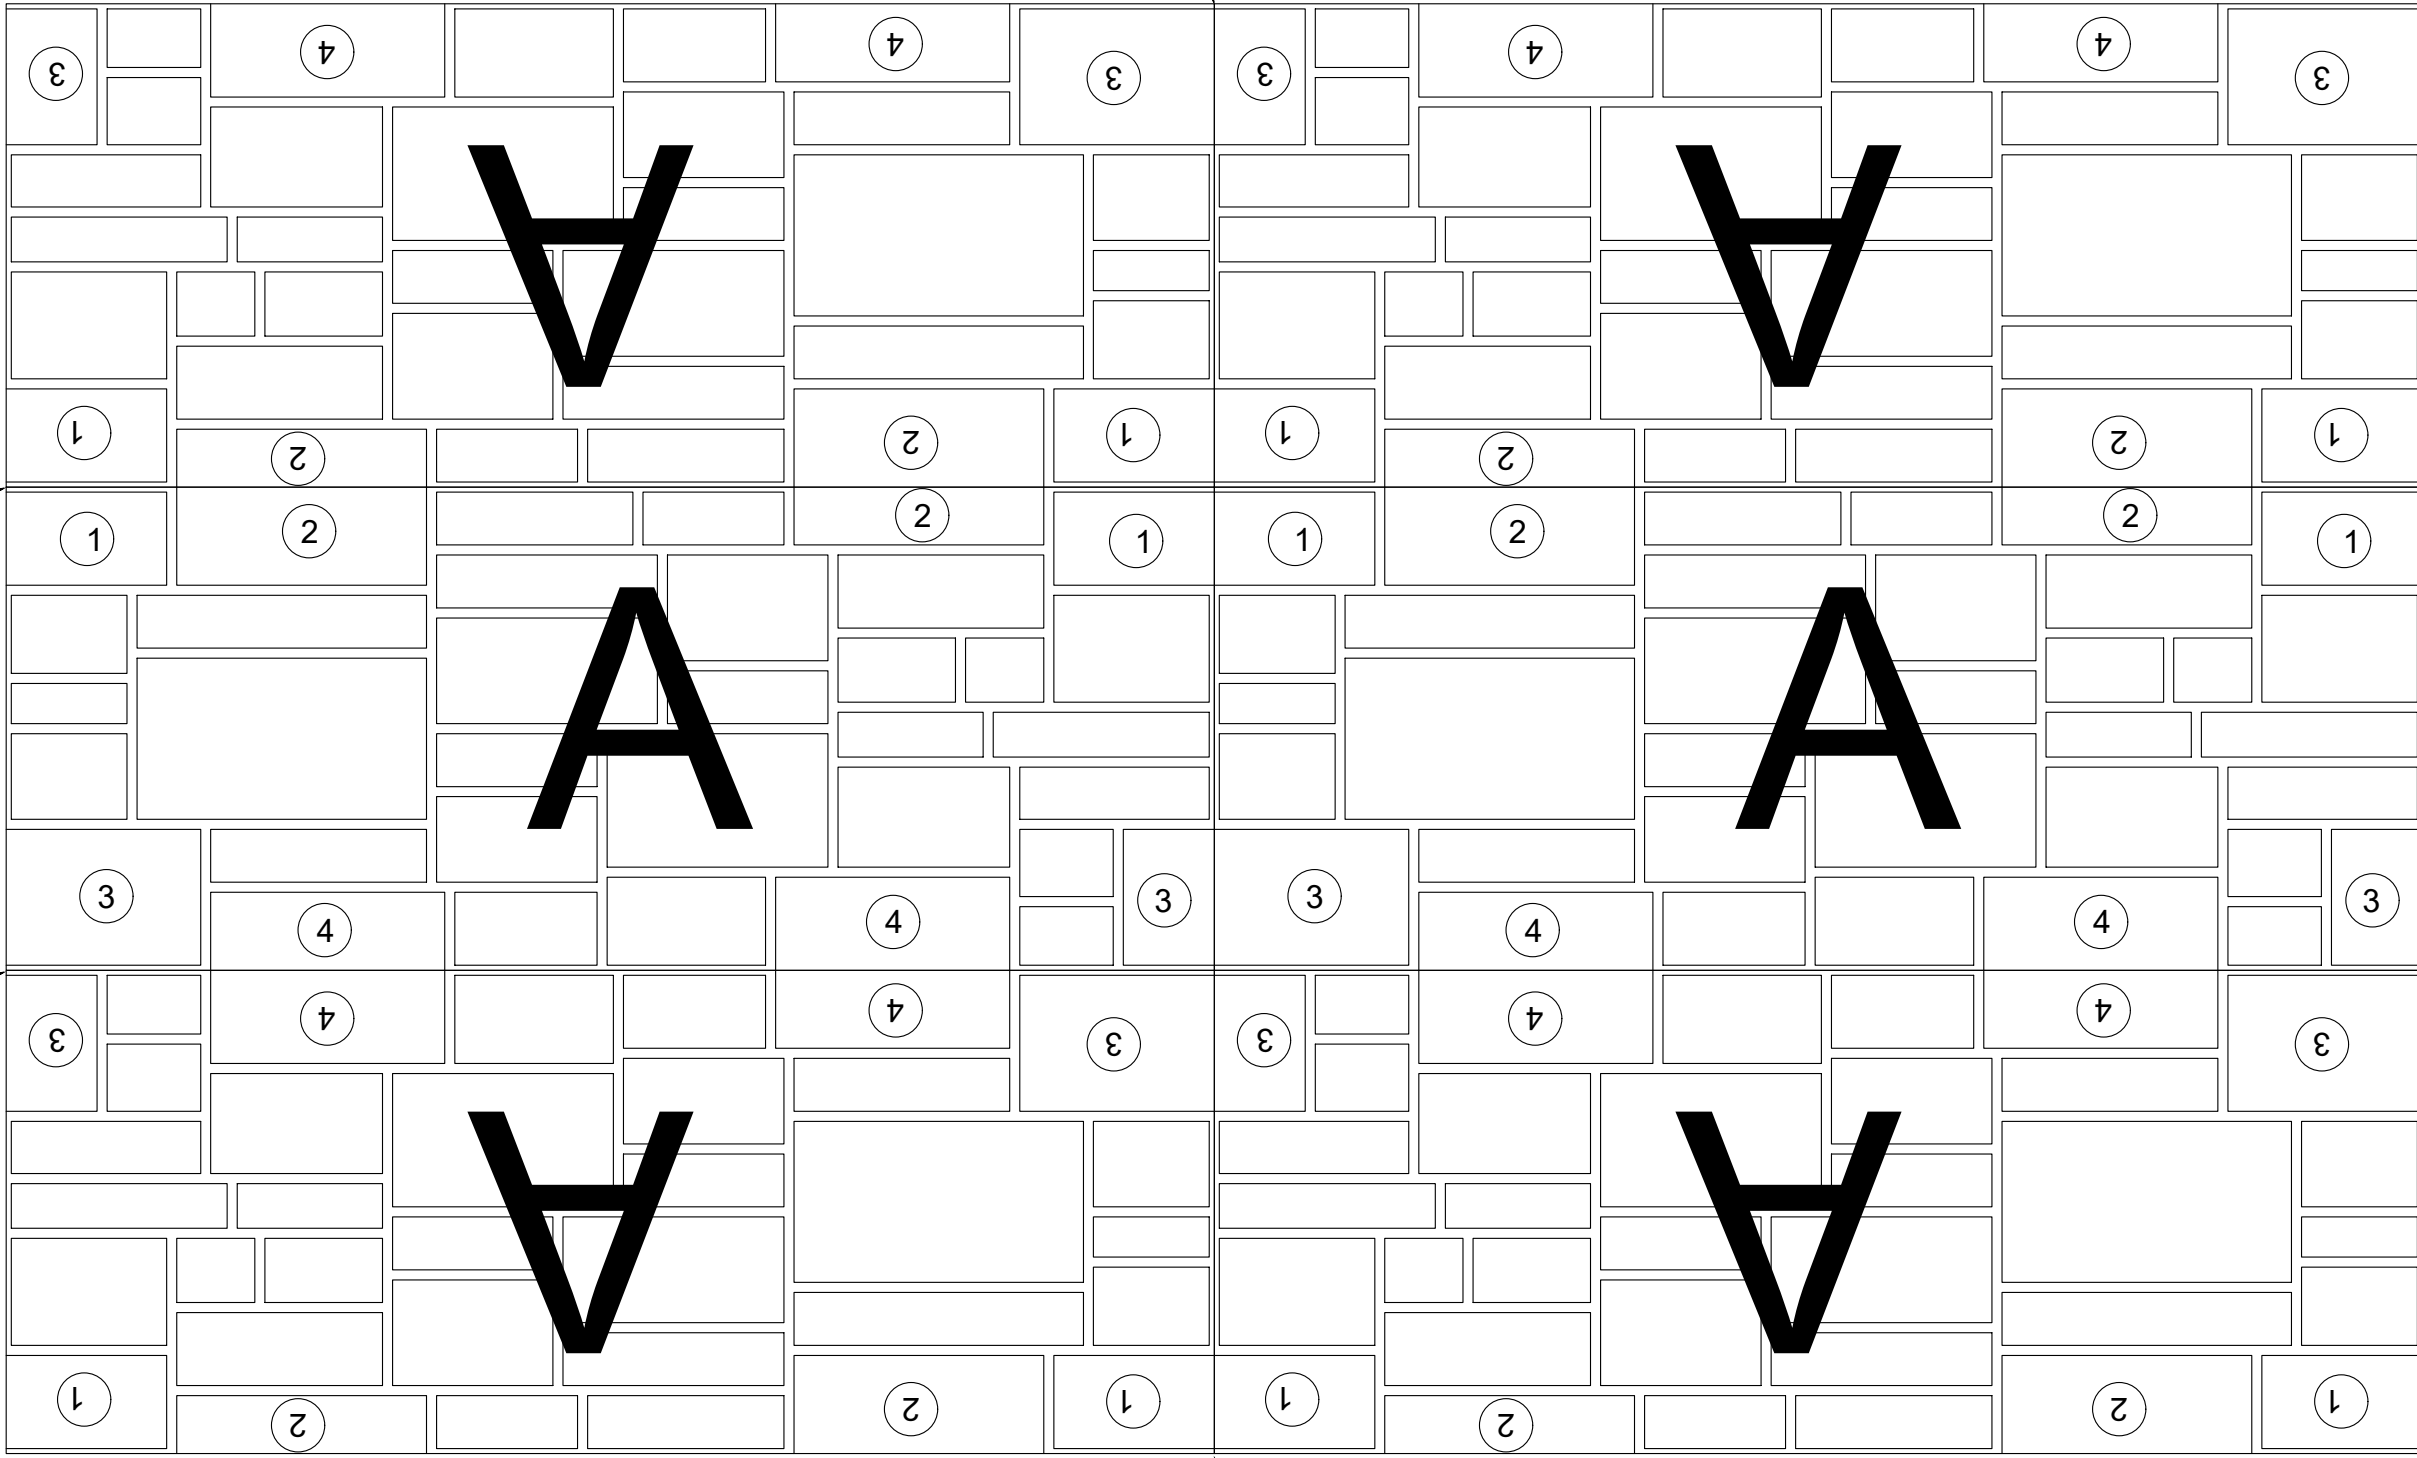
20'-0"

A noticeable seam will occur if not properly sealed when stacking liners.

12'-0"
