Customer:  
 Job Name:  
 Title: #913 New York Dot Ashlar

Customer:  
 Job Name:  
 Title: #913 New York DOT Ashlar Assembled

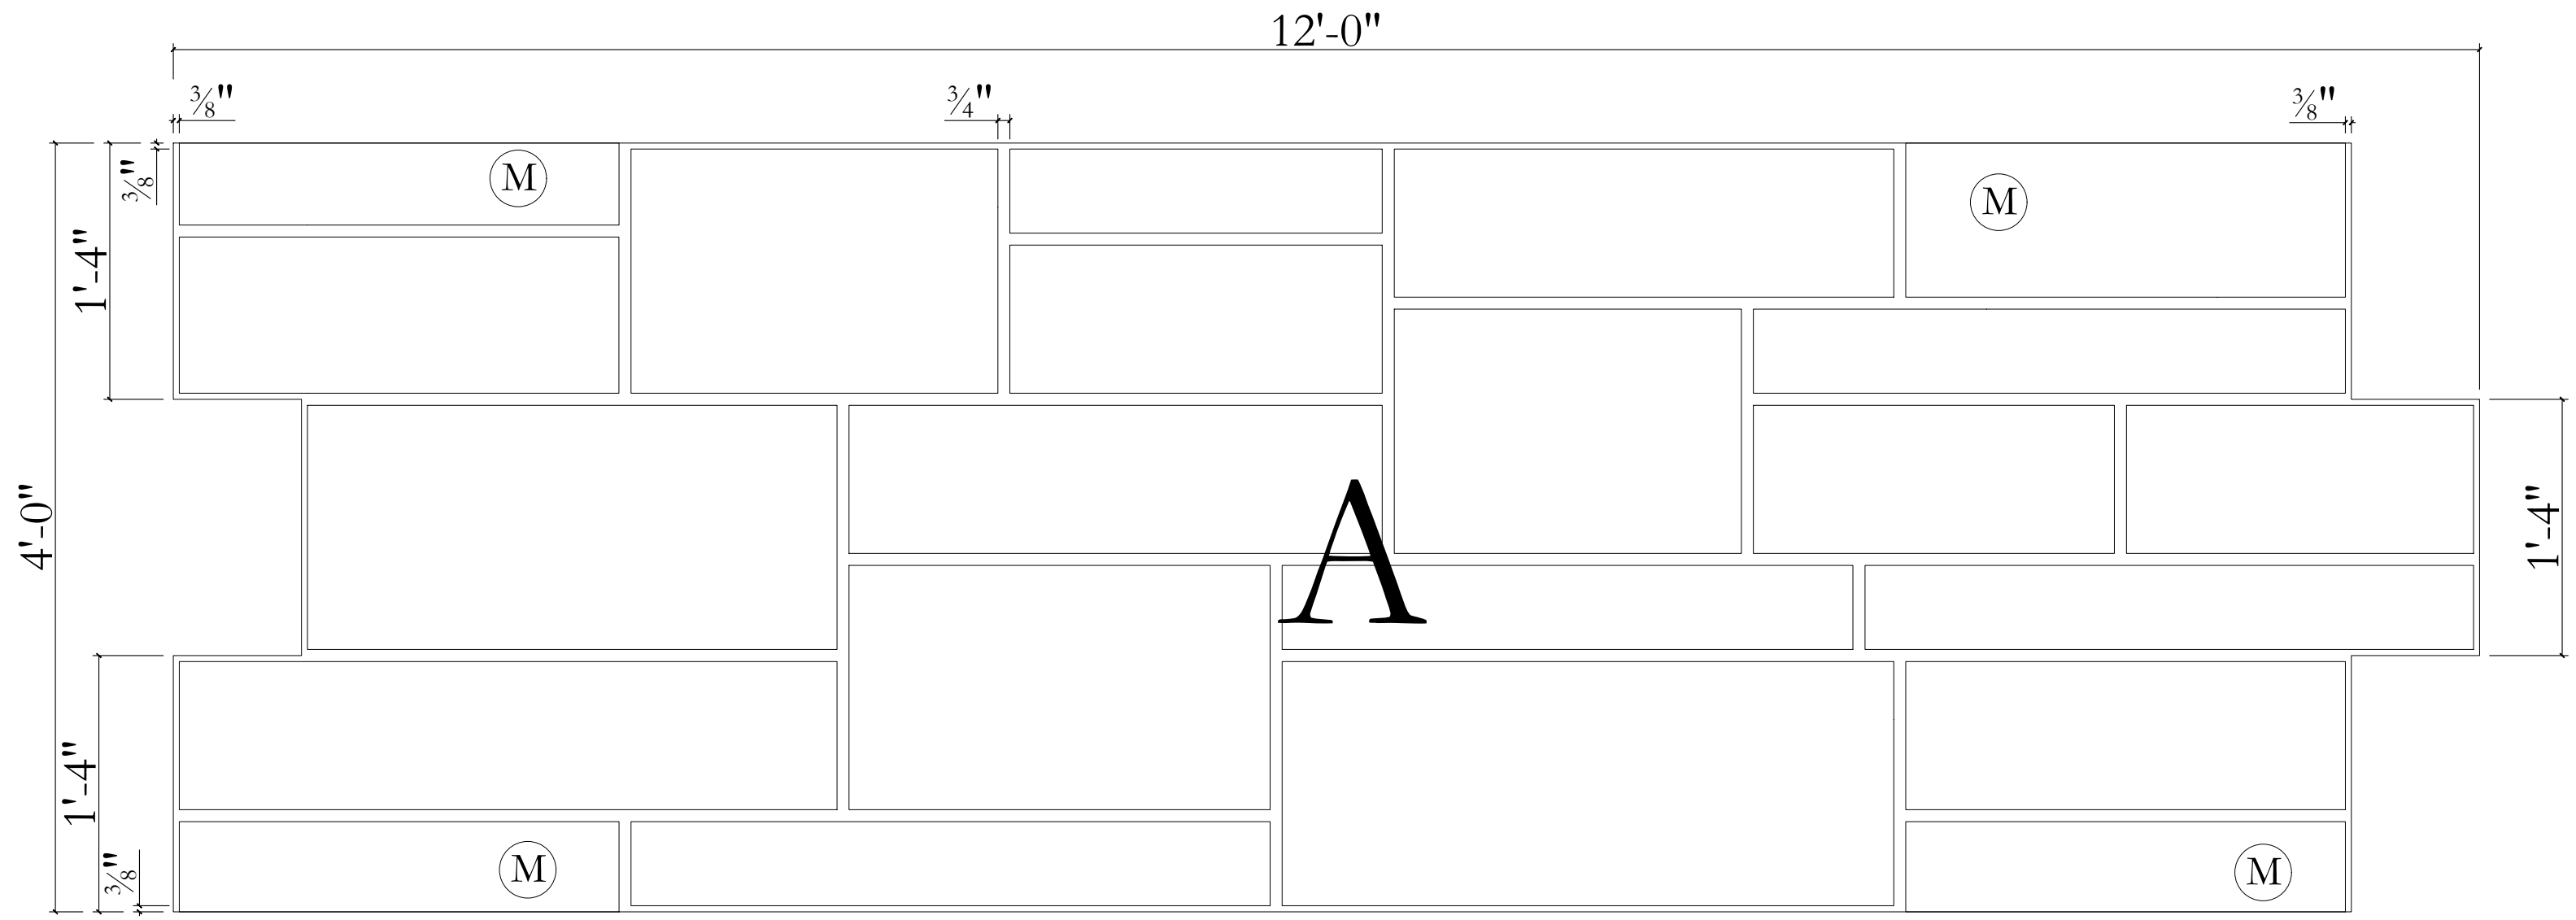
\*\*\*Stone Texture Not Shown For Clarity\*\*\*

22'-0"

A noticeable seam will occur if not properly sealed when stacking liners.

12'-0"

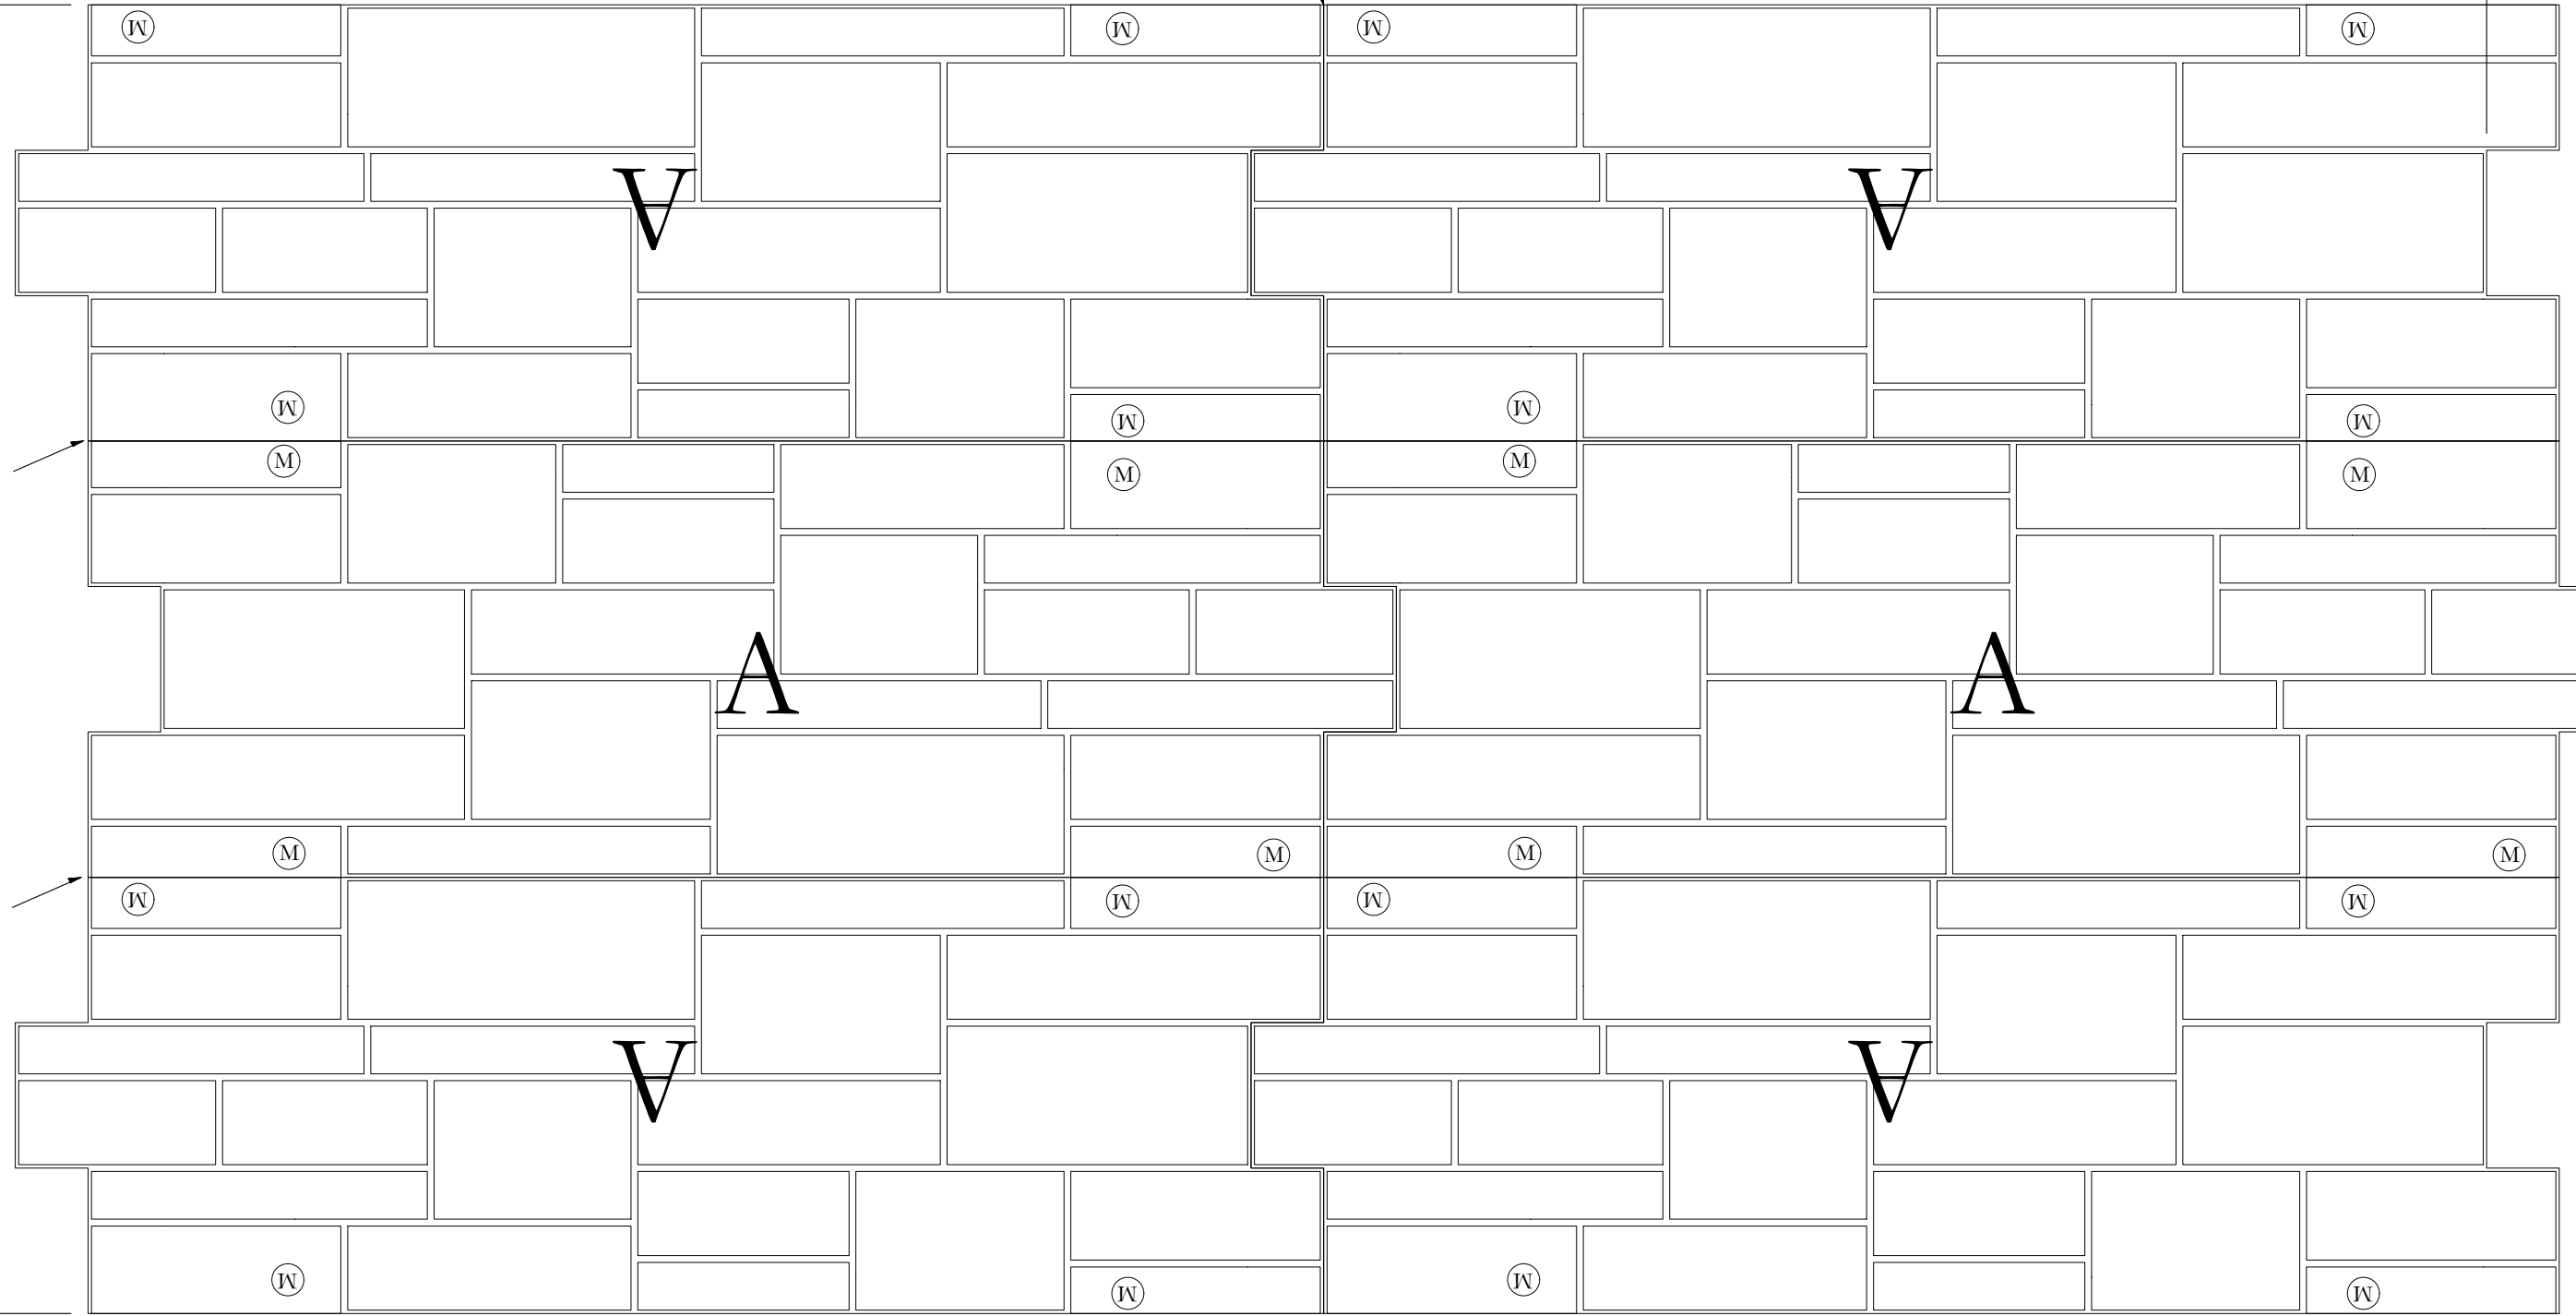
A noticeable seam will occur if not properly sealed when stacking liners.
