**ITEM # 308231**

Customer: \_\_\_\_\_  
 Job Name: \_\_\_\_\_  
 Title: # 929 8"x16" Hand Chiseled Block

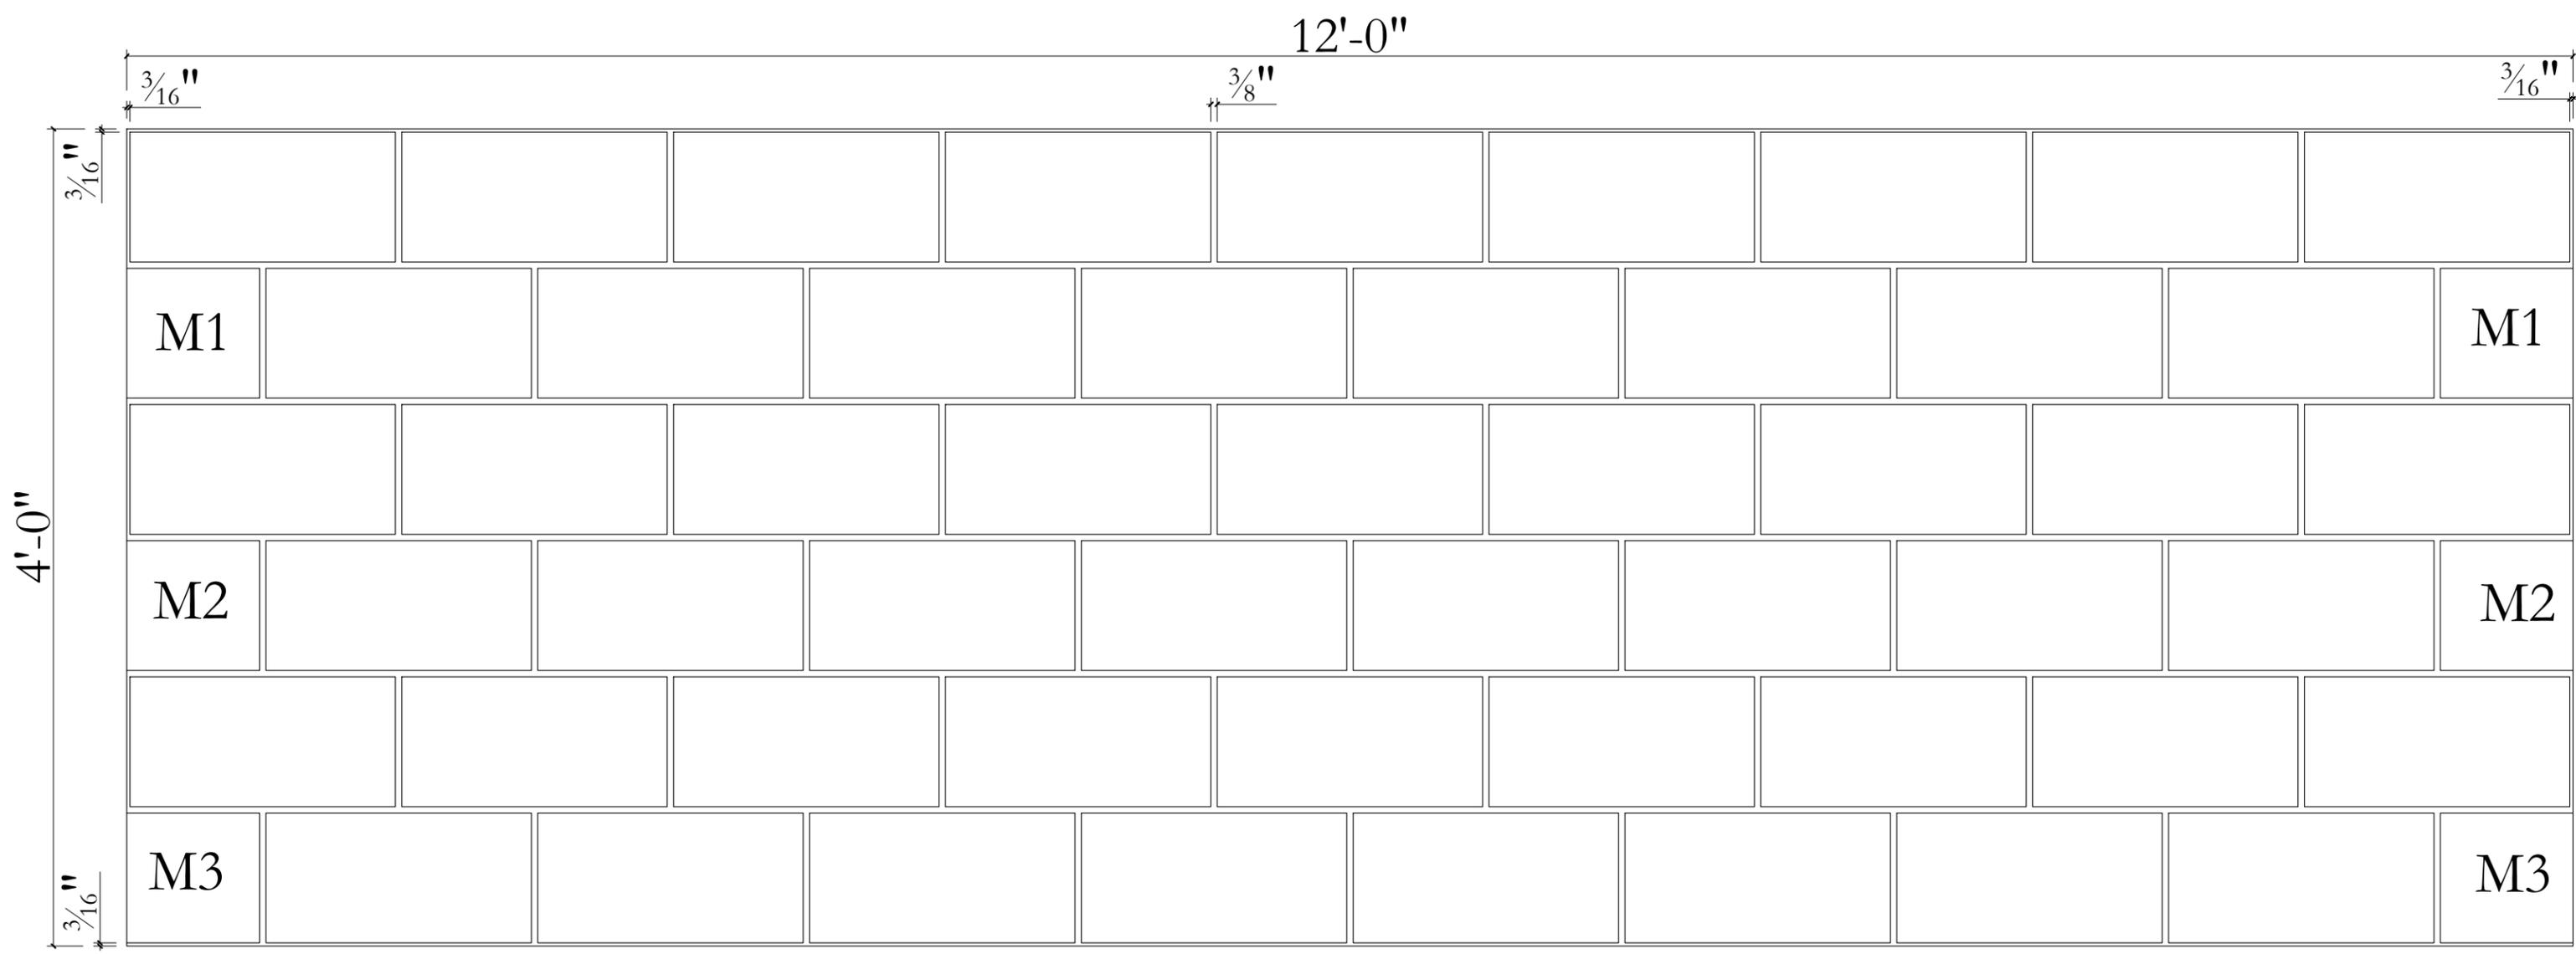
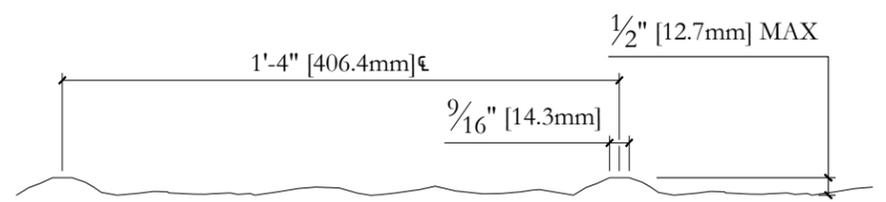
Typical Section

↖ **.060 HIPS Formliner**

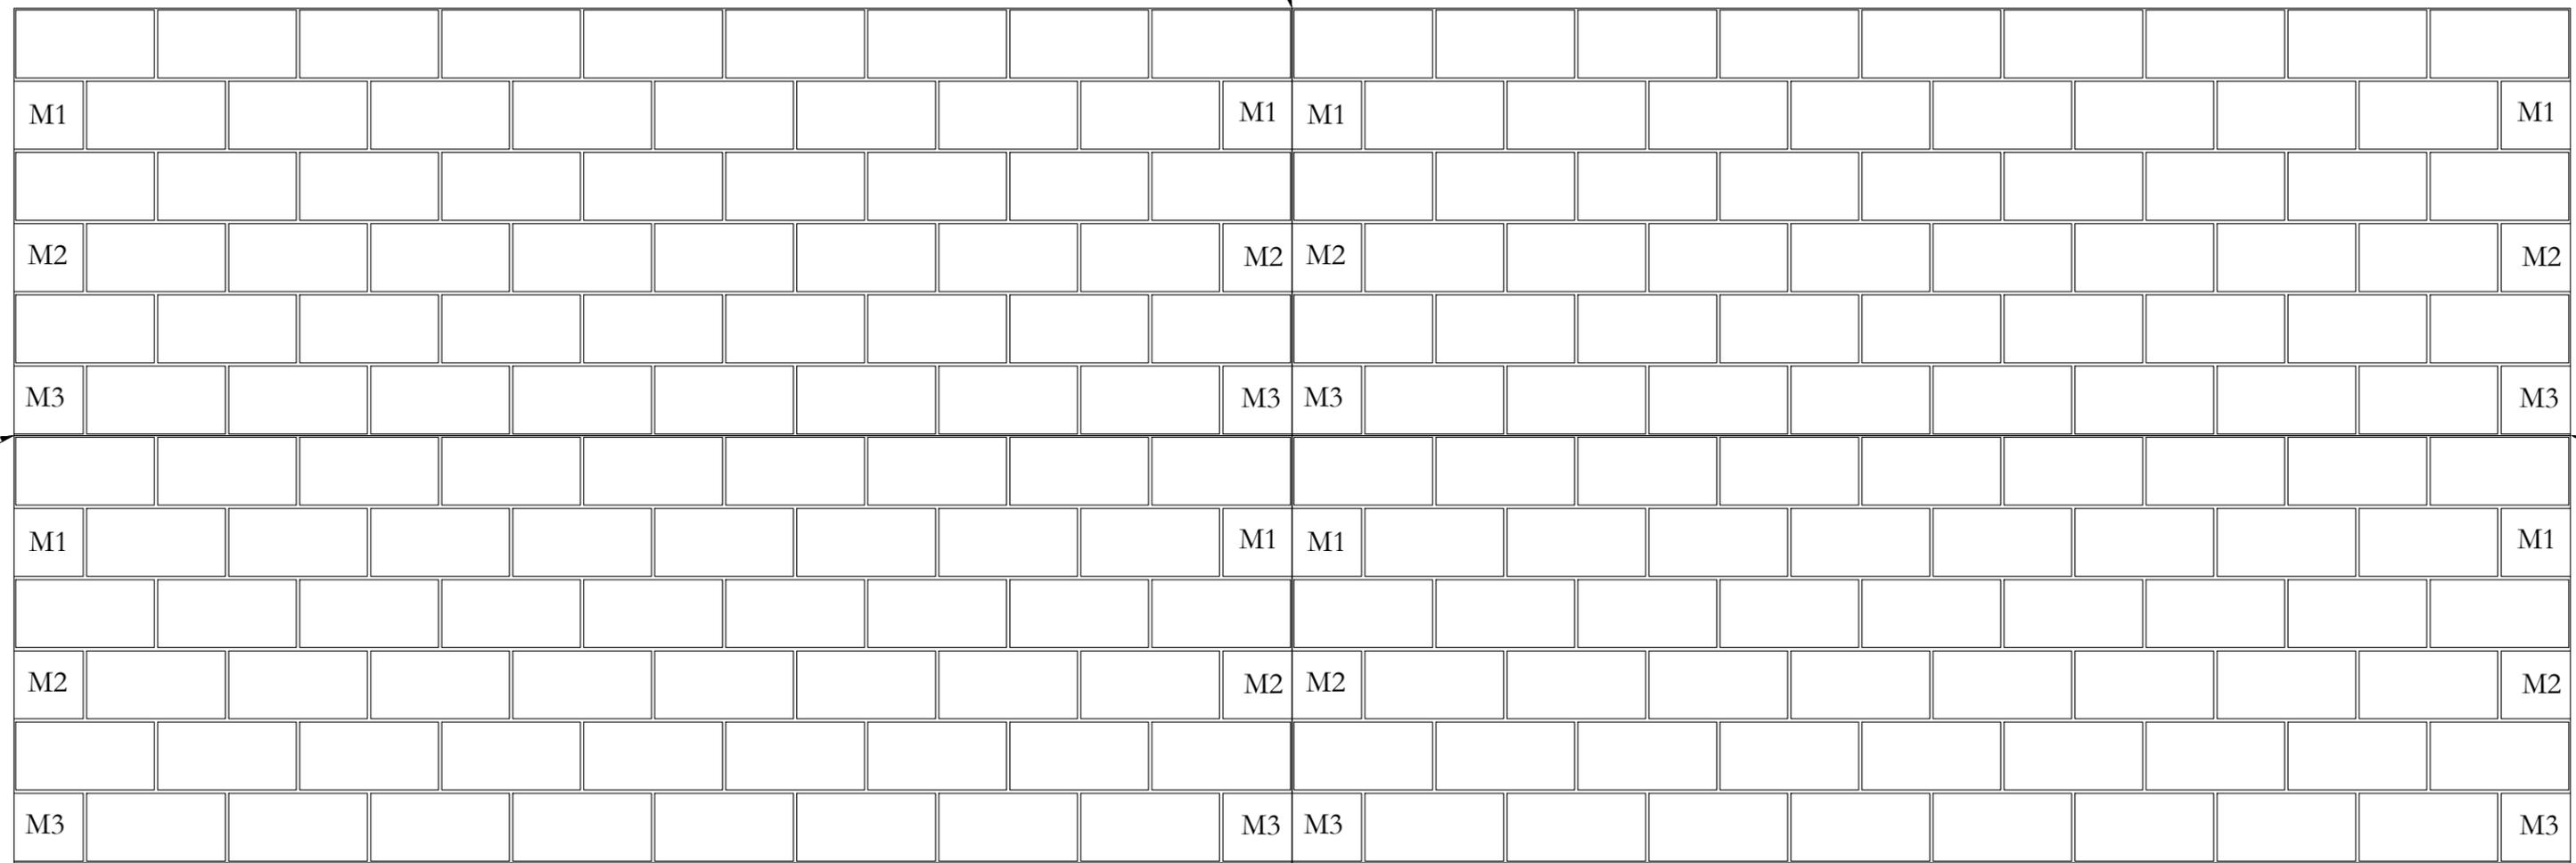
Customer:  
 Job Name:  
 Title: #929 8"x16" Hand Chiseled Block Assembled

24'-0"

A noticeable seam will occur if not properly sealed when stacking liners.

8'-0"  
A noticeable seam will occur if not properly sealed when stacking liners.
