Customer:
 Job Name:
 Title: #932 Random Coursed Ashlar

Customer:
Job Name:
Title: #932 Random Coursed Ashlar Assembled

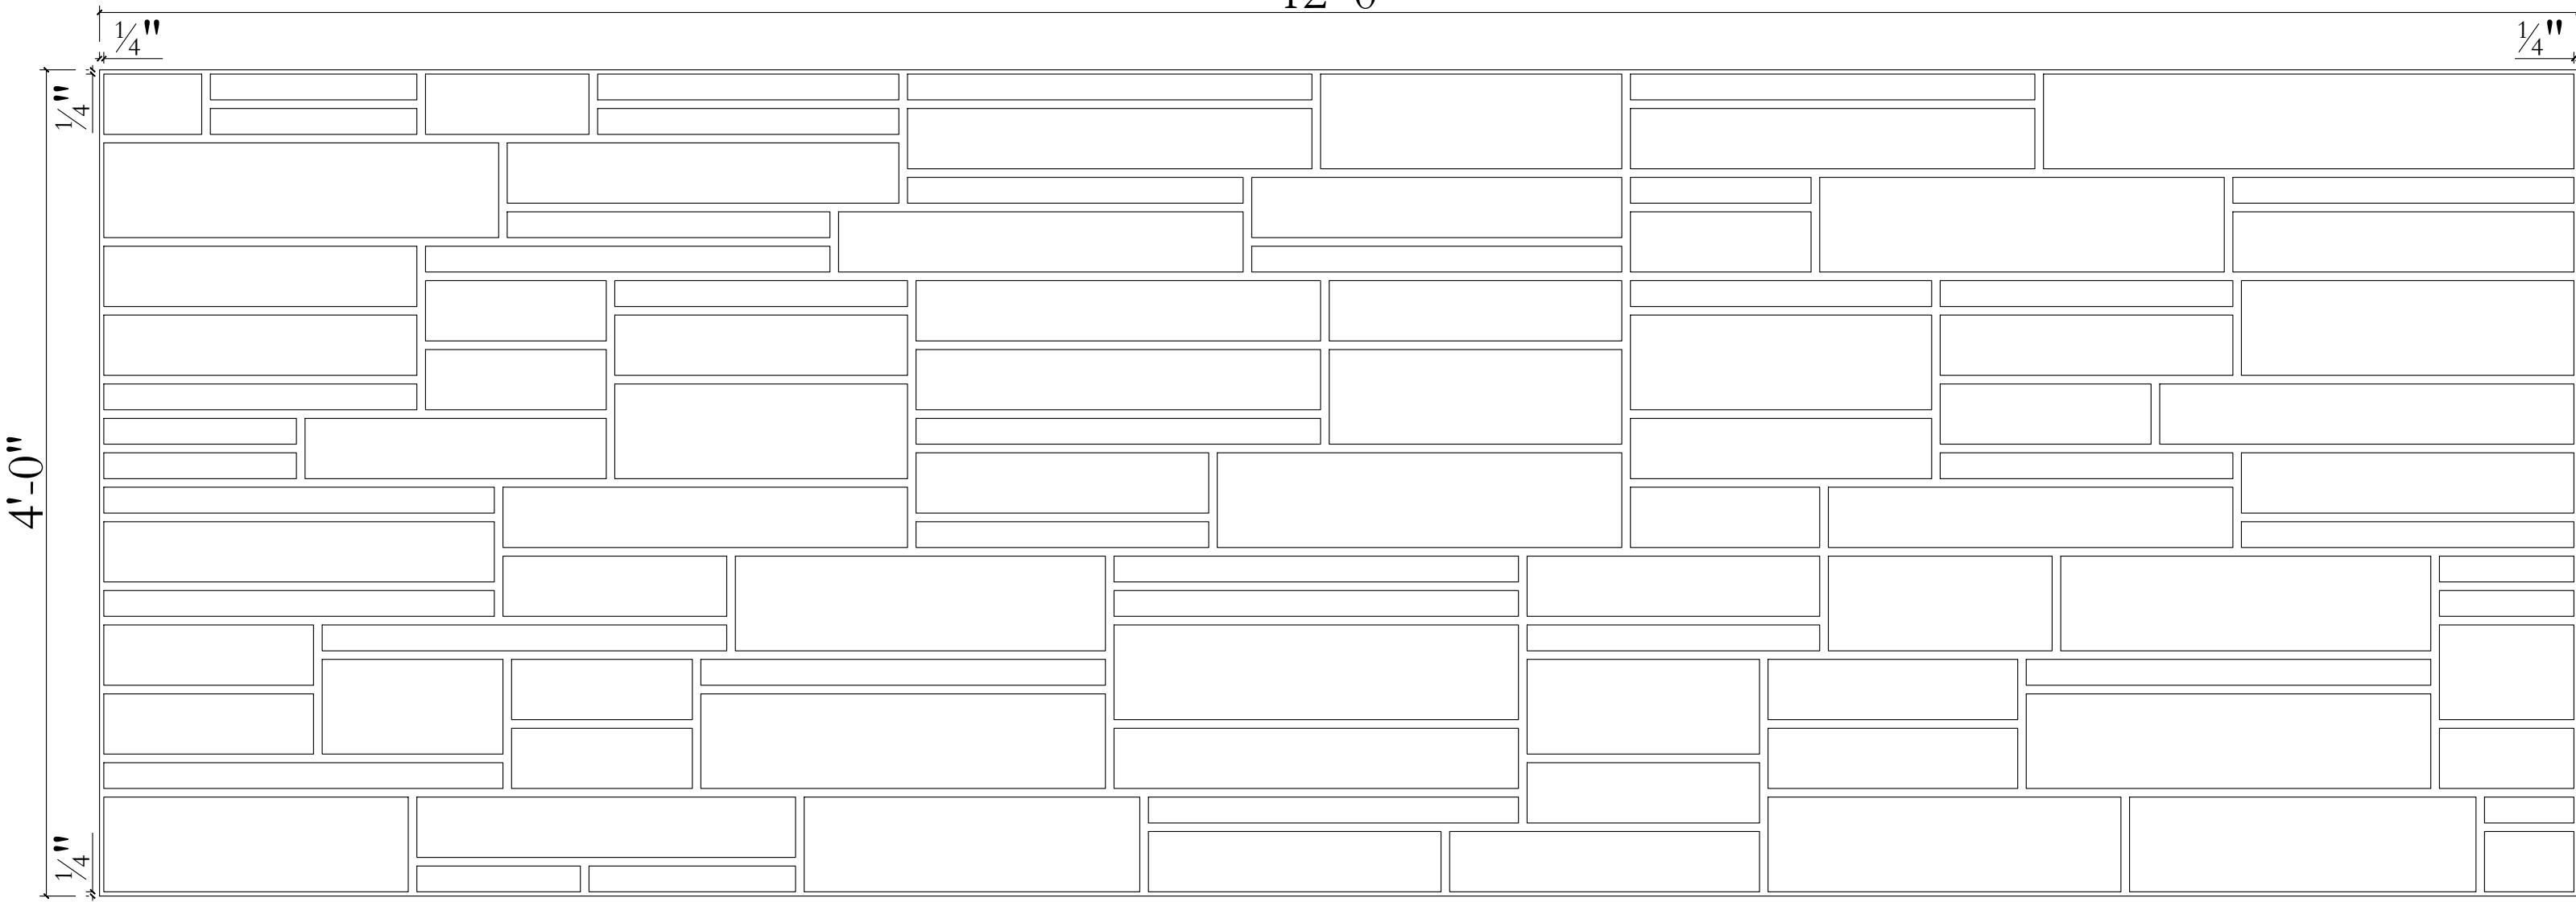
Stone layout for visual reference only. Actual stone layout to be determined by AP

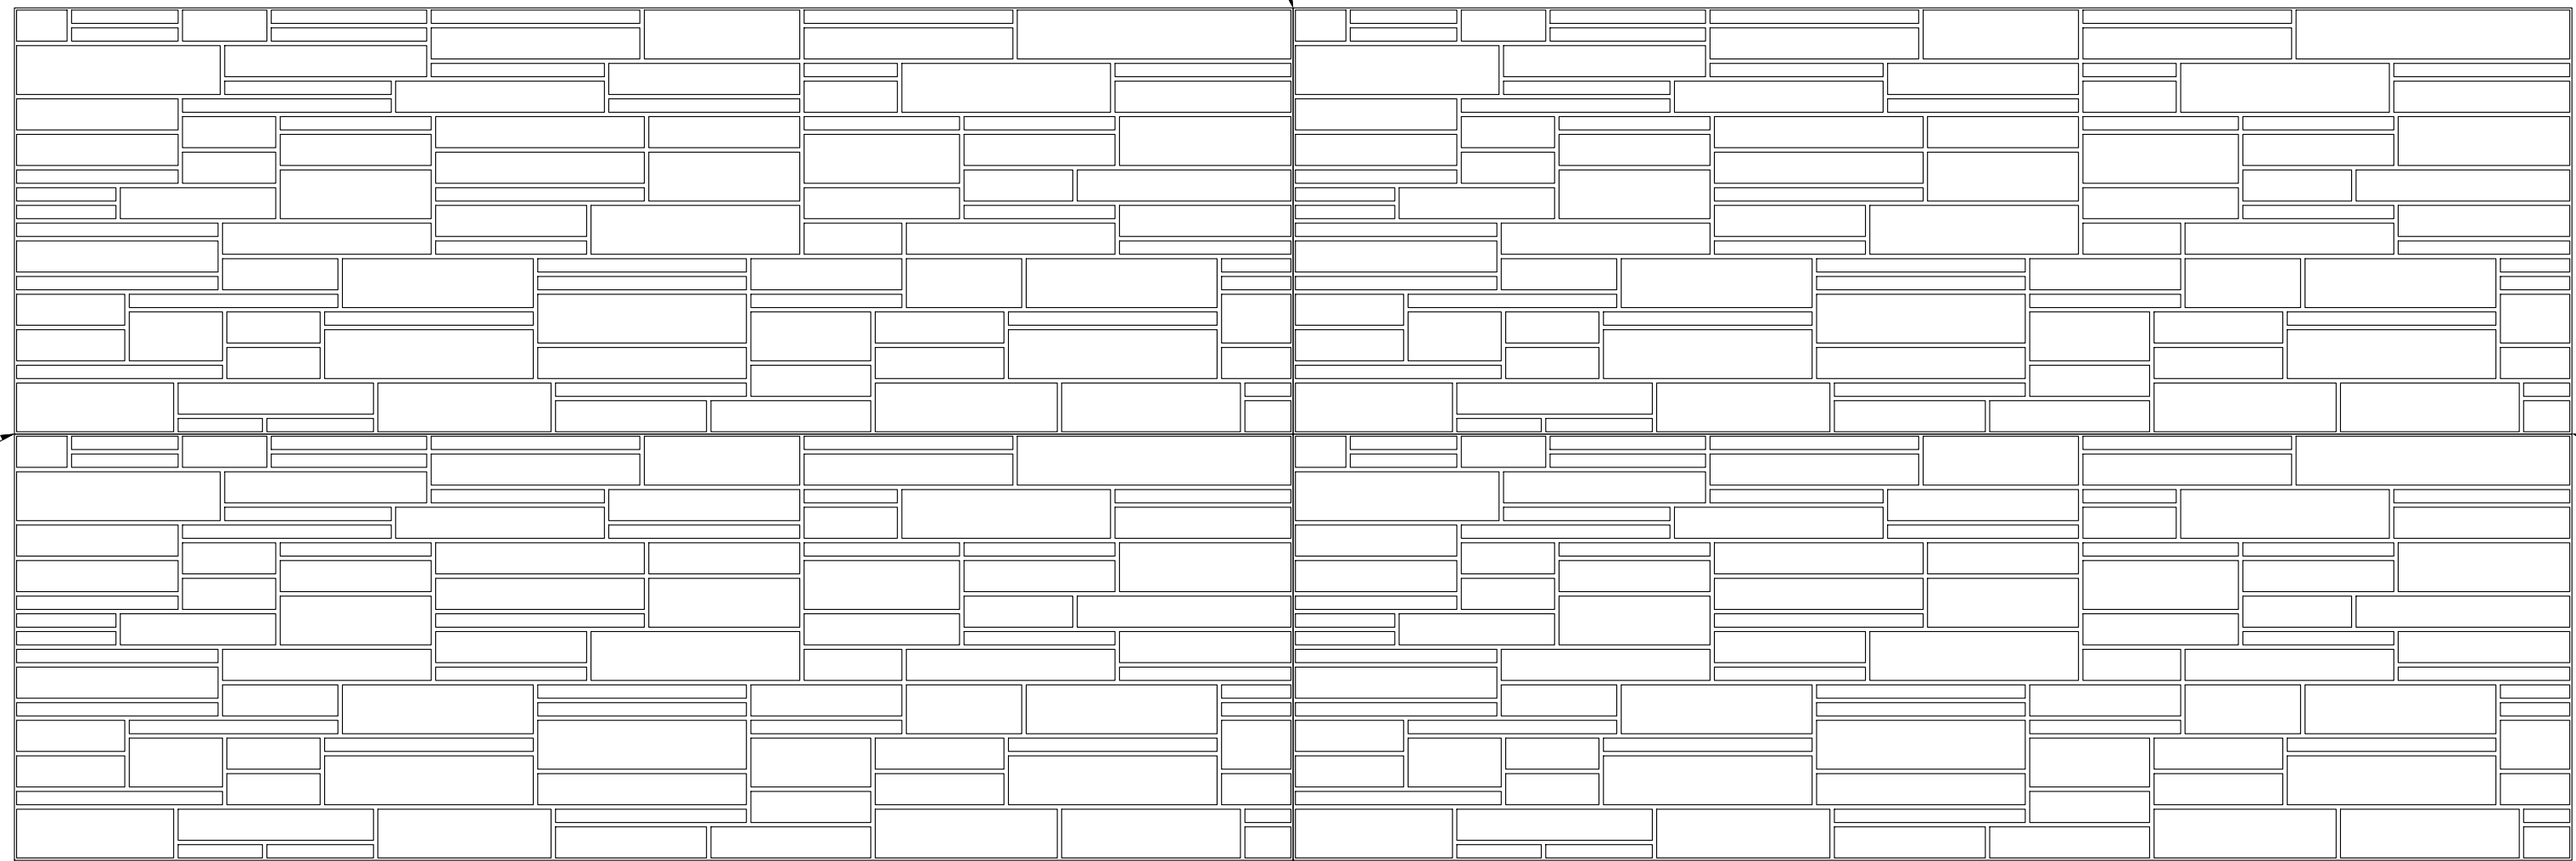
A noticeable seam will occur if not properly sealed when stacking liners.
