# #204 1.5" Standard Fractured Fin Horizontal

Customer: \_\_\_\_\_  
 Job Name: \_\_\_\_\_  
 Title: 204 1.5" Standard Fractured Fin Horizontal

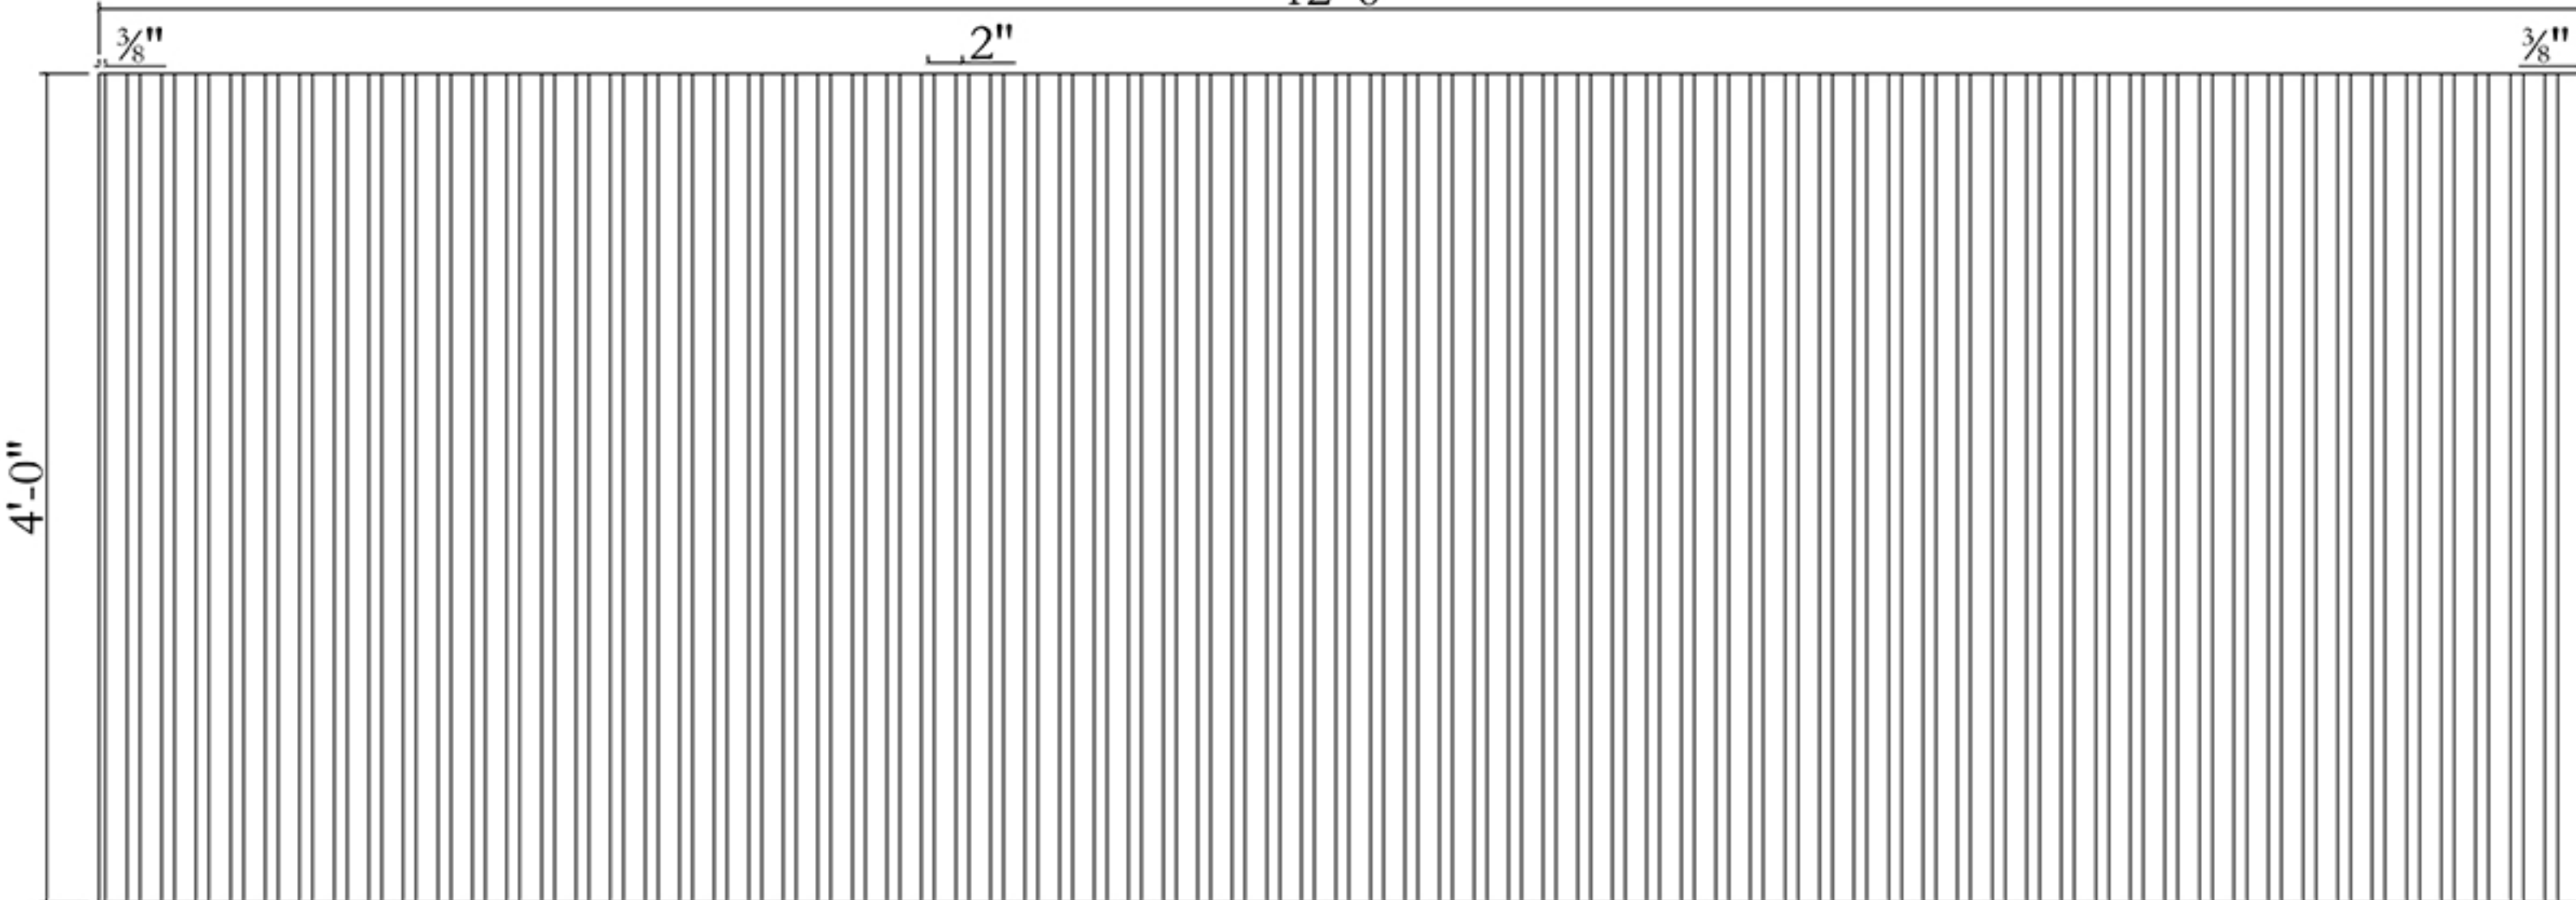
12'-0"
