Customer:	Drawn By:
Job Name:	Date:
Title:	Scale: None
#313 Salem Matched Ends 4x12	Tolerance: ±3/16
	Page: 1
	Drawing Number:

Customer:
 Job Name:
 Title: #313 Salem Matched Ends Assembled

Customer:	
Job Name:	
Title:	#313 Salem Backing Set Details

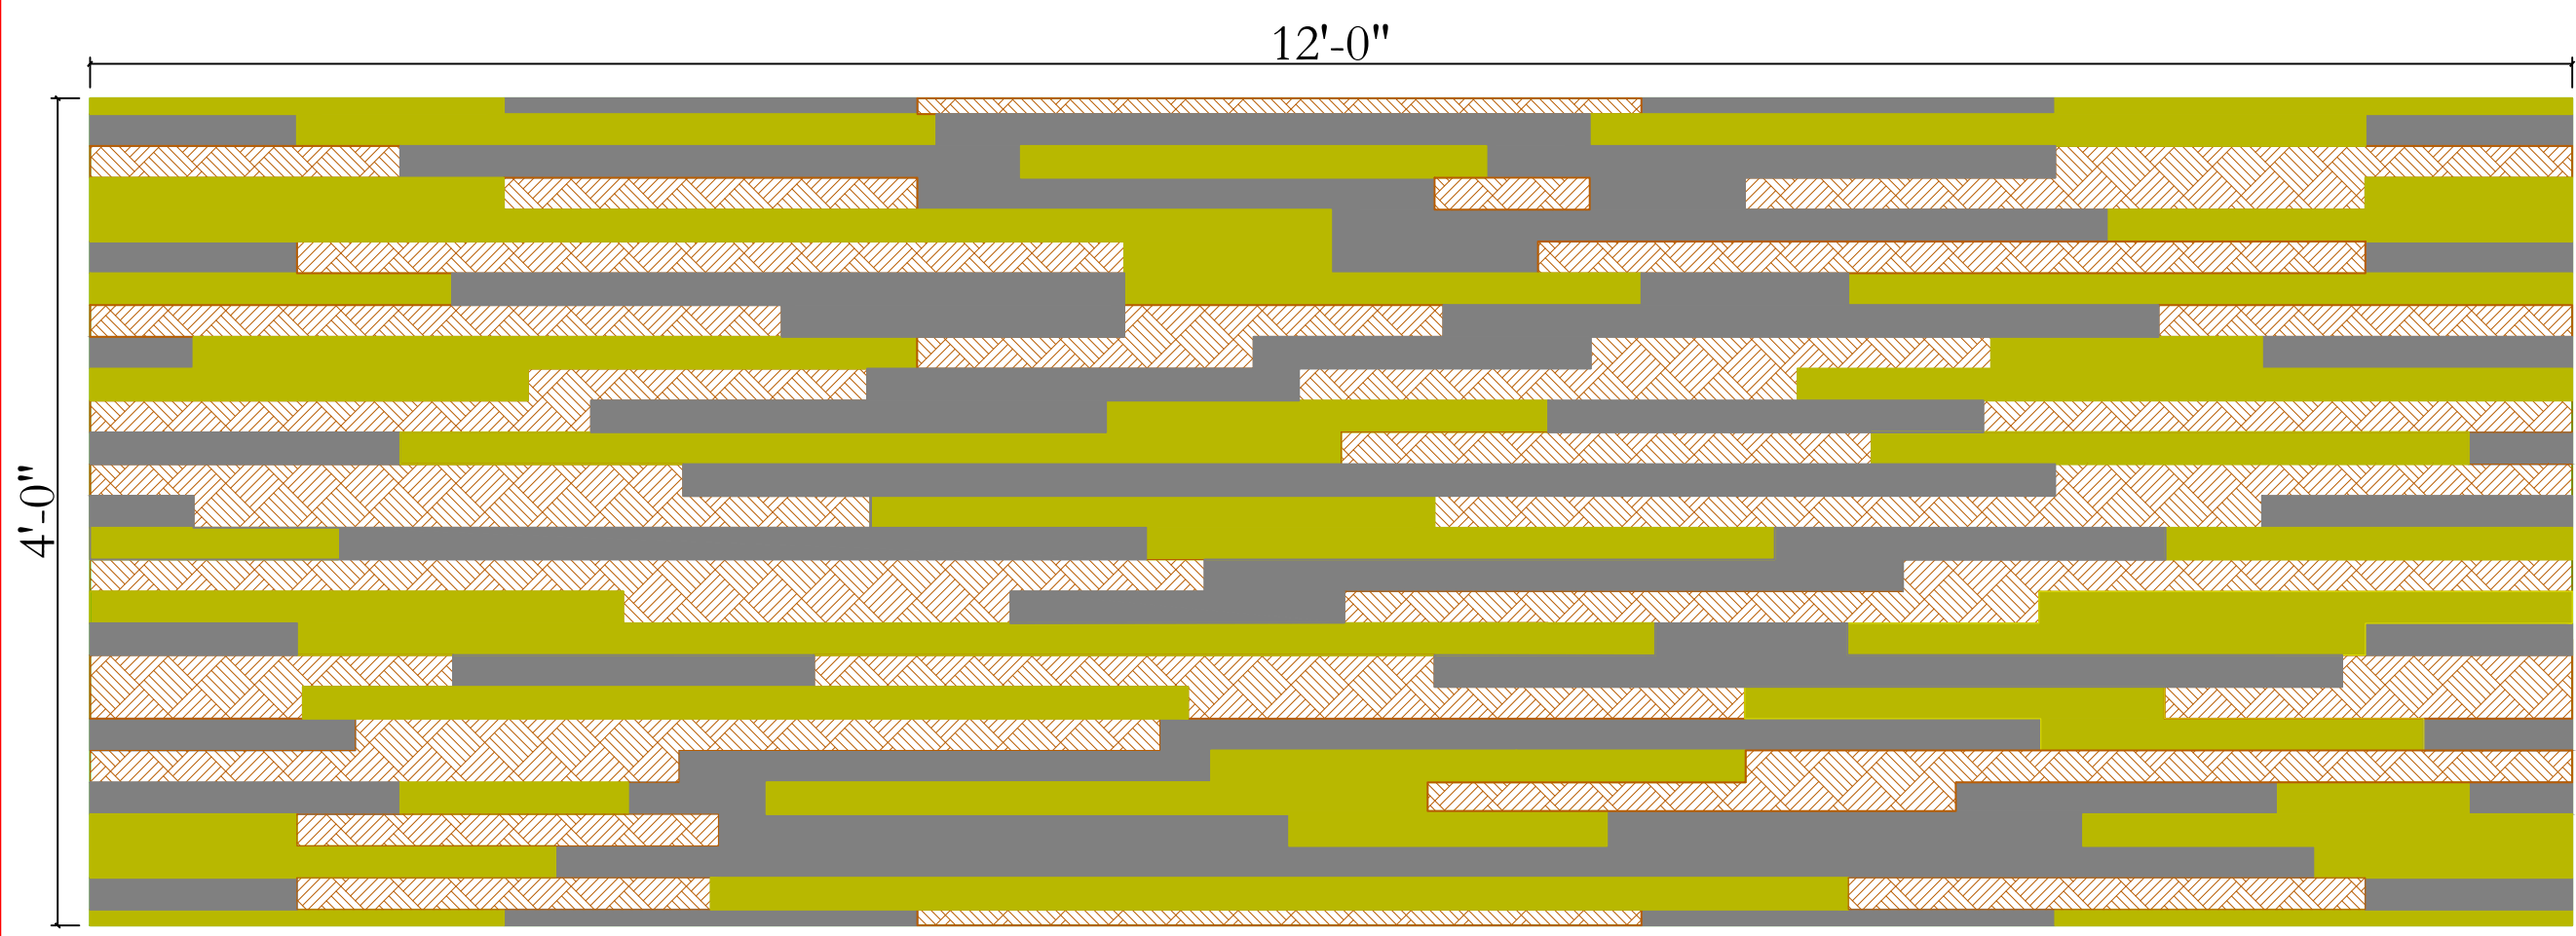
Typical Section

- Face of Concrete
- .25 in Concrete
- .5 in Concrete

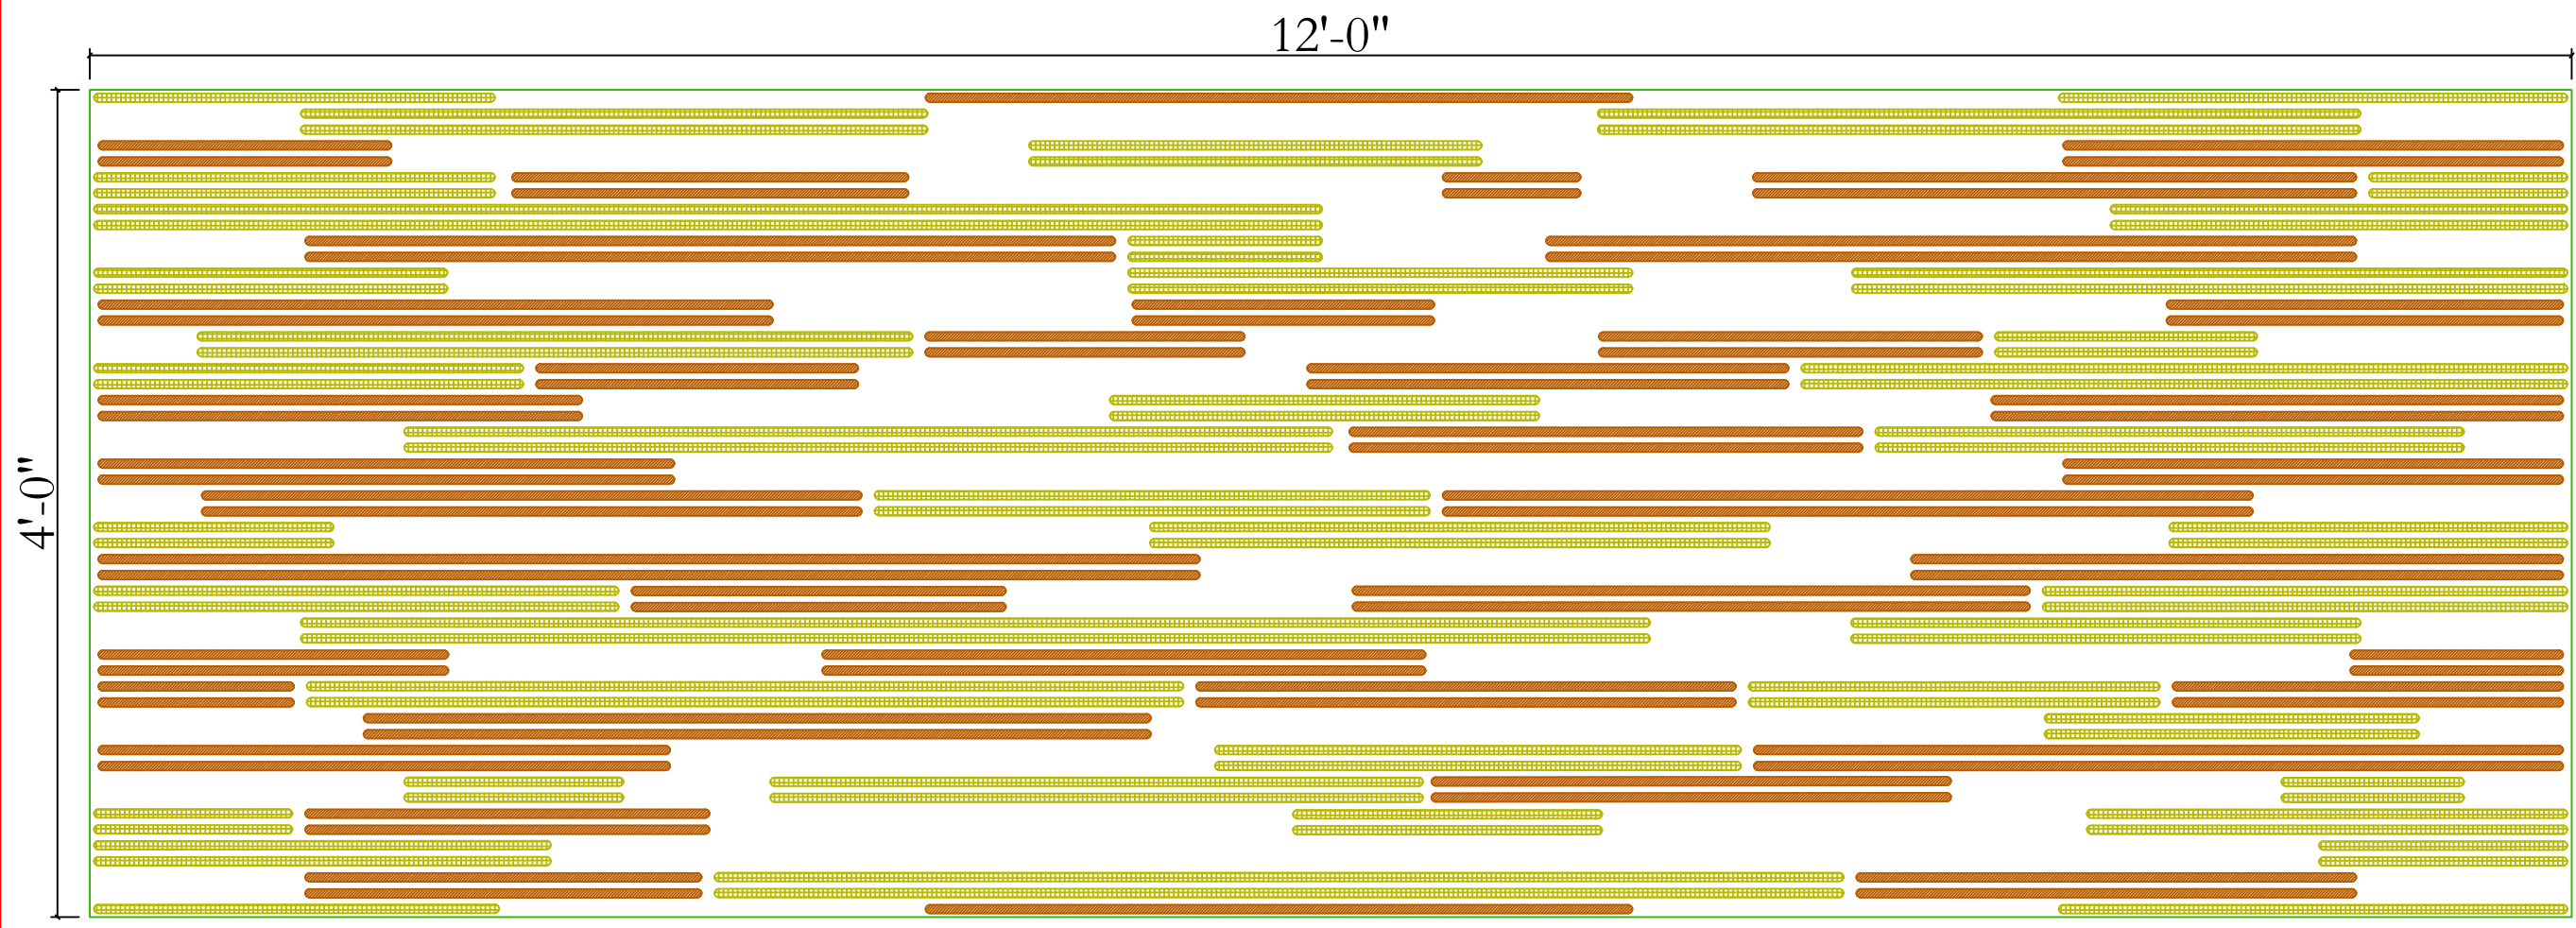
-.25 Support
-

-.5 Support
