ITEM # 305623

AP THERMOFORMING, LLC

520 Weathered Fir

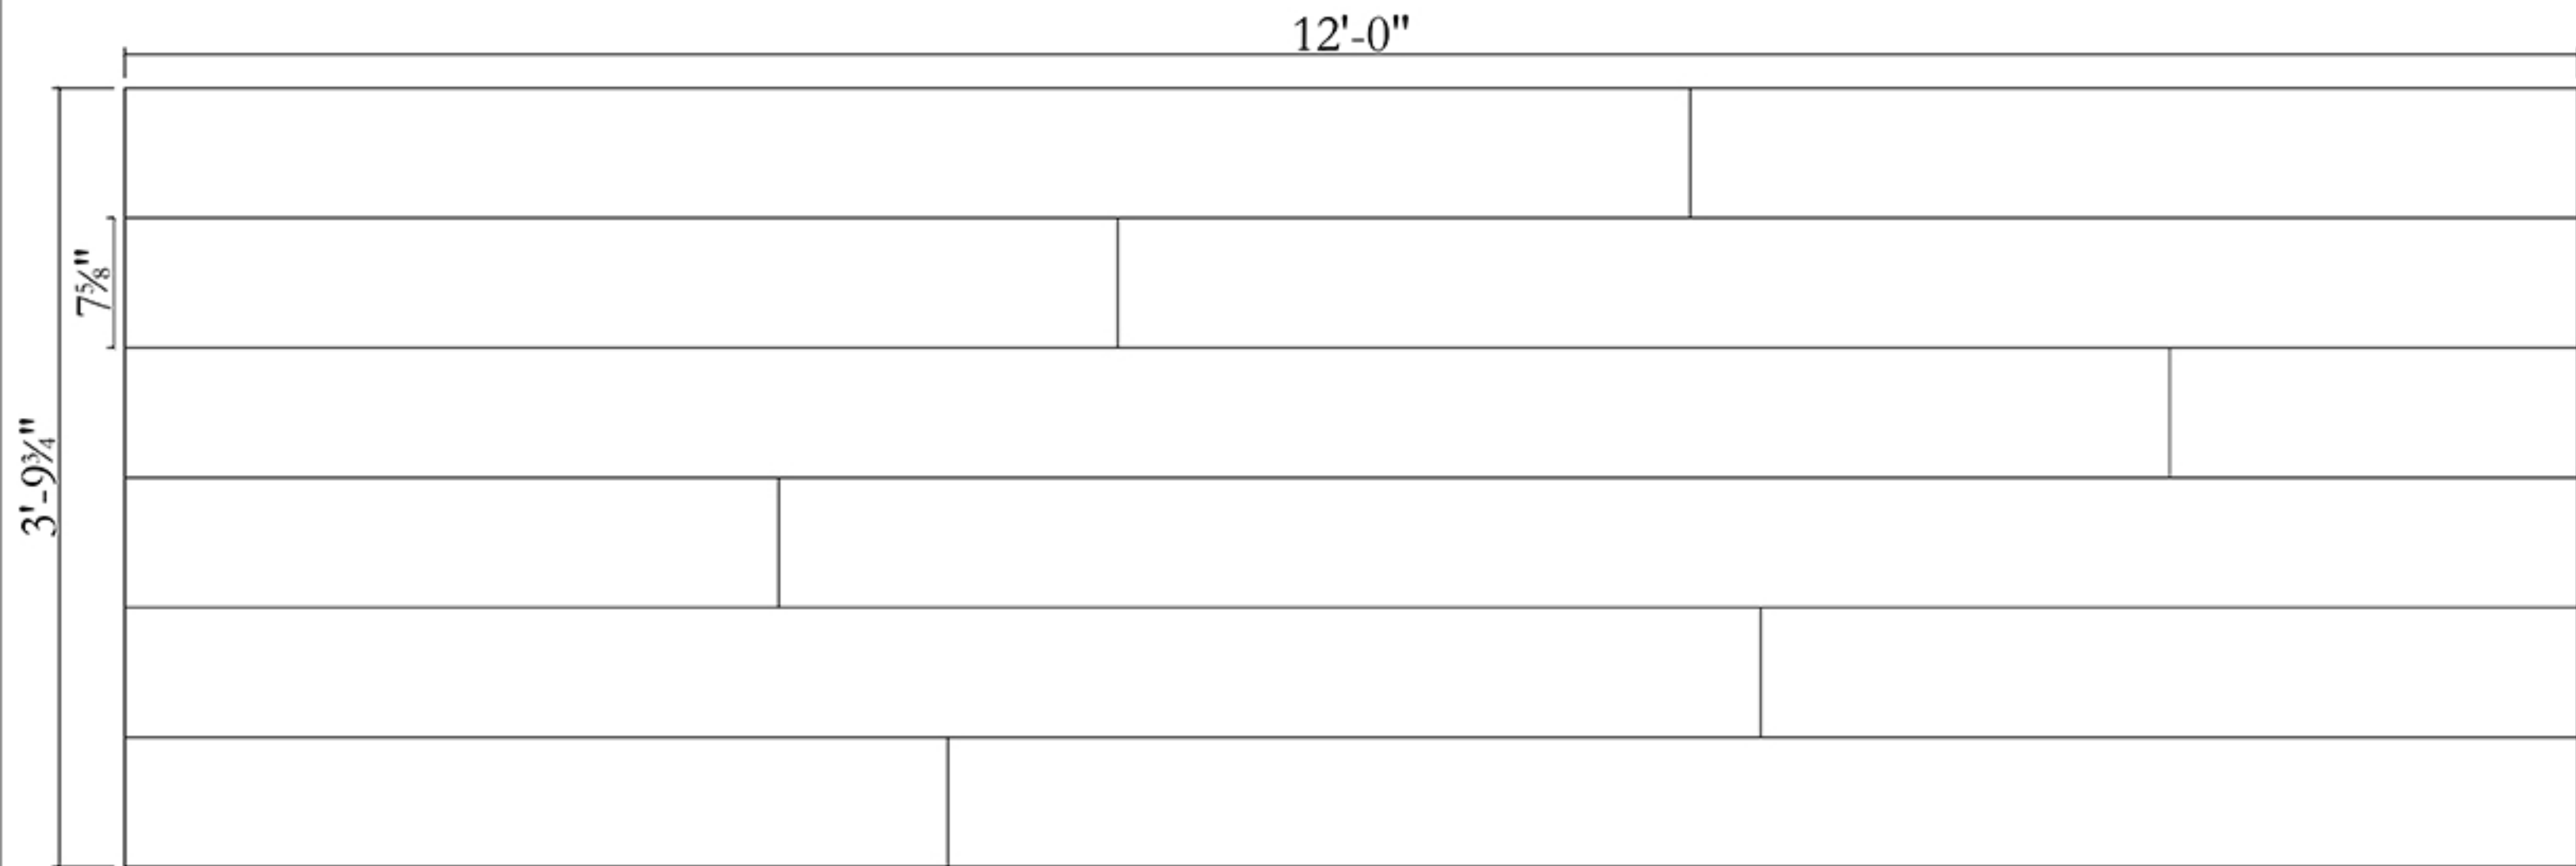
Seam Location for visual reference only. Actual seam location determined by AP
 Board texture not shown for clarity
