Customer:
Job Name:
Title: 719 Longmeadow

#719 LONGMEADOW

Customer:	
Job Name:	
Title:	719 Longmeadow Assembled

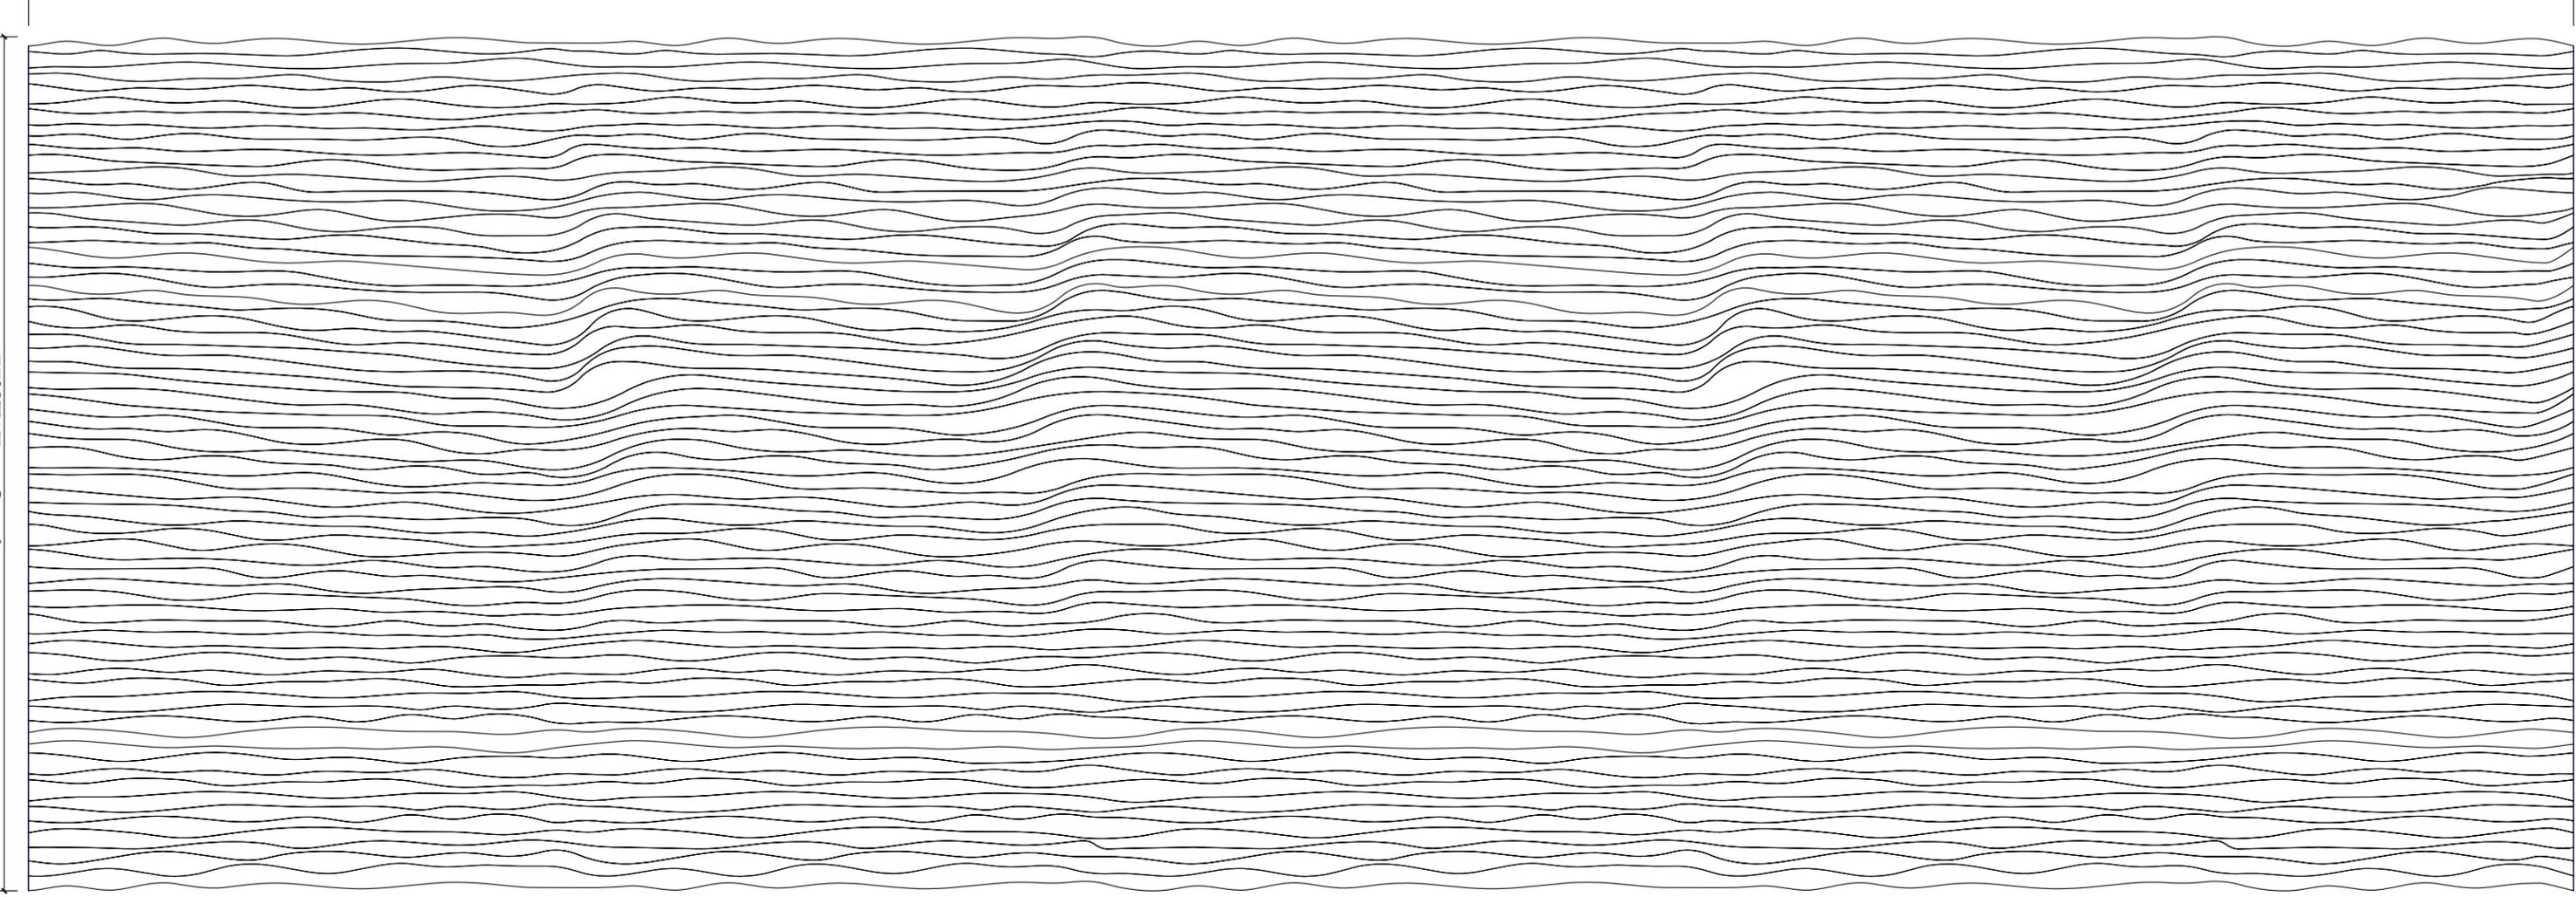
Typical Section

12'-0"

Varies With Pattern
4'-0" Max

Actual Pattern May Vary

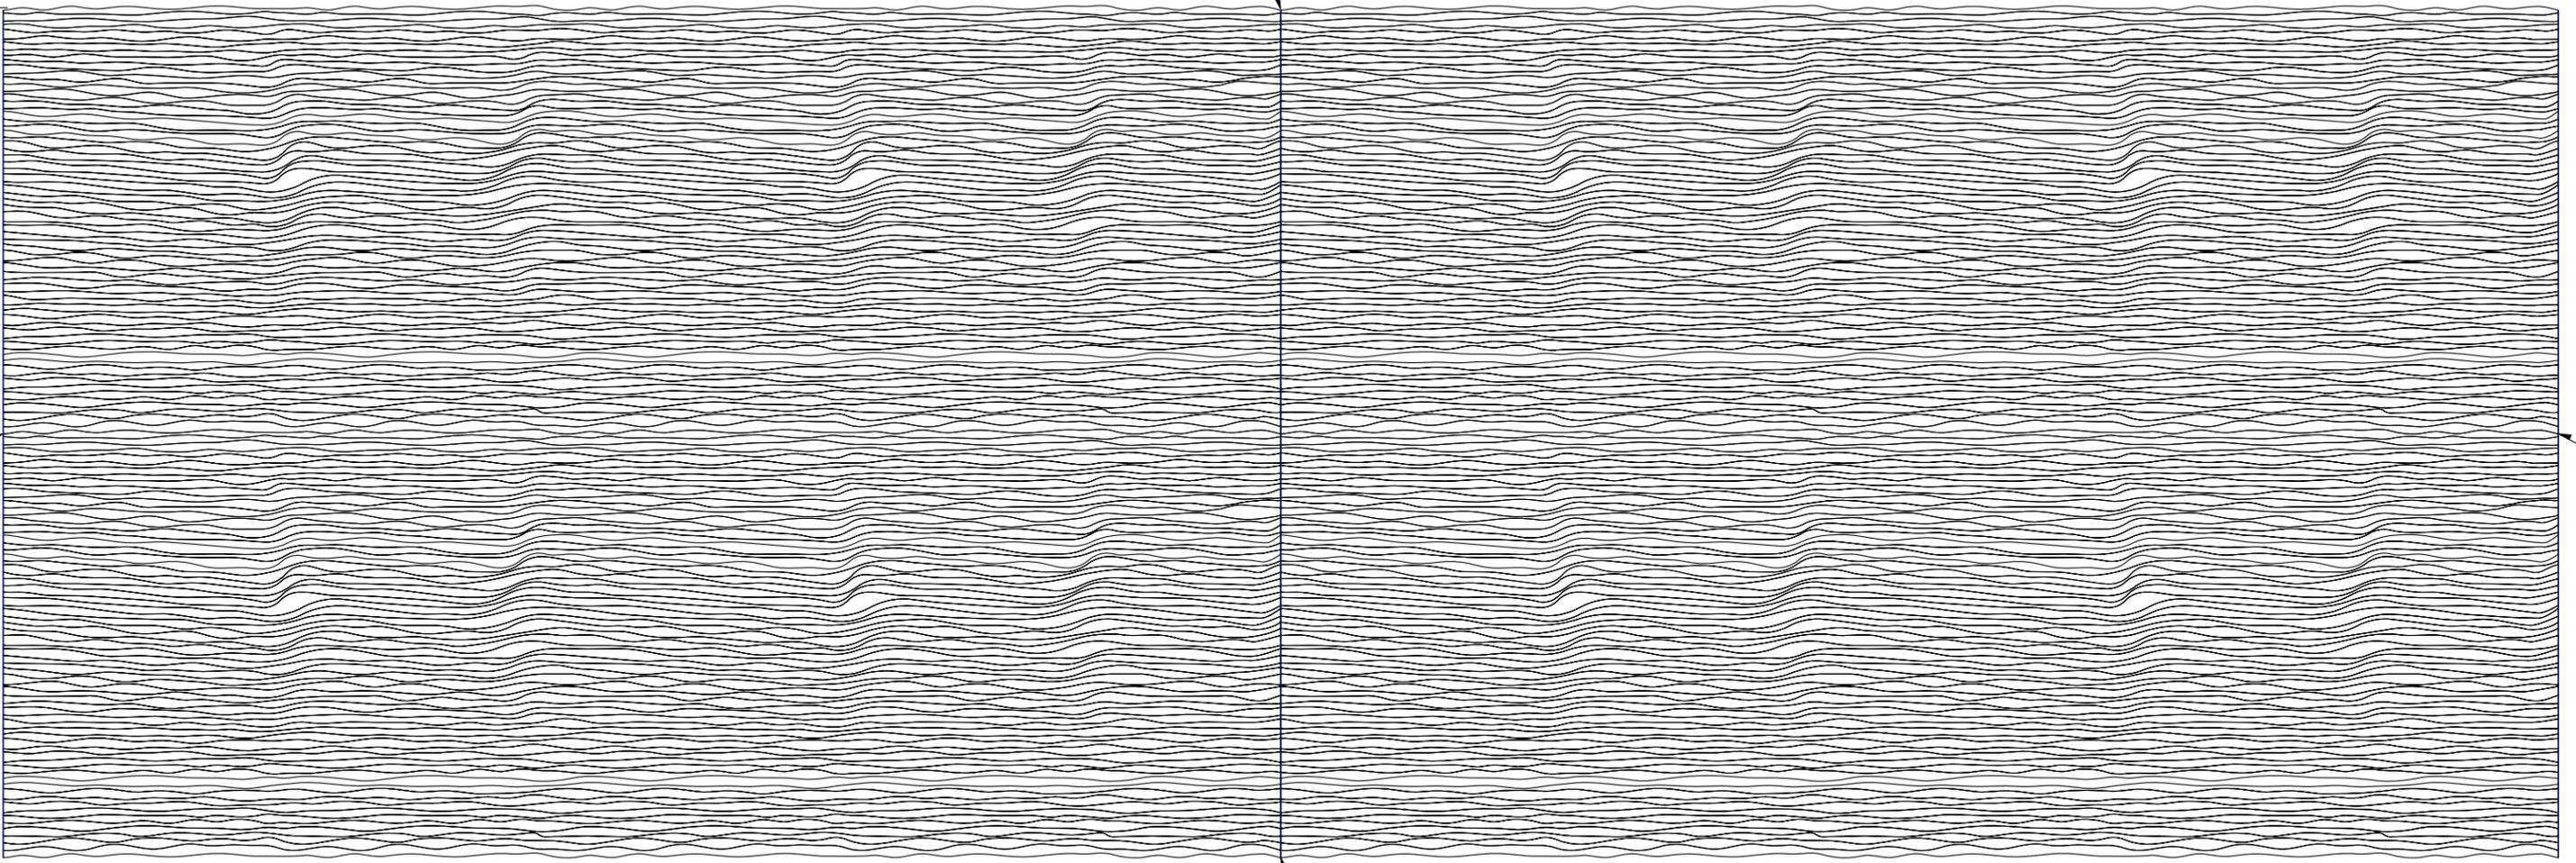
24'-0"

A noticeable seam will occur if not properly sealed when stacking liners.

Varies With Pattern

8'-0" Max
