Customer:
 Job Name:
 Title: #889 8in Quarry Stone

Customer:
 Job Name:
 Title: #889 8in Quarry Stone Assembled

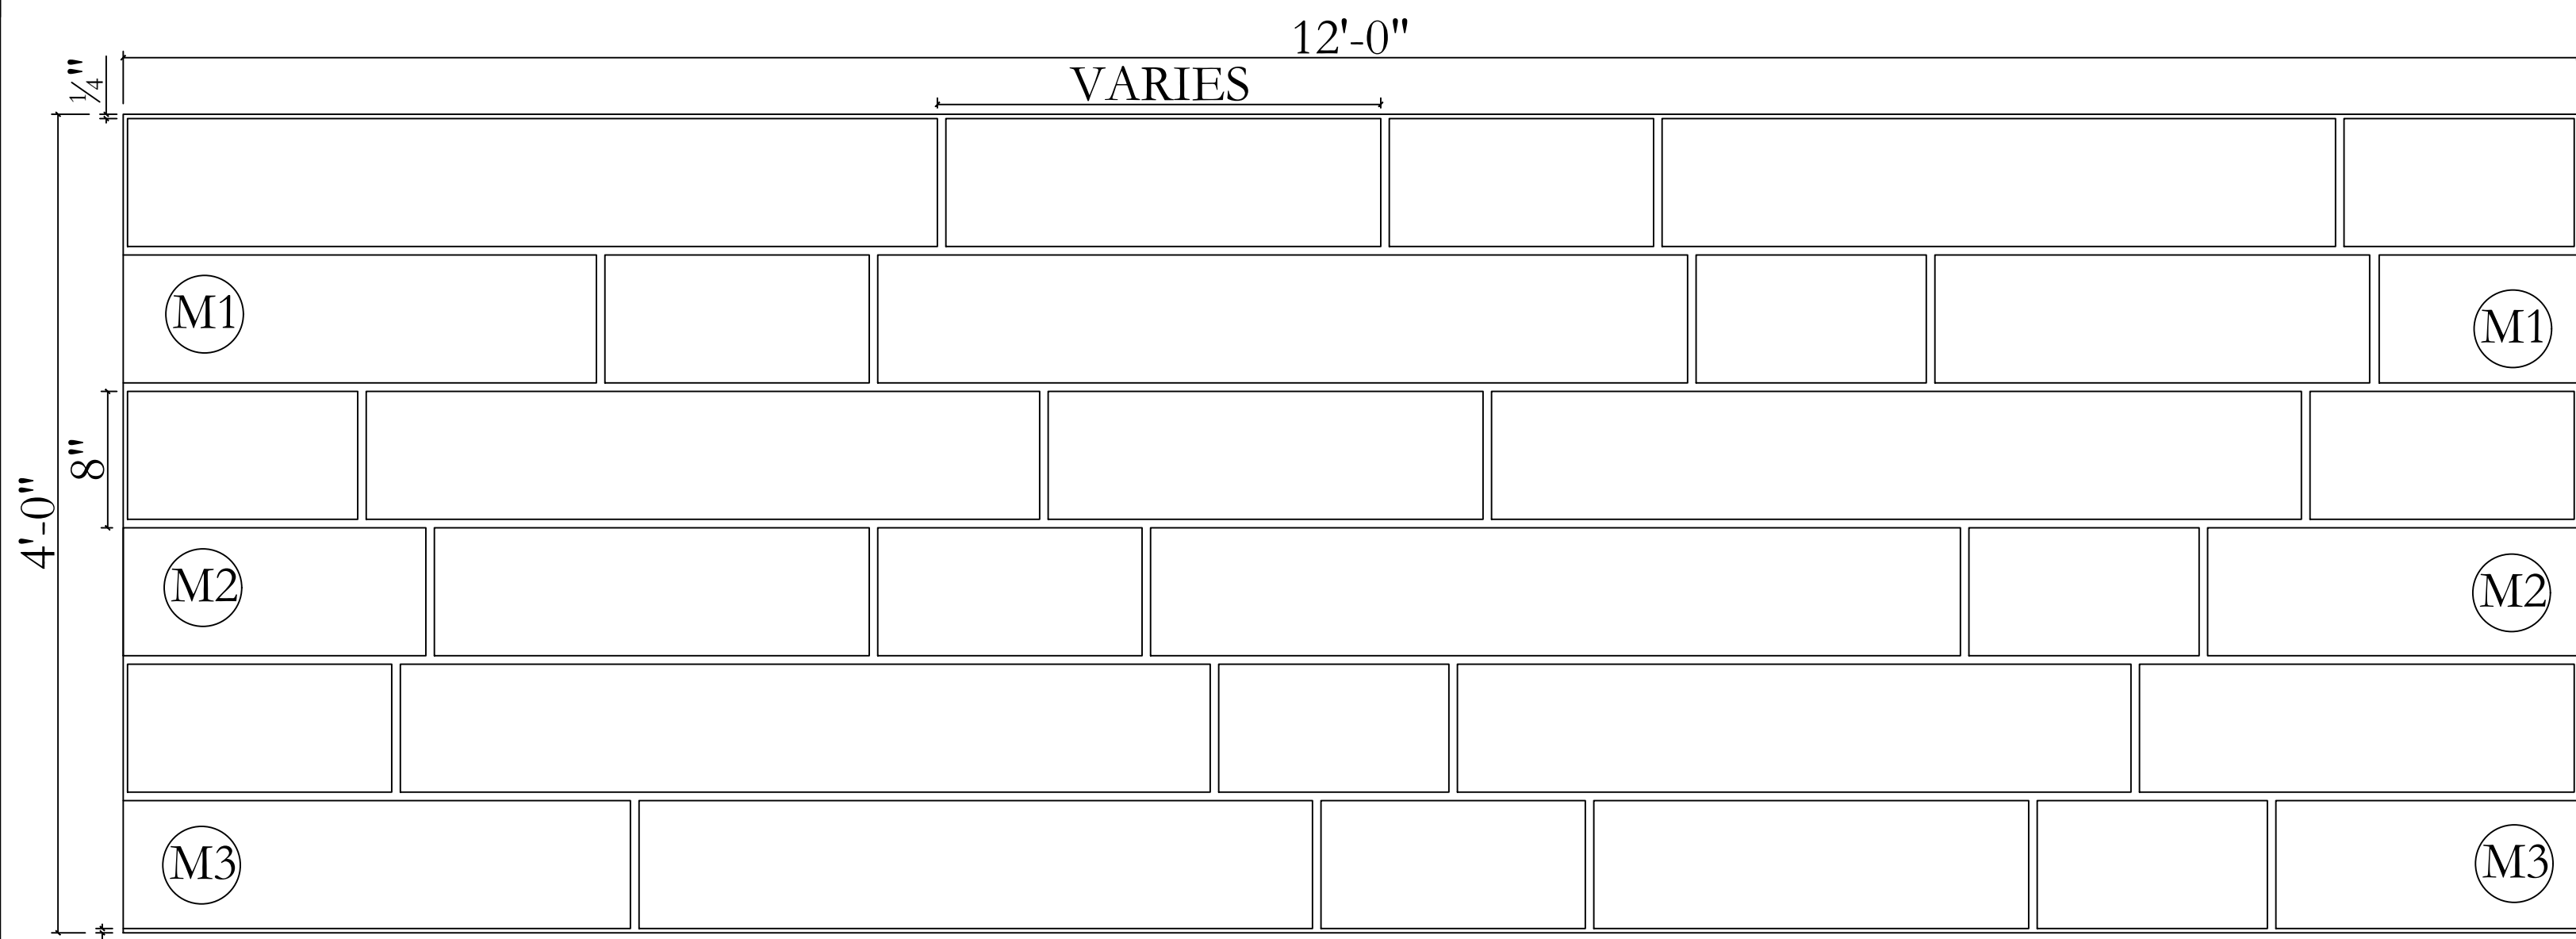
STONE LAYOUT FOR CONCEPT ONLY ACTUAL LAYOUT MAY VARY

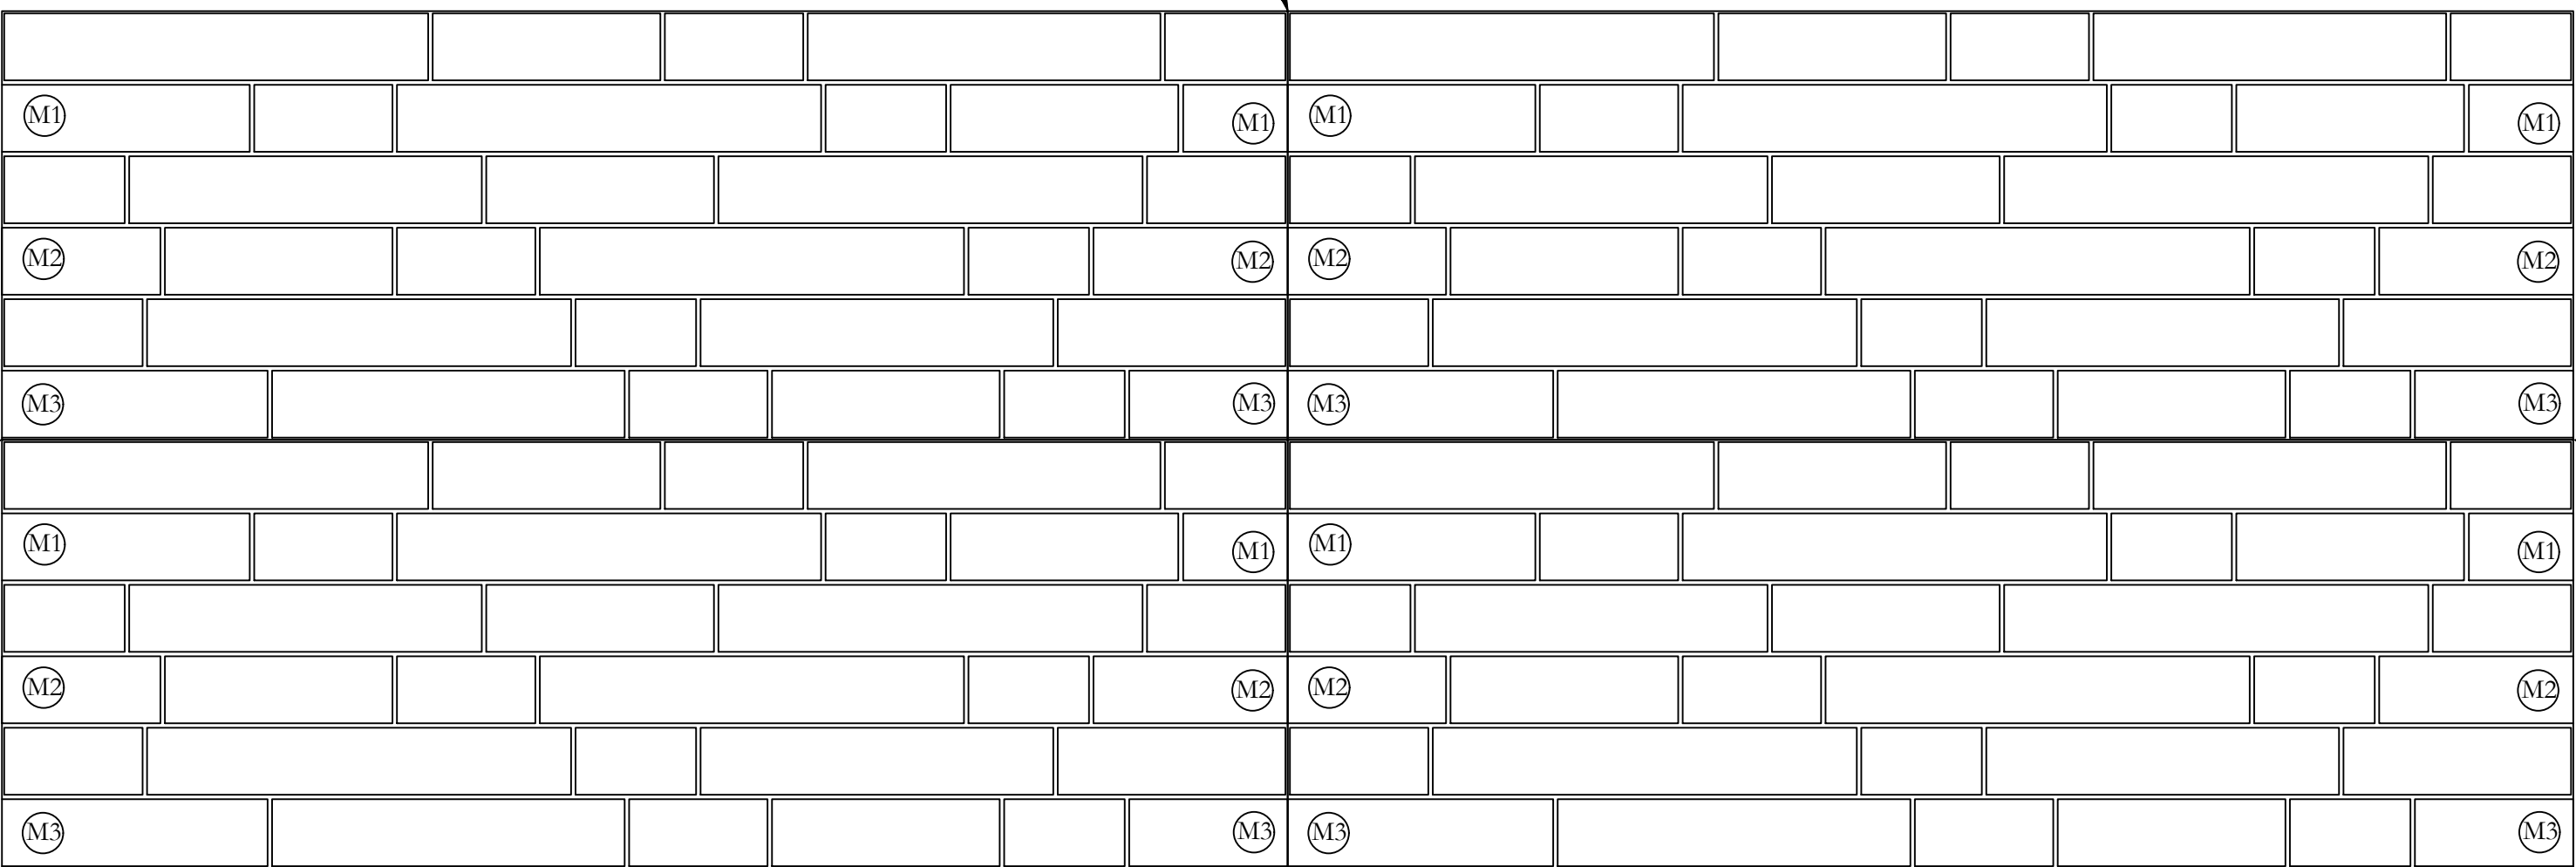
24'-0"

8'-0"

A noticeable seam will occur if not properly sealed when stacking liners.
