Customer:
 Job Name:
 Title: #892A 12in Quarry Stone

Customer: _____
 Job Name: _____
 Title: #892A 12in Quarry Stone Assembled

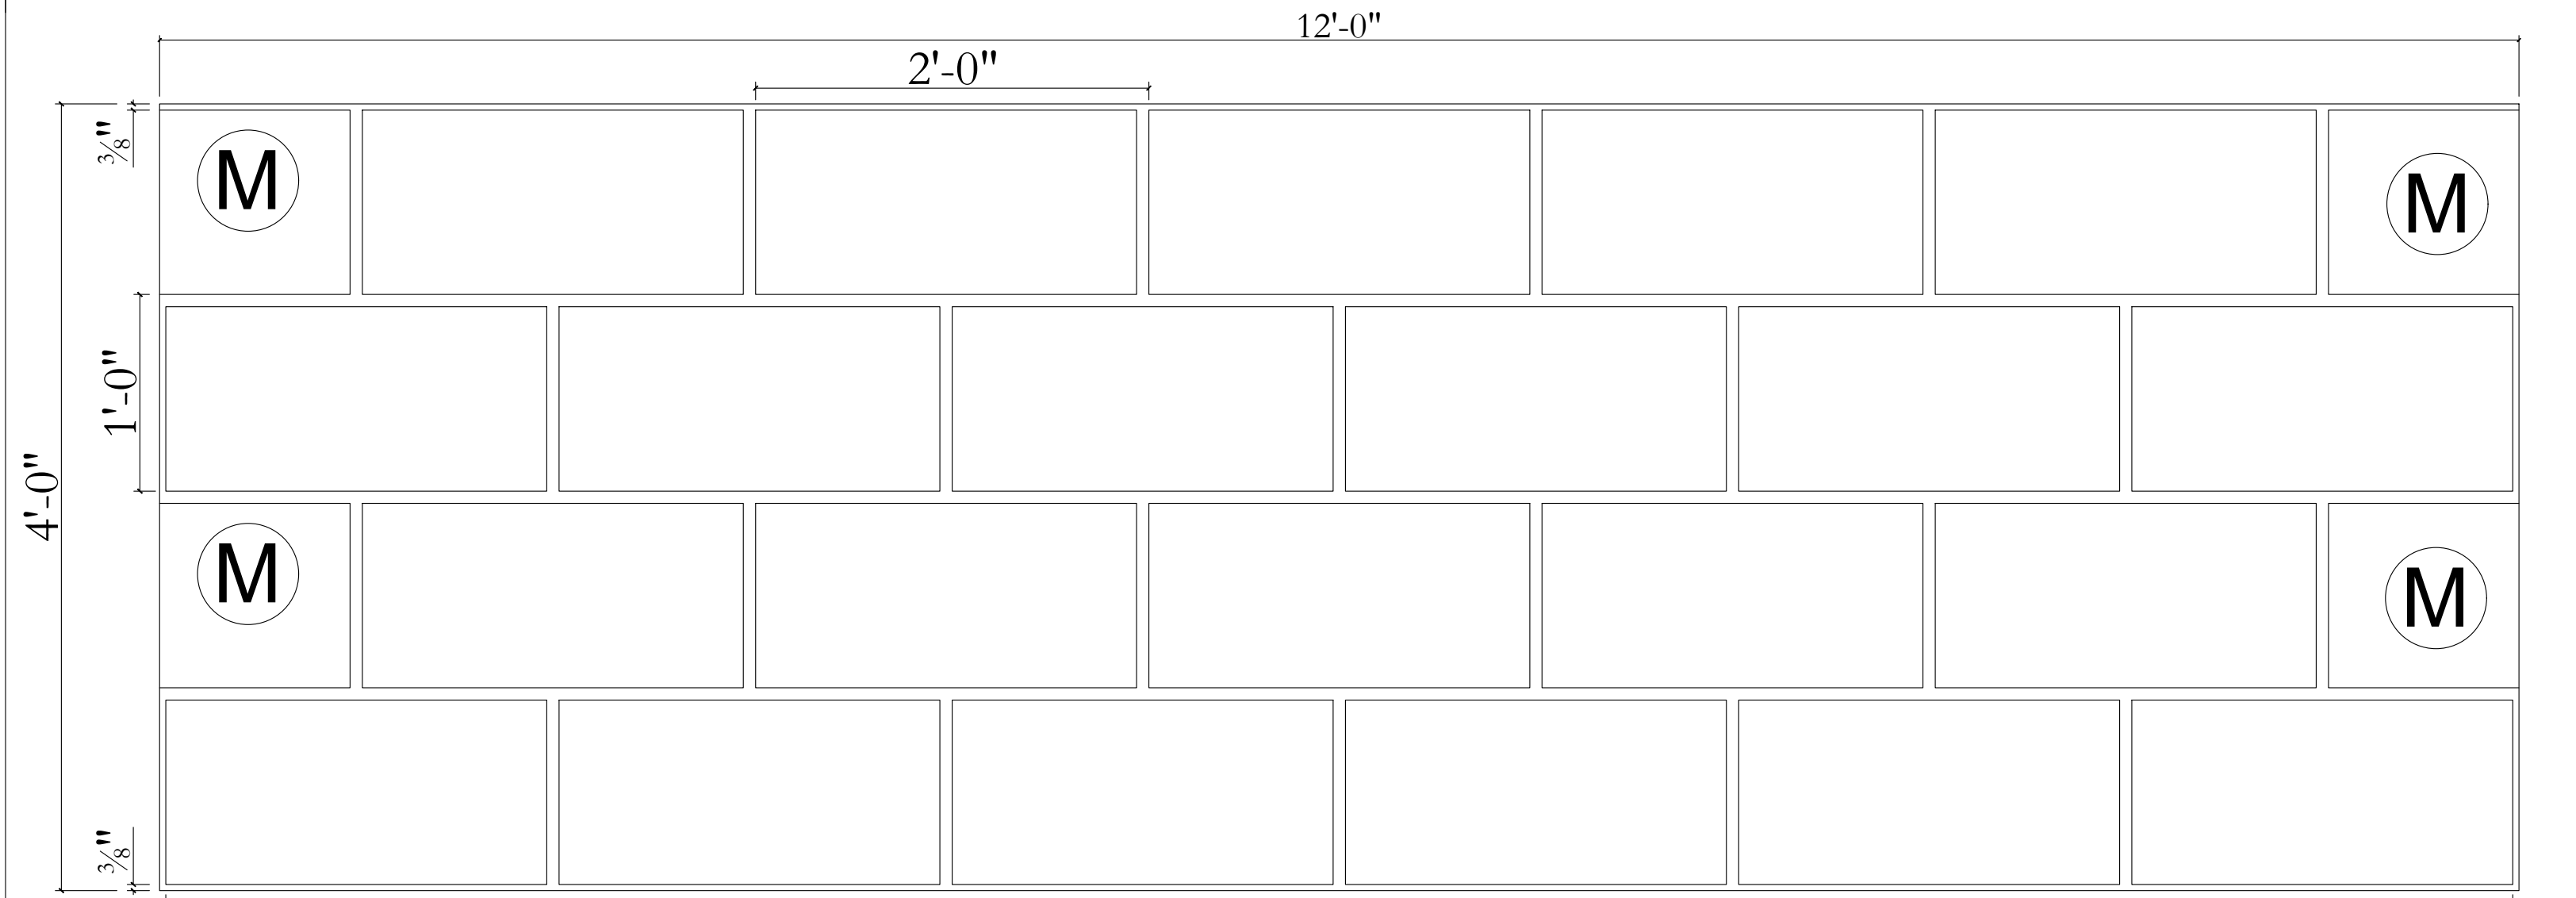
M DENOTES MATCHED STONES LT TO RIGHT

24'-0"

8'-0"

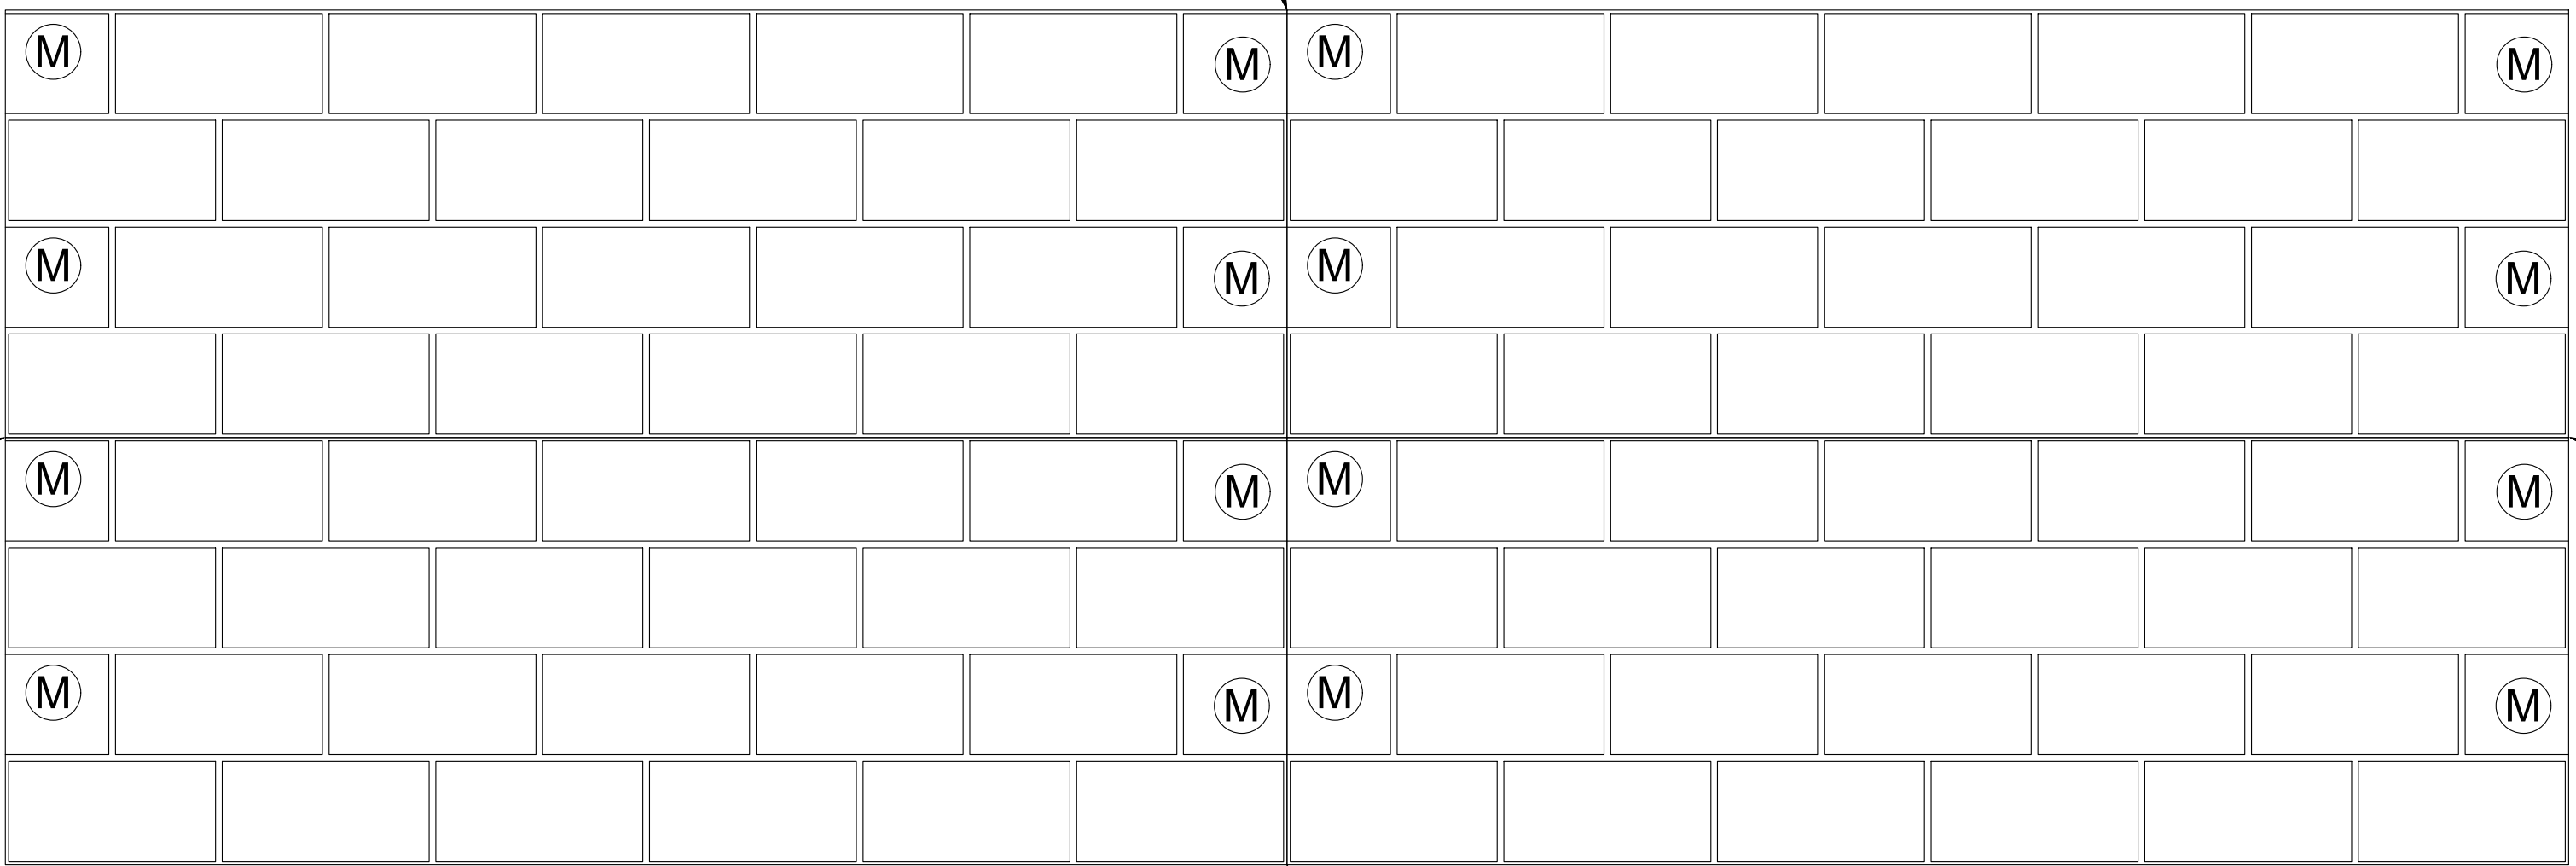
A noticeable seam will occur if not properly sealed when stacking liners.
