Customer:
 Job Name:
 Title: #901A Vertical 8"x16" Split Block (Cove)

Customer:
Job Name:
Title: #901A Vertical 8"x16" Split Block (Cove) Assembled

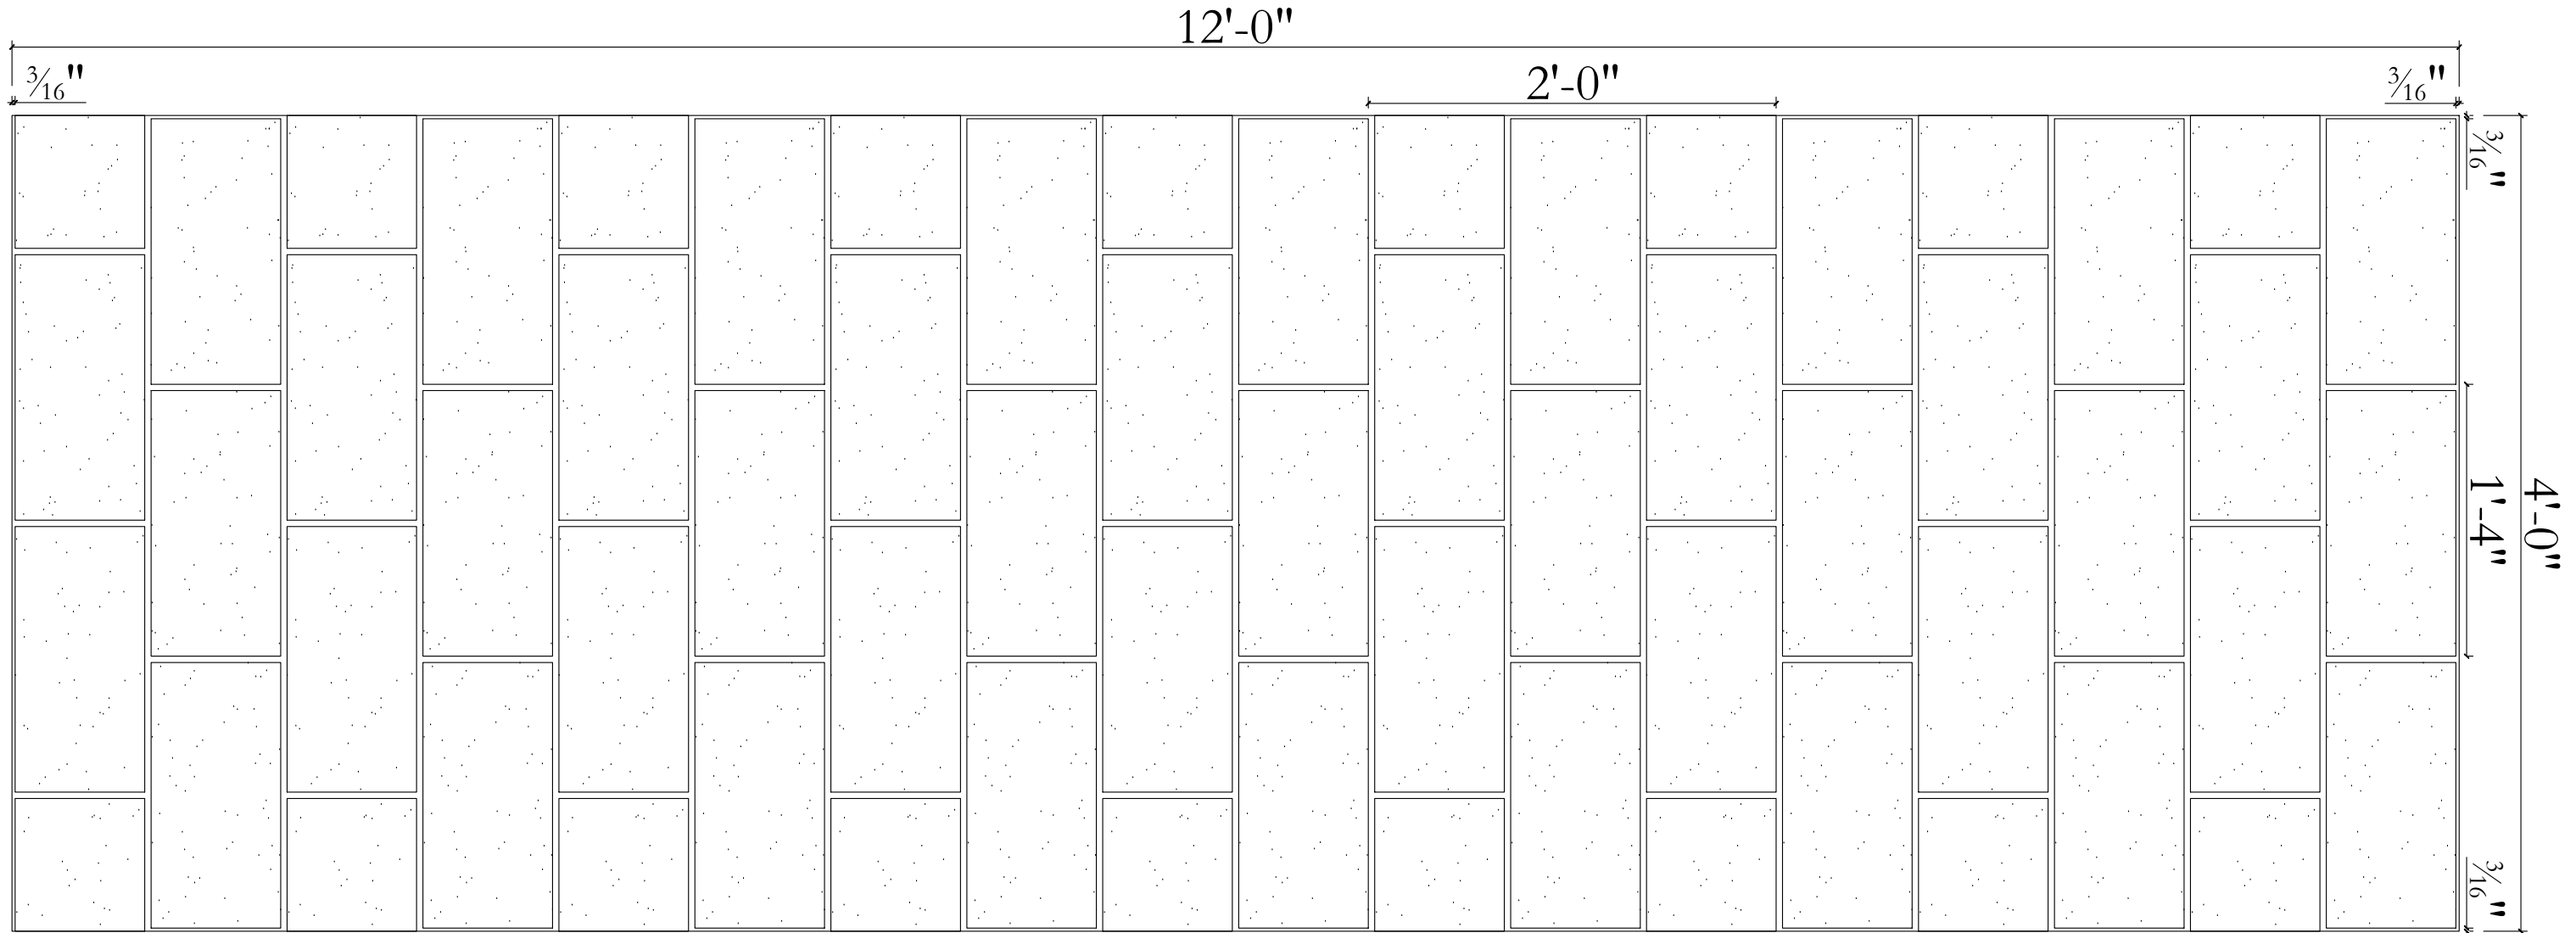
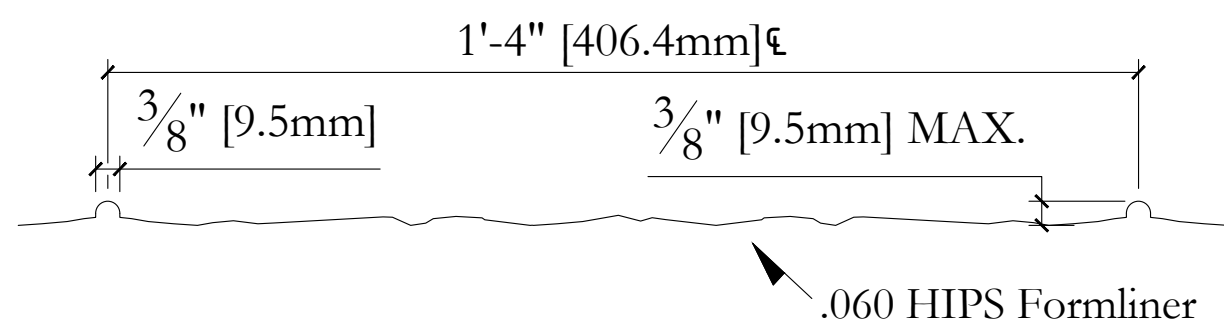
Typical Section

Hatch For Visual Reference Only. Actual Texture Will Vary

24'-0"

8'-0"

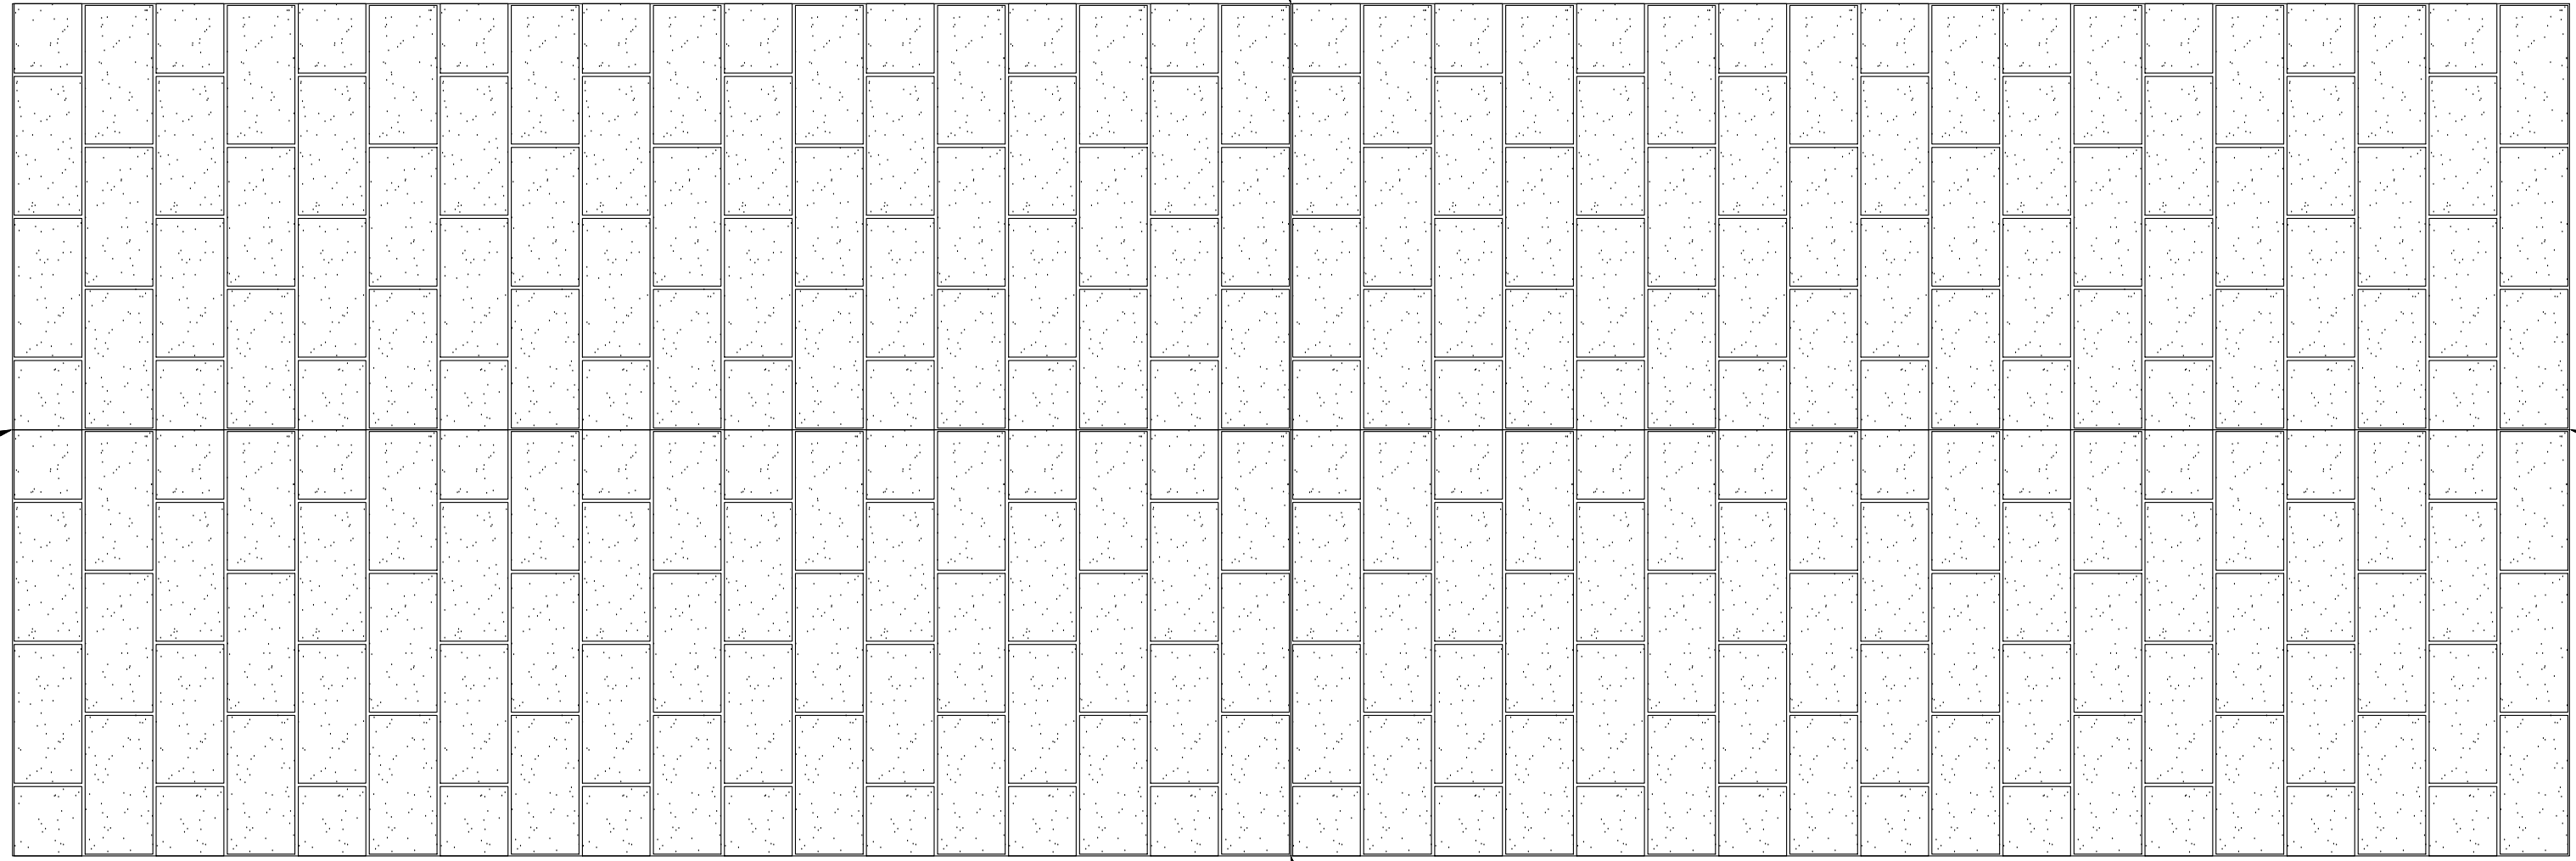
A noticeable seam will occur if not properly sealed when stacking liners.

A noticeable seam will occur if not properly sealed when stacking liners.
