Customer:  
 Job Name:  
 Title: #901C 8"x16" Split Block Heavy Relief (Cove) Zippered

Customer:  
 Job Name:  
 Title:  
 #901C 8"x16" Split Block Heavy Relief (Cove) Zippered Assembled

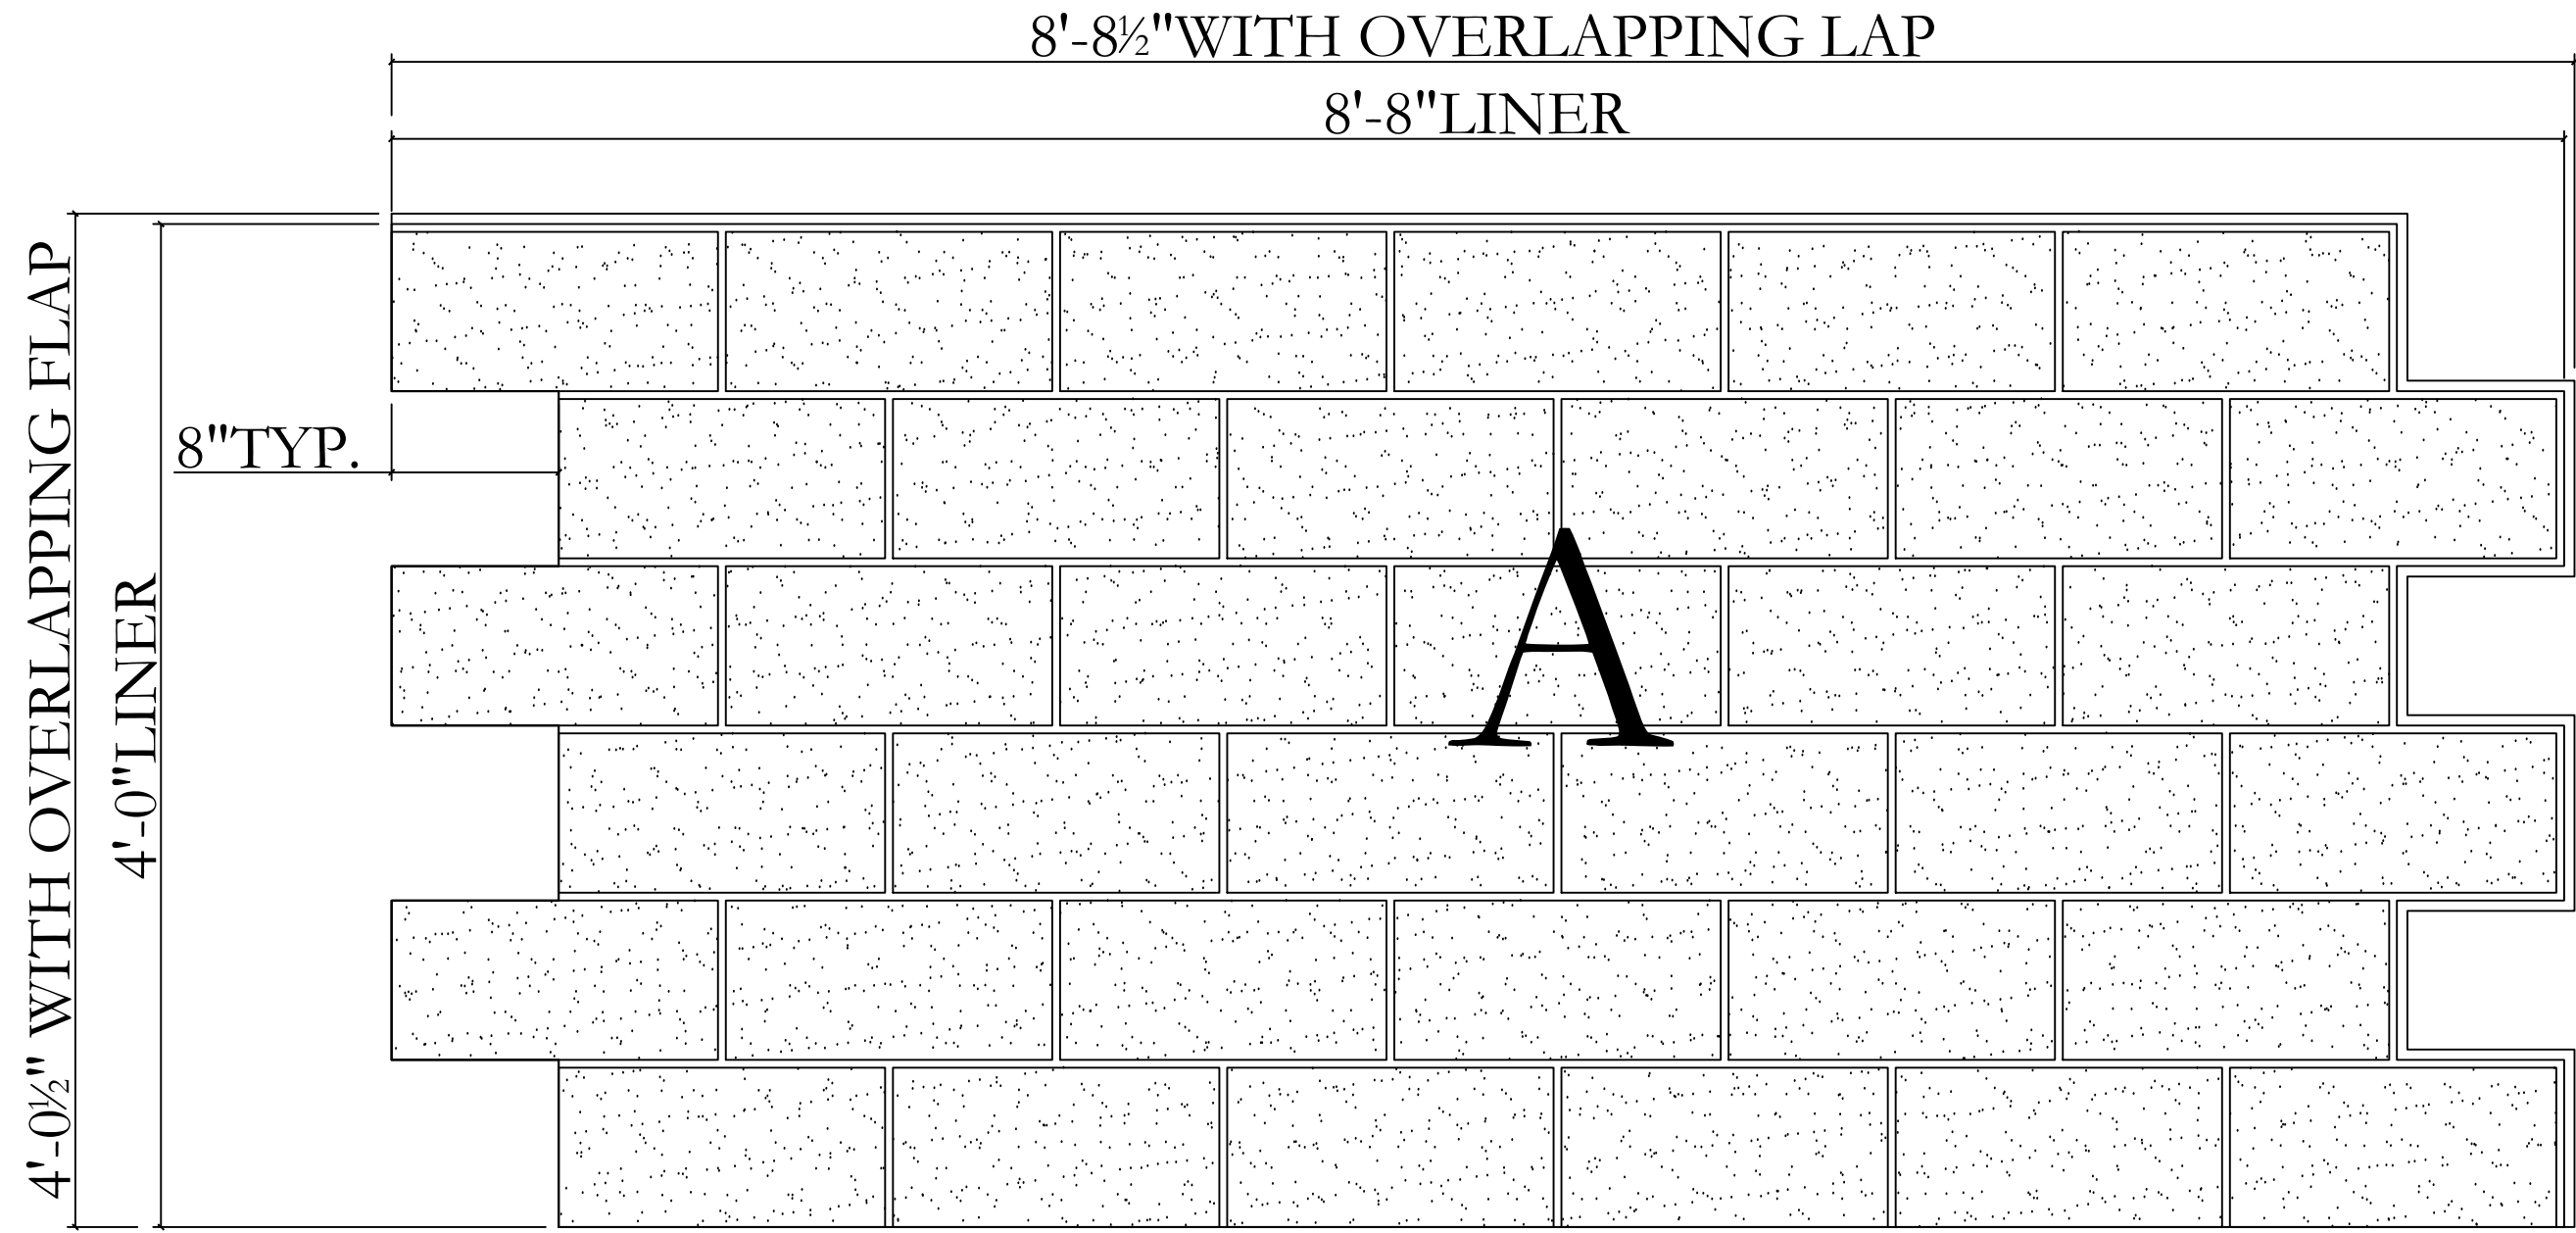
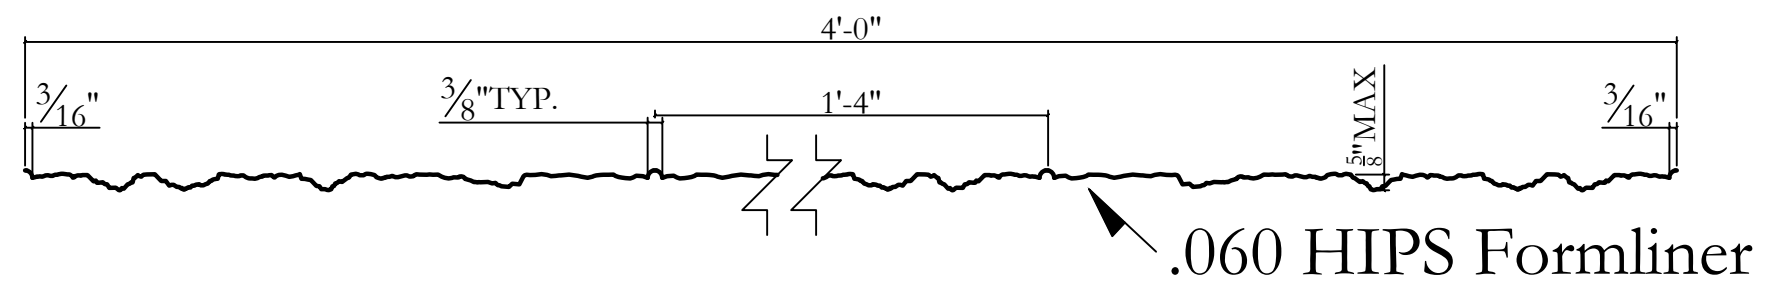
Typical Section

.060 HIPS Formliner

# 16'-8"

A noticeable seam will occur if not properly sealed when stacking liners.

# 8'-0"

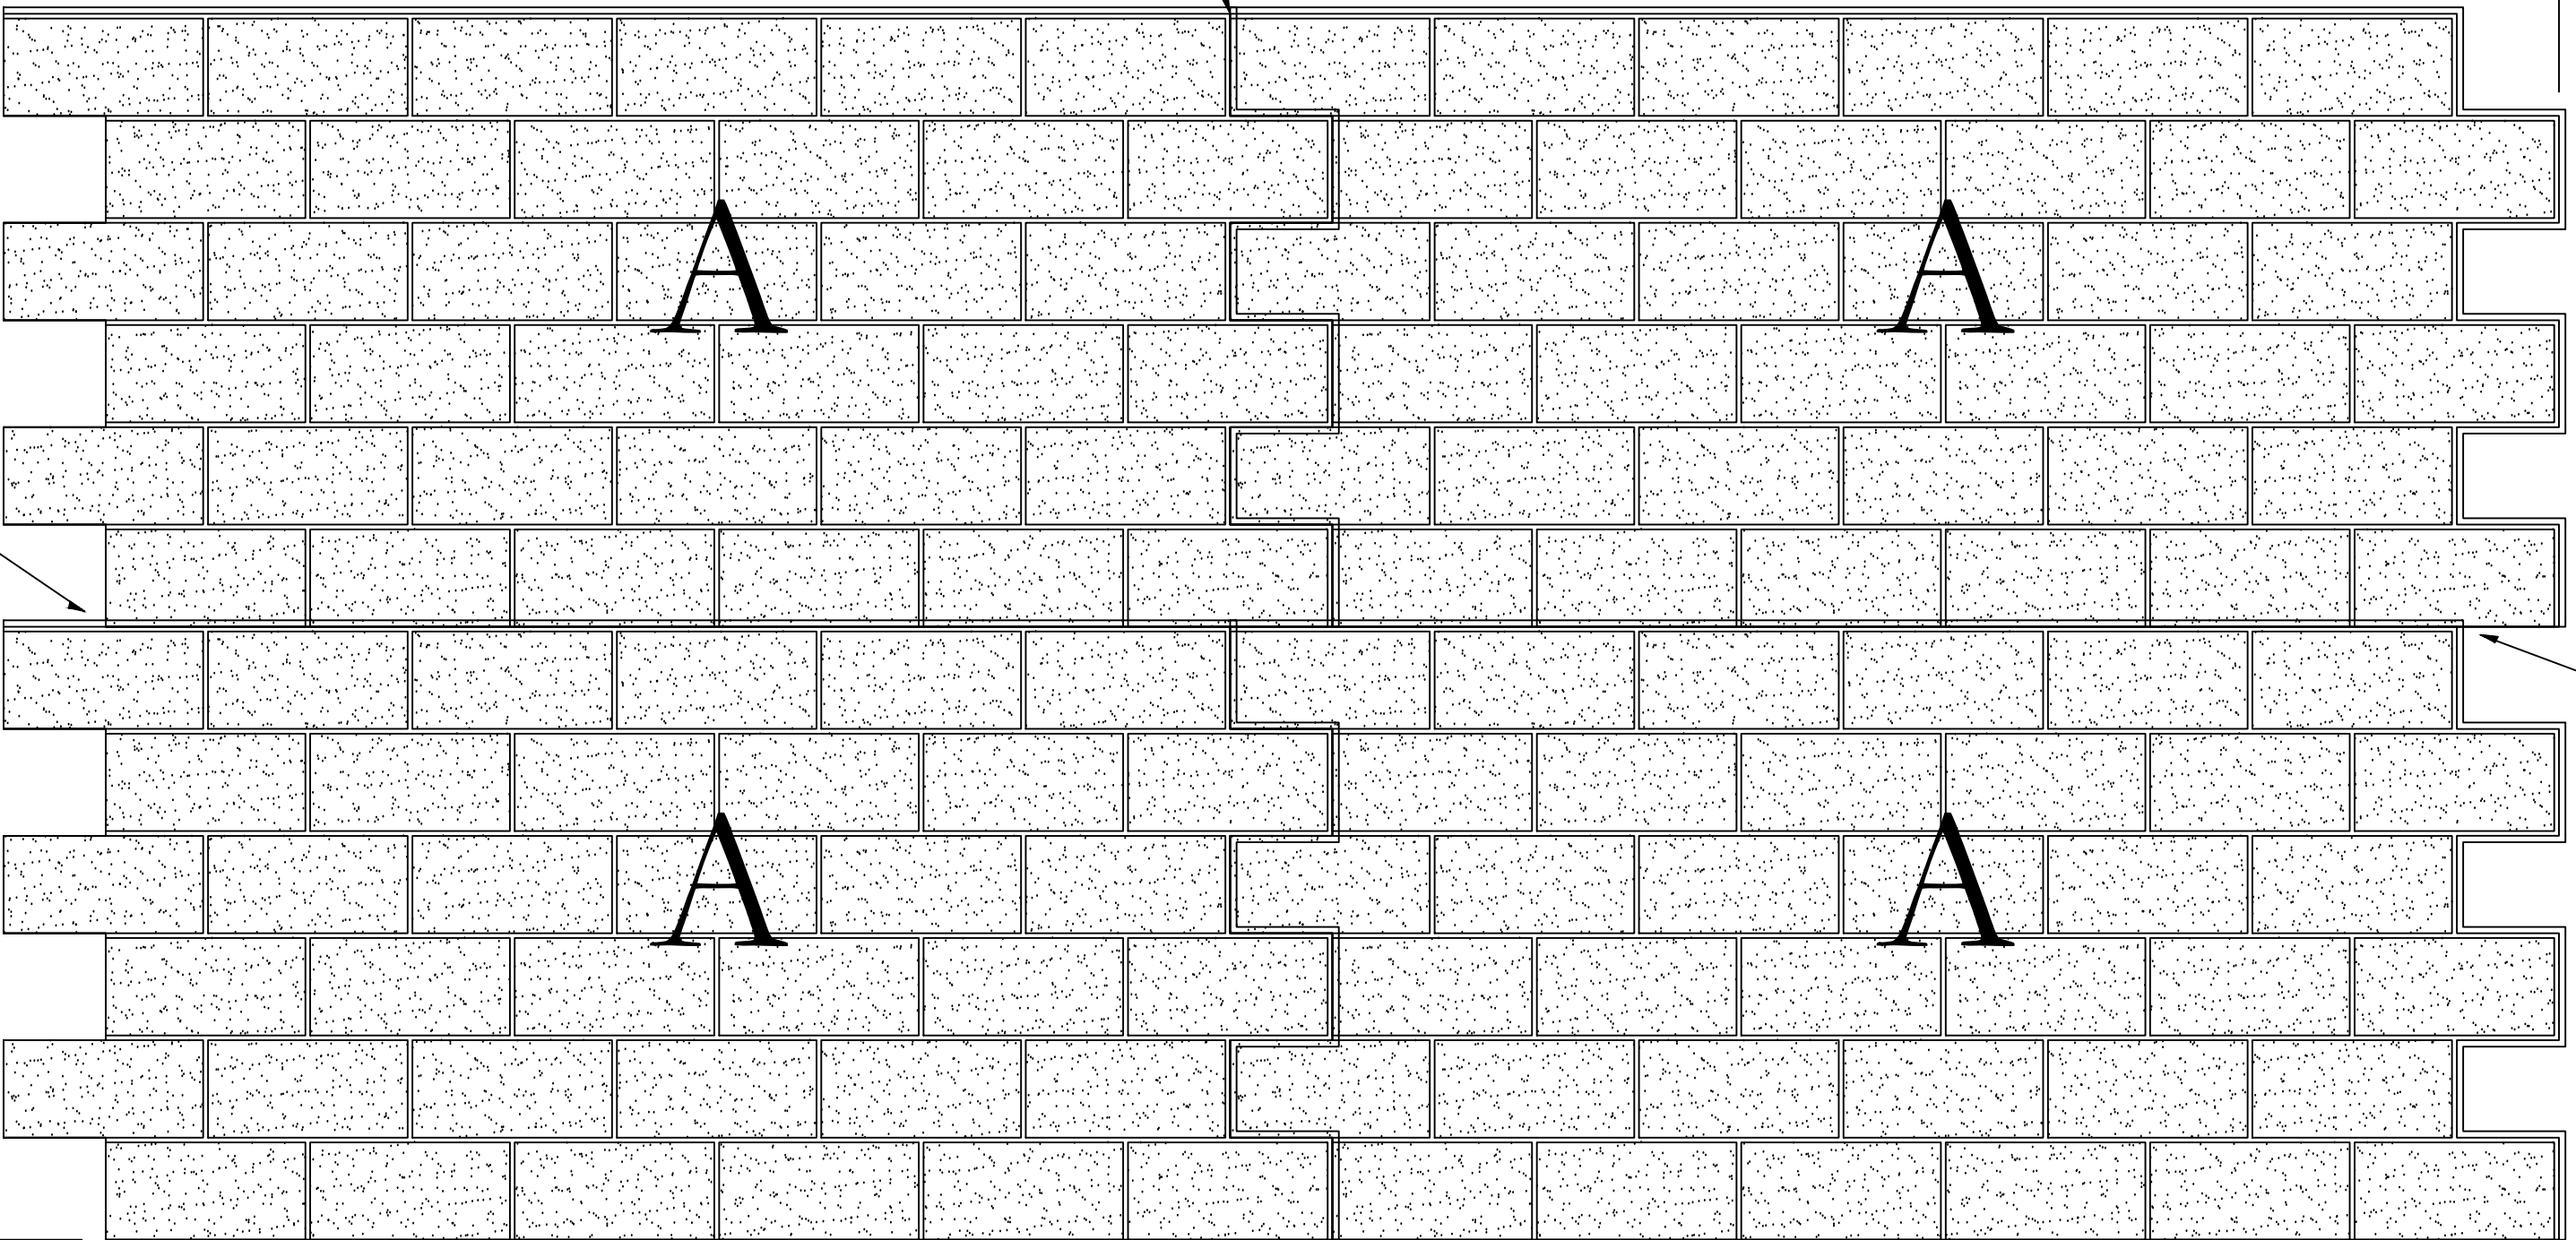
A noticeable seam will occur if not properly sealed when stacking liners.
