Customer:  
 Job Name:  
 Title: #901C 8"x16" Split Block Heavy Relief (Cove)

Customer:  
Job Name:  
Title:  
#901C 8"x16" Split Block Heavy Relief (Cove) Assembled

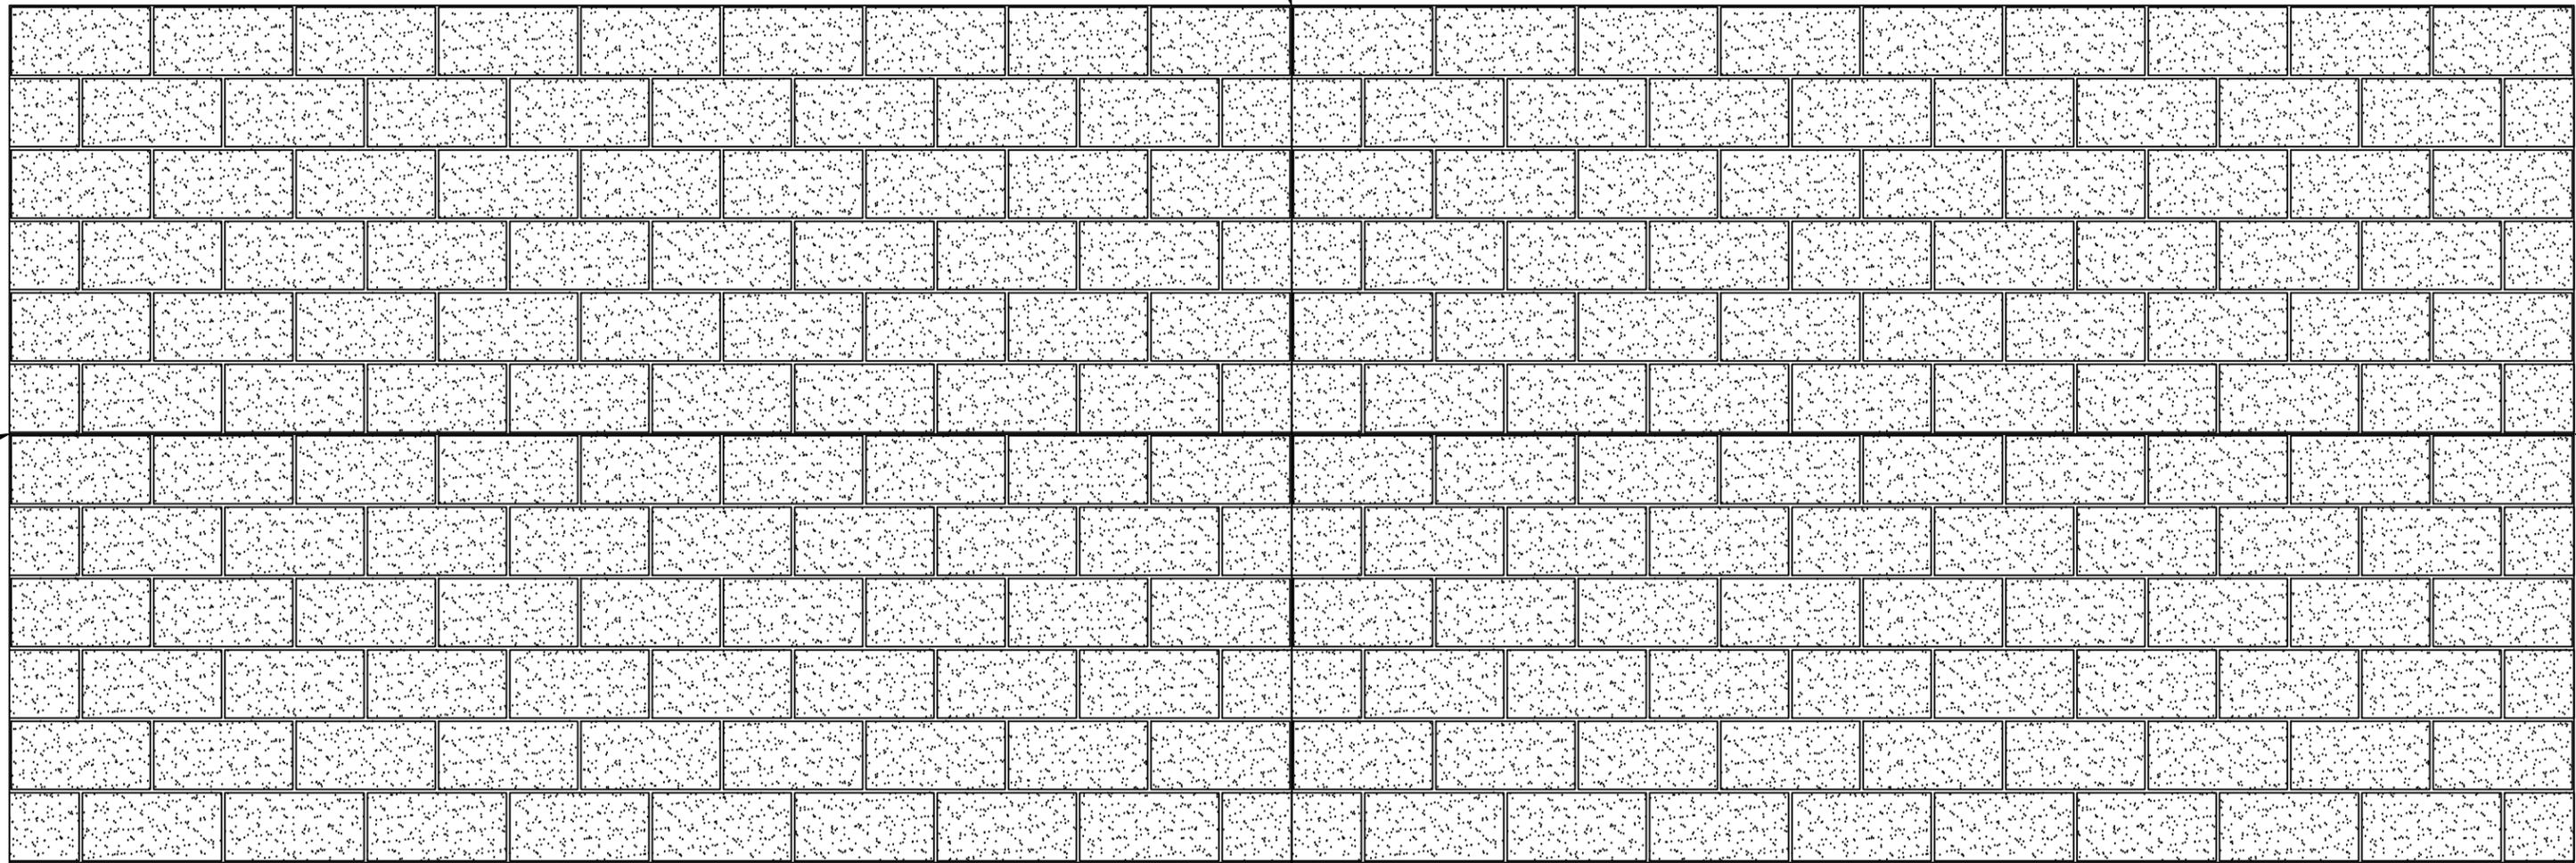
24'-0"

8'-0"  
A noticeable seam will occur if not properly sealed when stacking liners.

A noticeable seam will occur if not properly sealed when stacking liners.
