**.060 HIPS FORMLINER**

**ITEM # 309188**

Customer:  
 Job Name:  
 Title: #909 Westmoreland Drystack

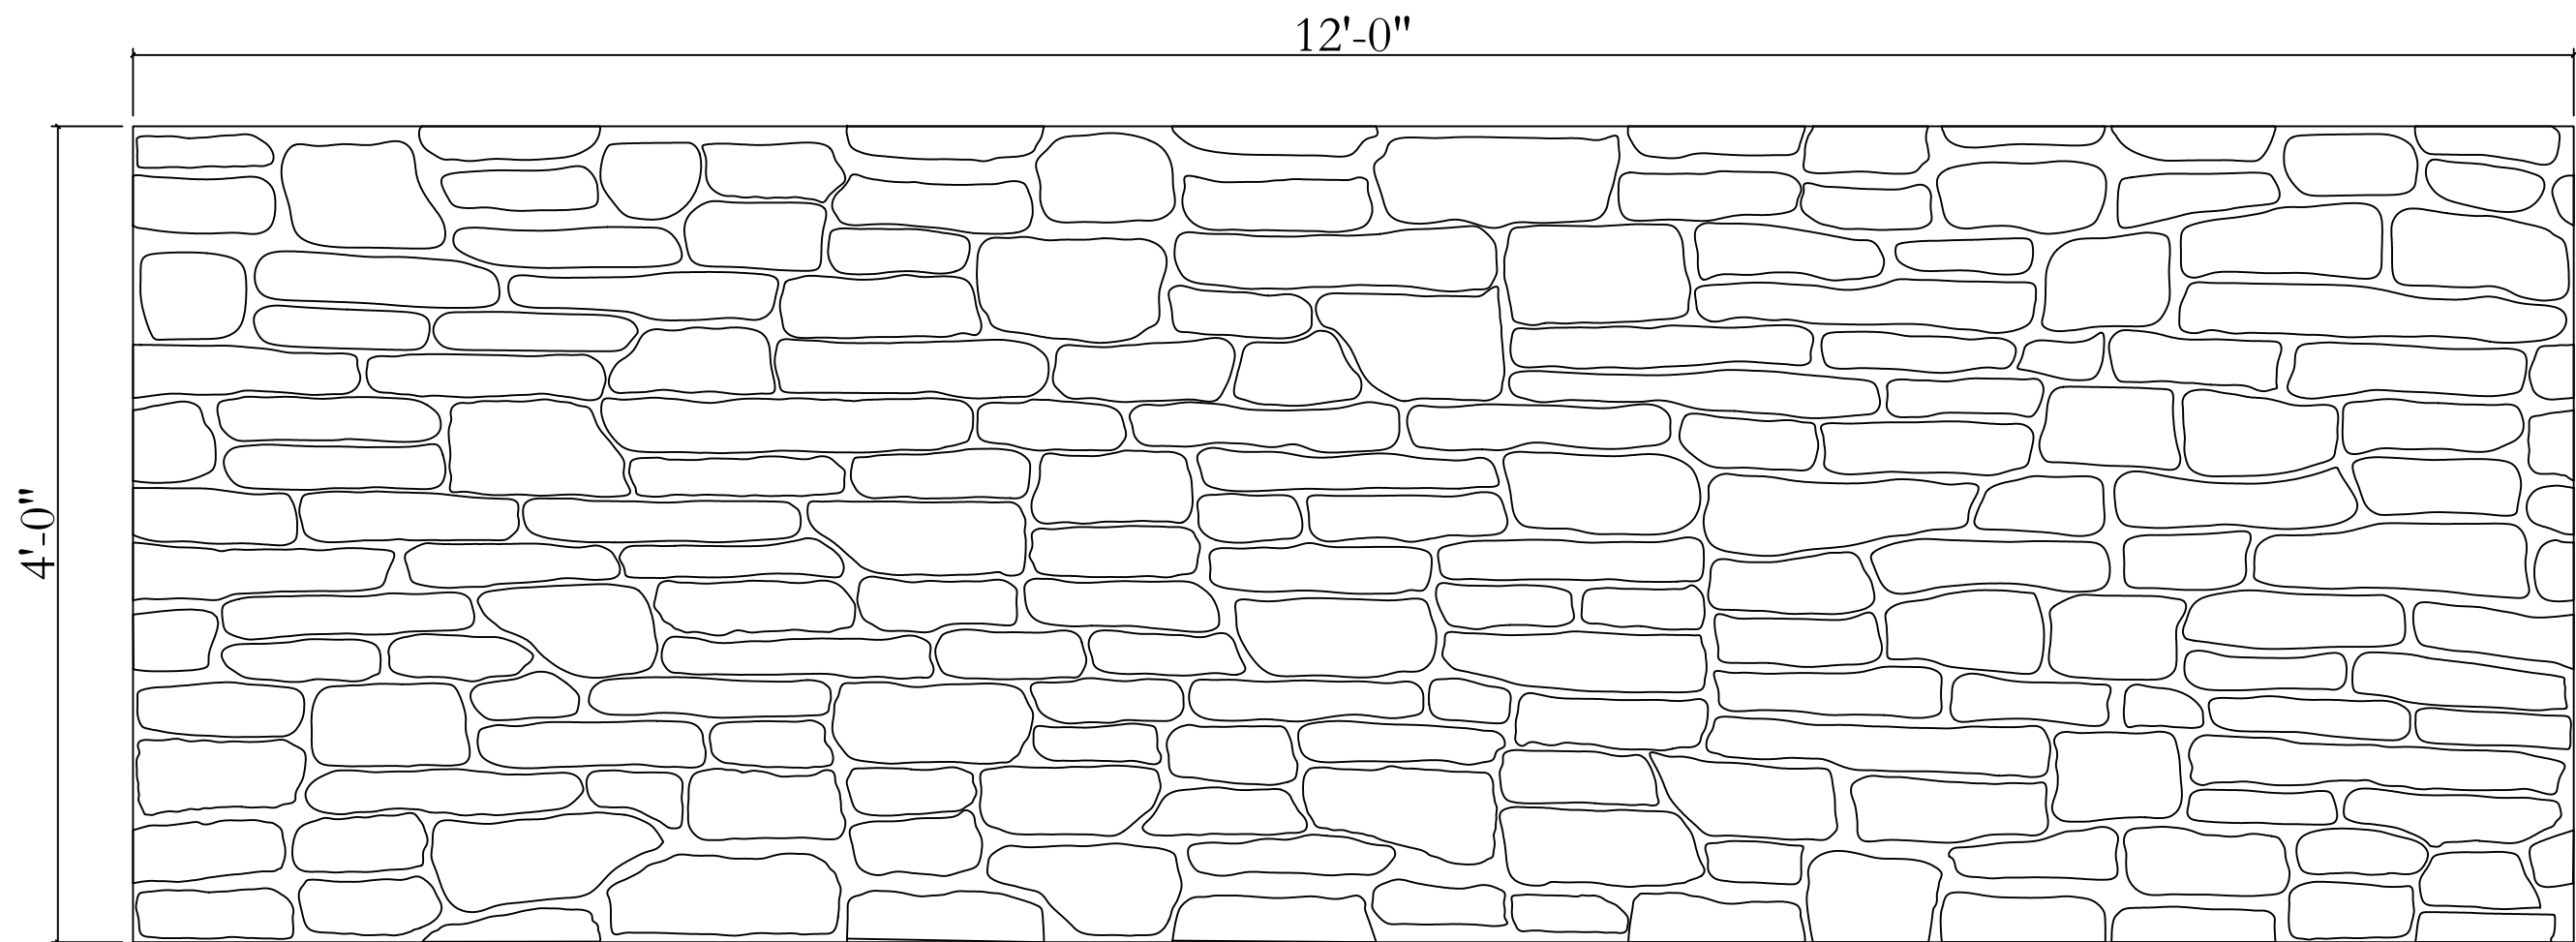
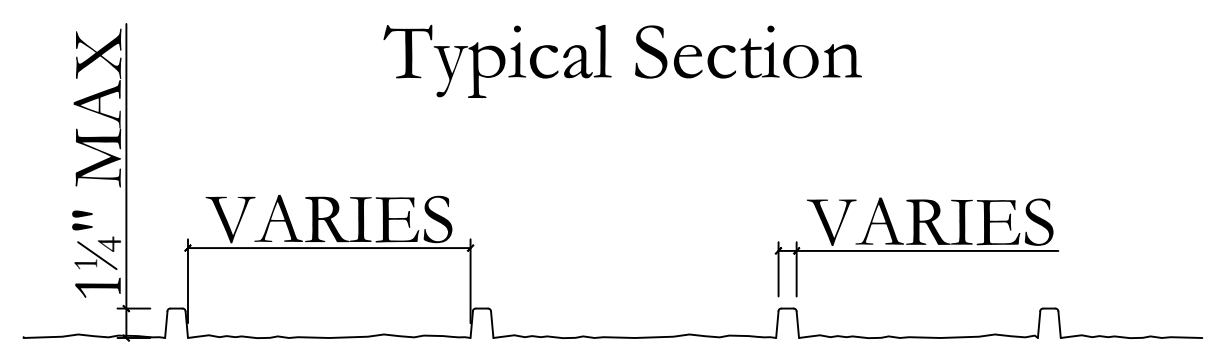
MUST MATCH TOP/BOTTOM AND LEFT/RIGHT  
 STONE LAYOUT DETERMINED BY AP

A noticeable seam will occur if not properly sealed when stacking liners.

8'-0"  
A noticeable seam will occur if not properly sealed when stacking liners.

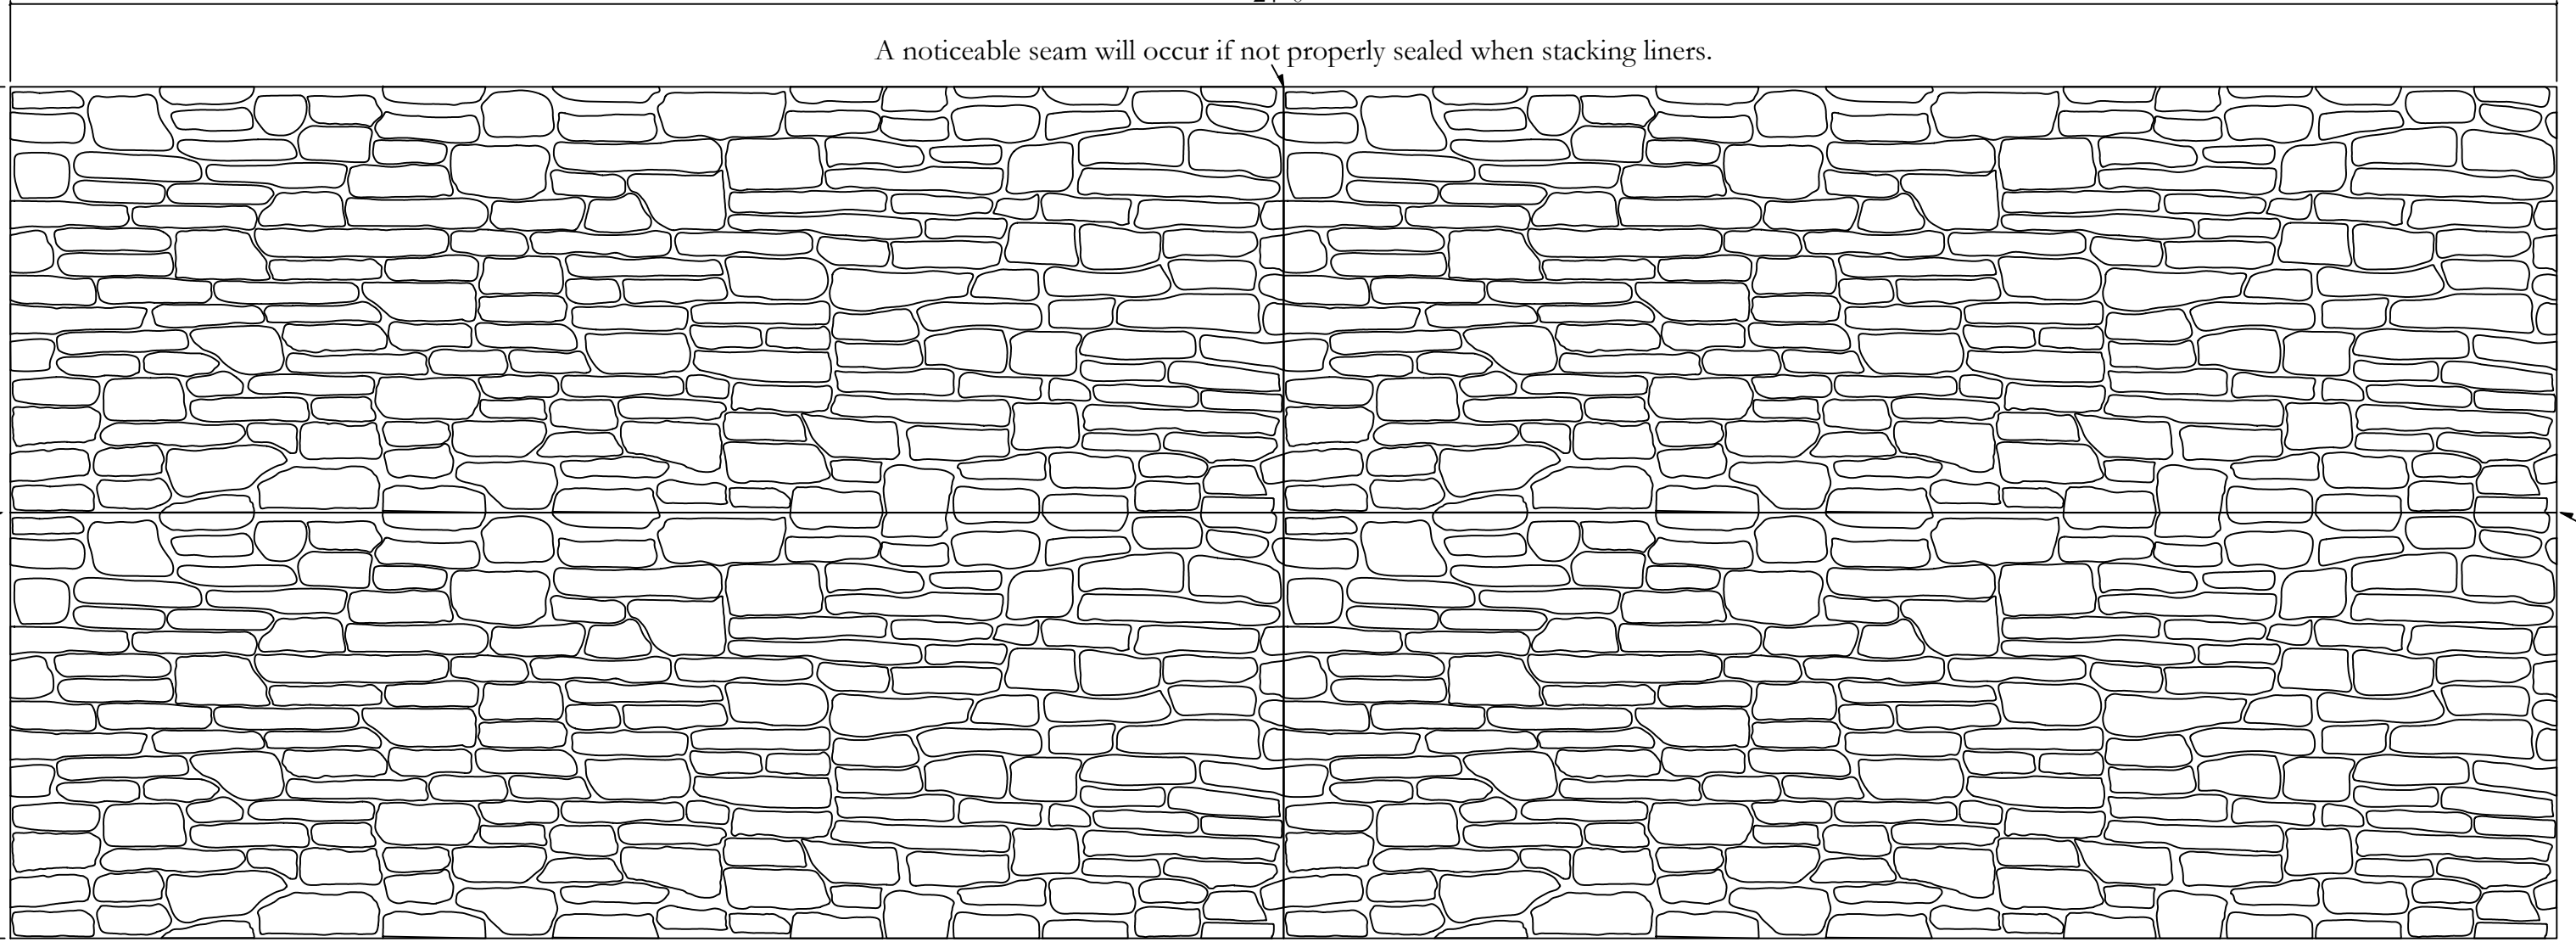
24'-0"

A noticeable seam will occur if not properly sealed when stacking liners.
