ITEM # 304817

Customer:
 Job Name:
 Title: #911 Large Stone Drystack 2 1/2" Max Relief

Customer:
 Job Name:
 Title:
 #911 Large Stone Drystack 2 1/2" Max Relief Assembled

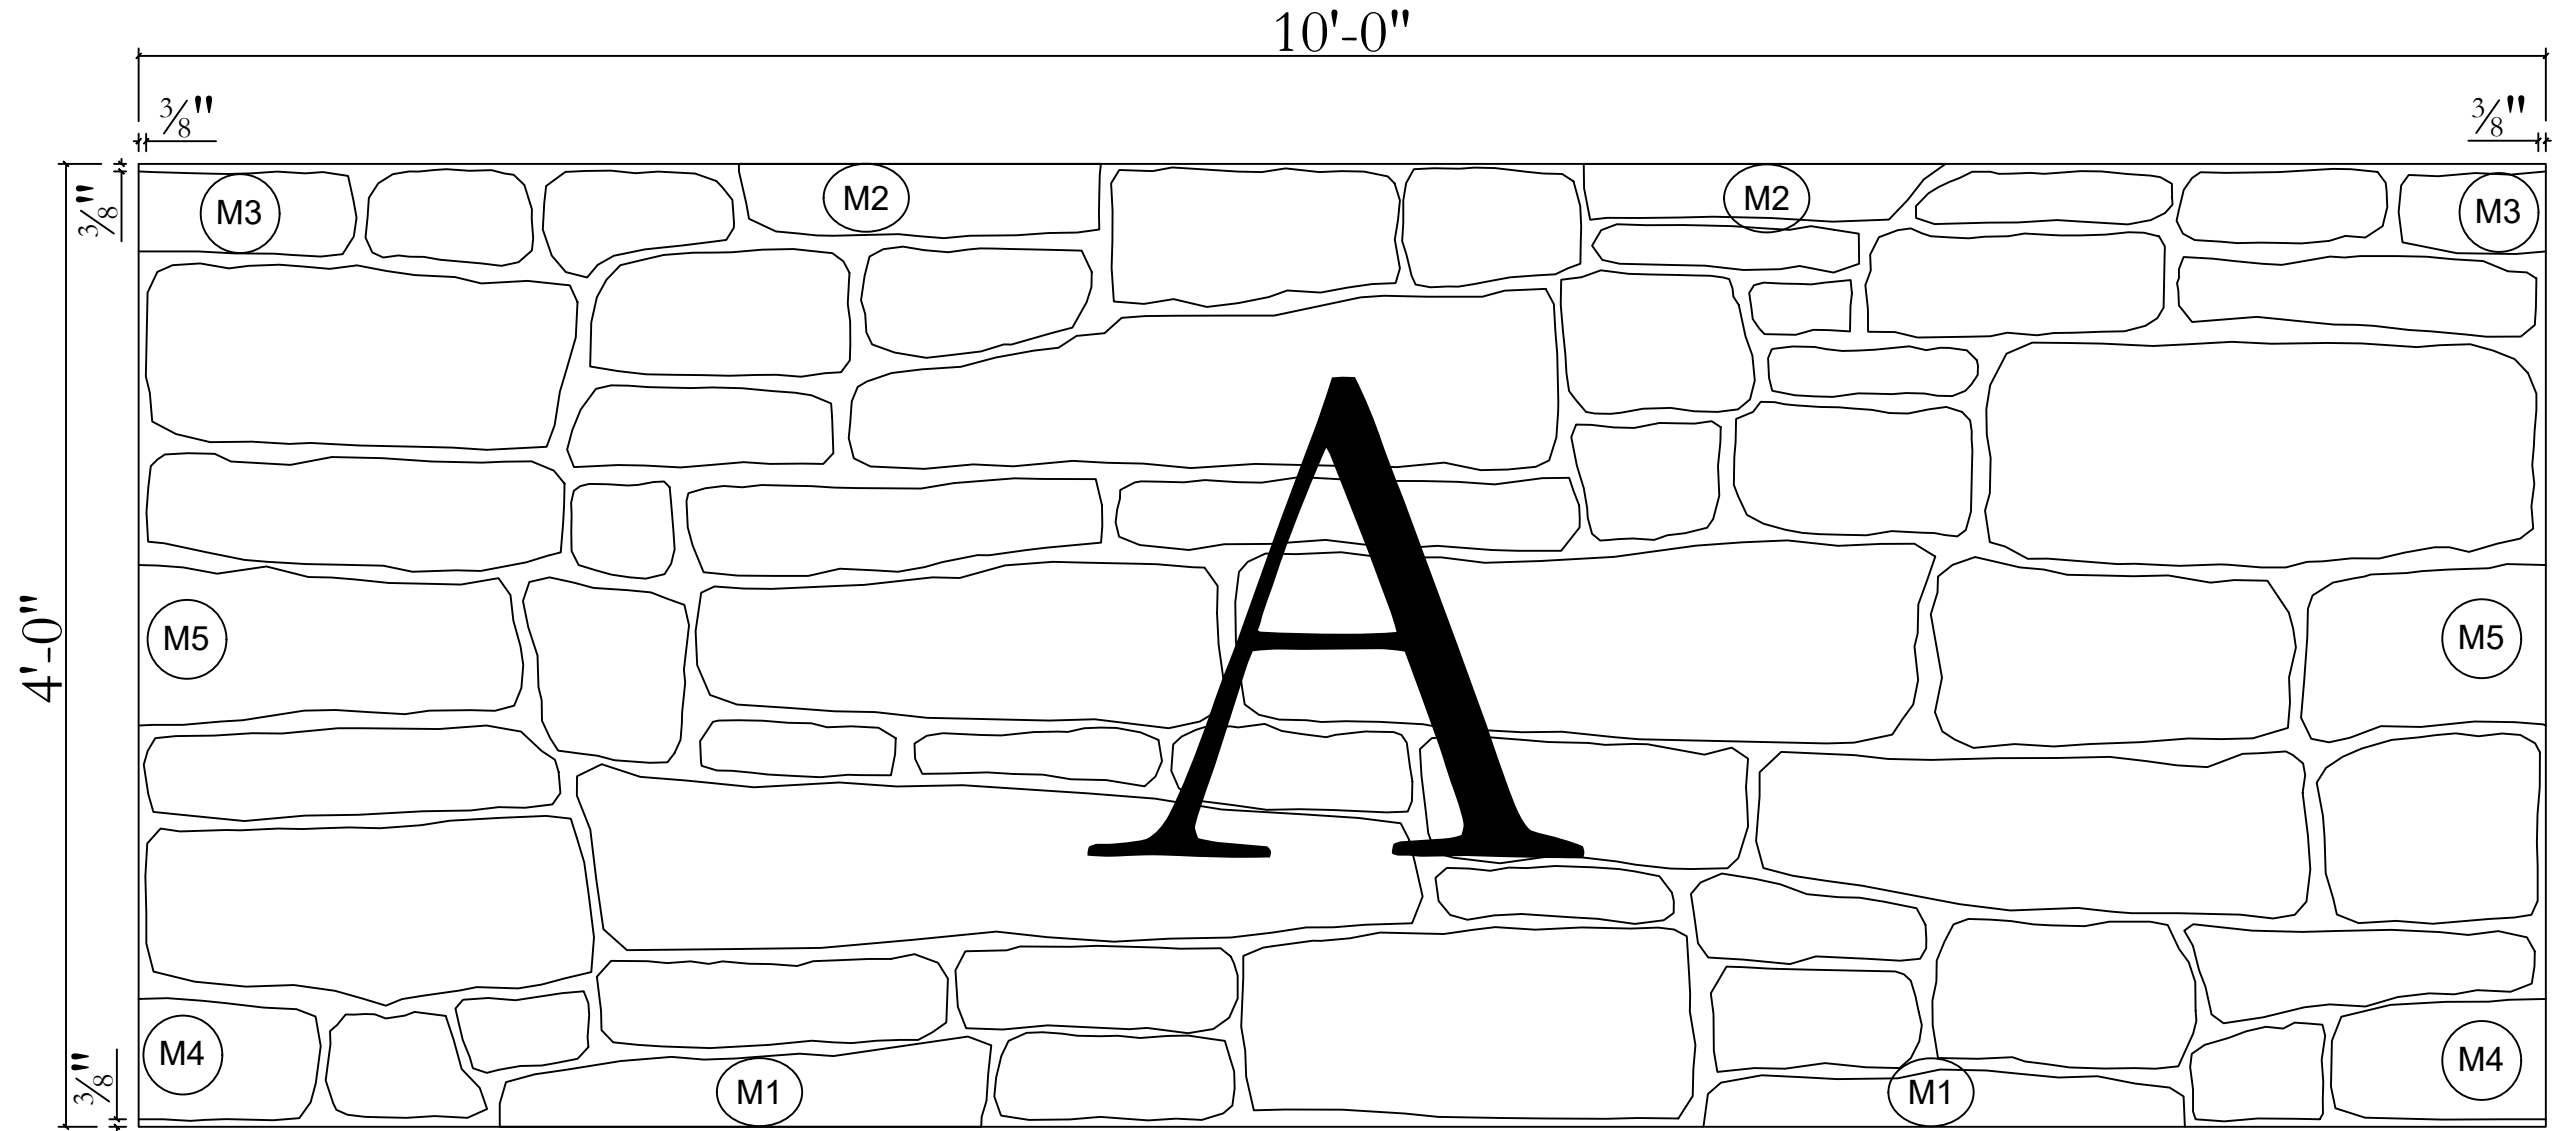
STONE LAYOUT FOR CONCEPT ONLY ACTUAL LAYOUT WILL VARY

20'-0"

8'-0"

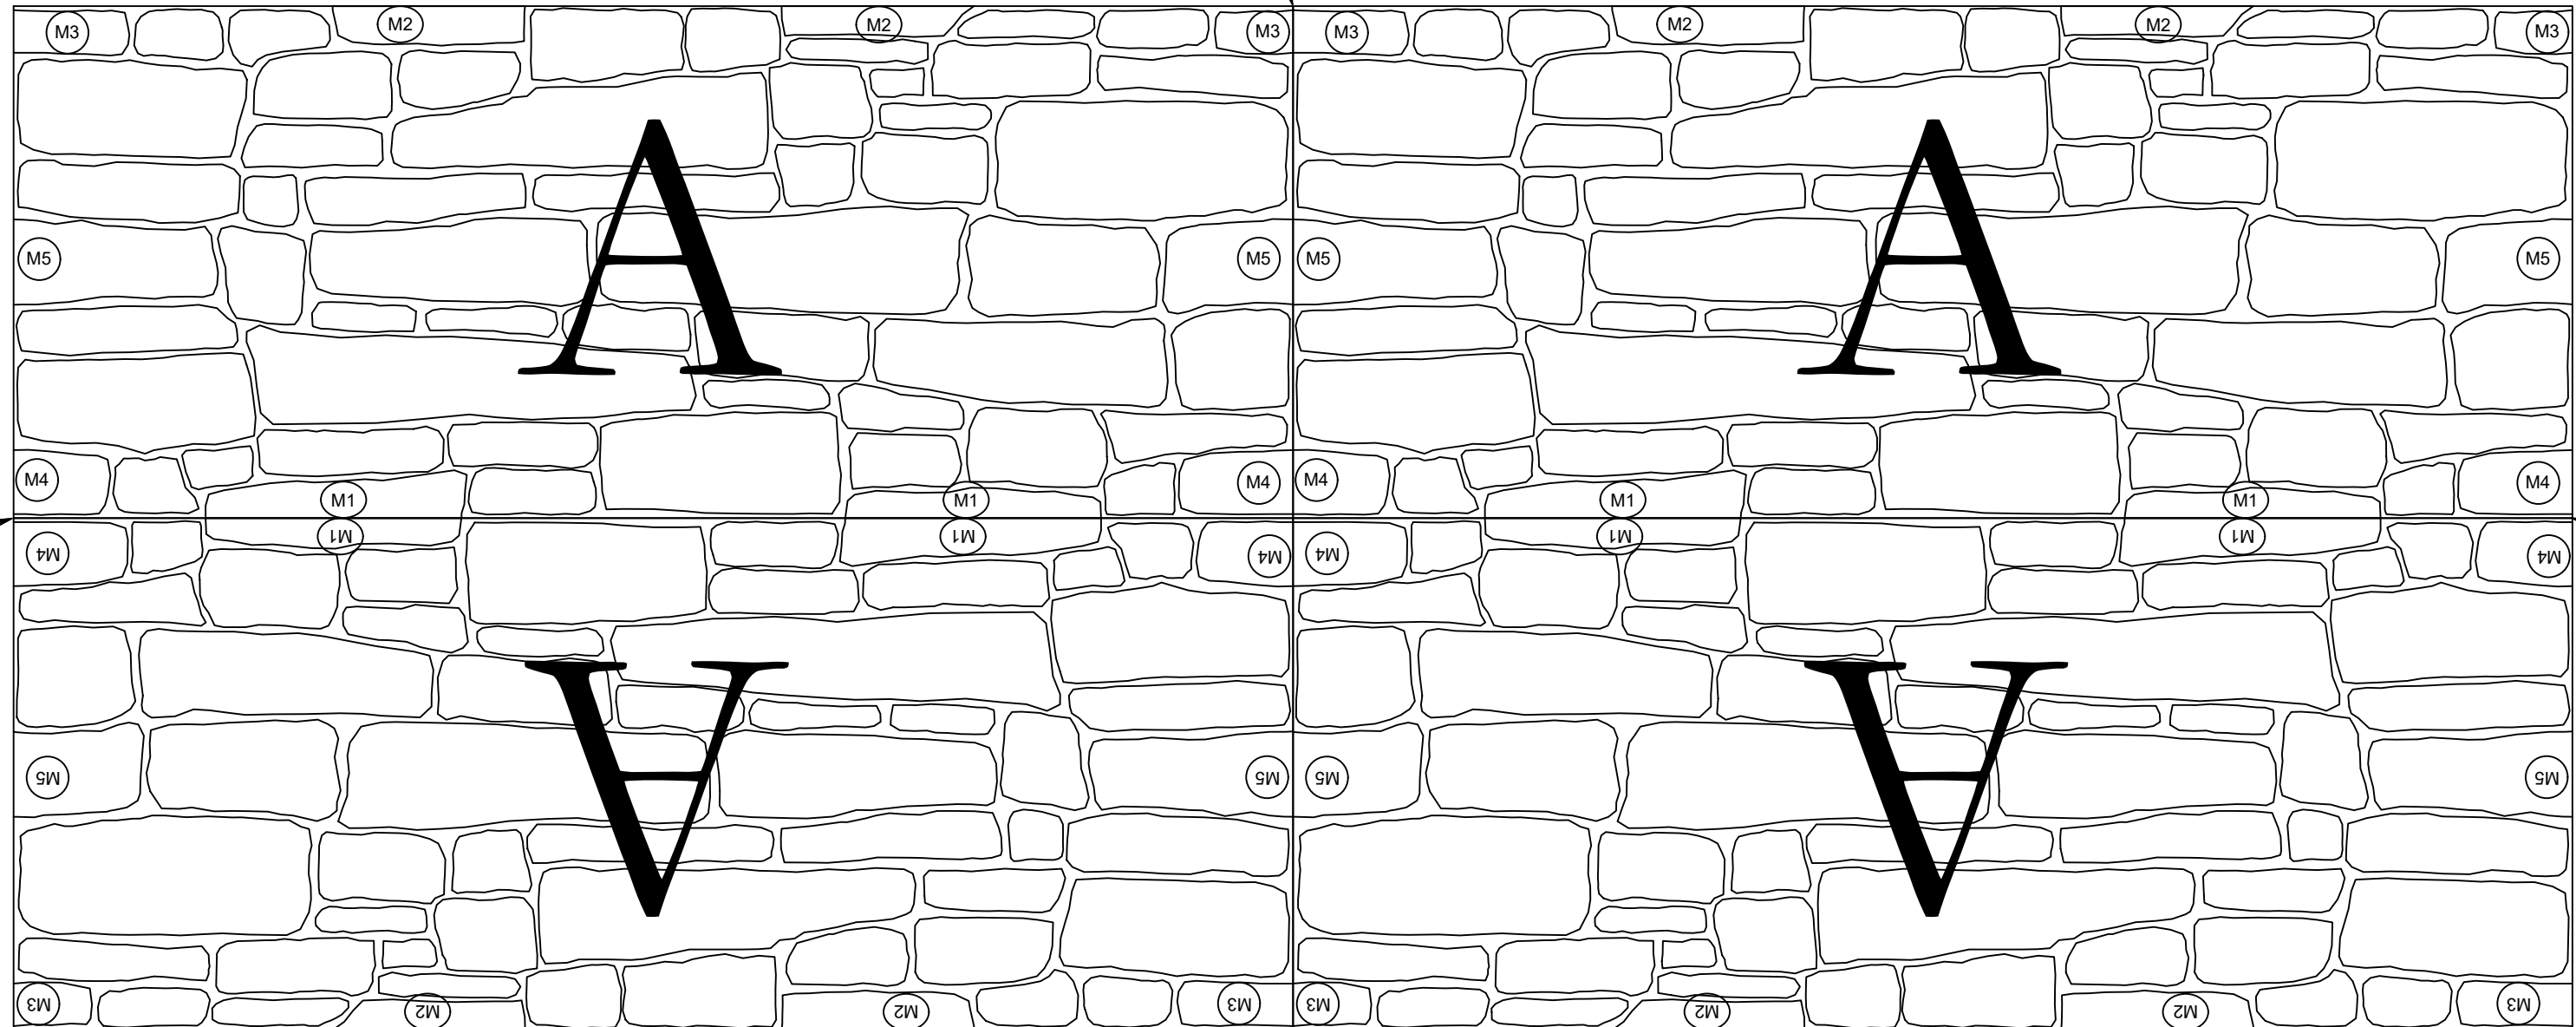
A noticeable seam will occur if not properly sealed when stacking liners.

24'-0"

8'-0"

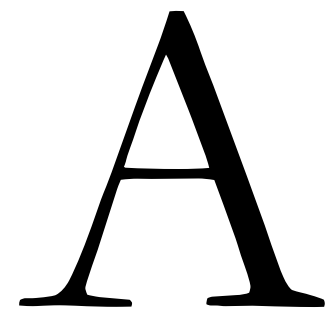
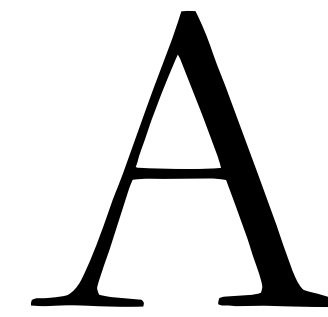
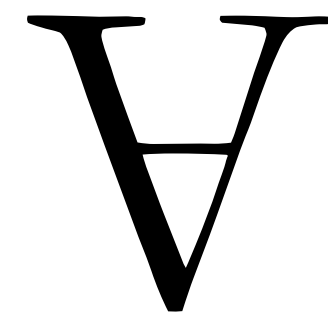
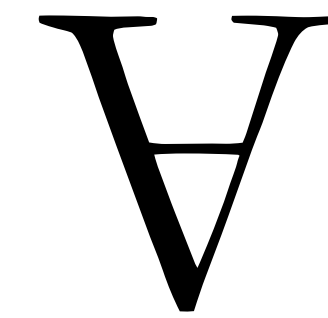
Customer:
Job Name:
Title:
#911 Large Stone Drystack 2 1/2" Max Relief Assembled

A noticeable seam will occur if not properly sealed when stacking liners.
