Customer:
 Job Name:
 Title: #911A Large Stone Drystack 1" Max Relief

Customer: _____
 Job Name: _____
 Title: #911A Large Stone Drystack 1" Max Relief Assembled

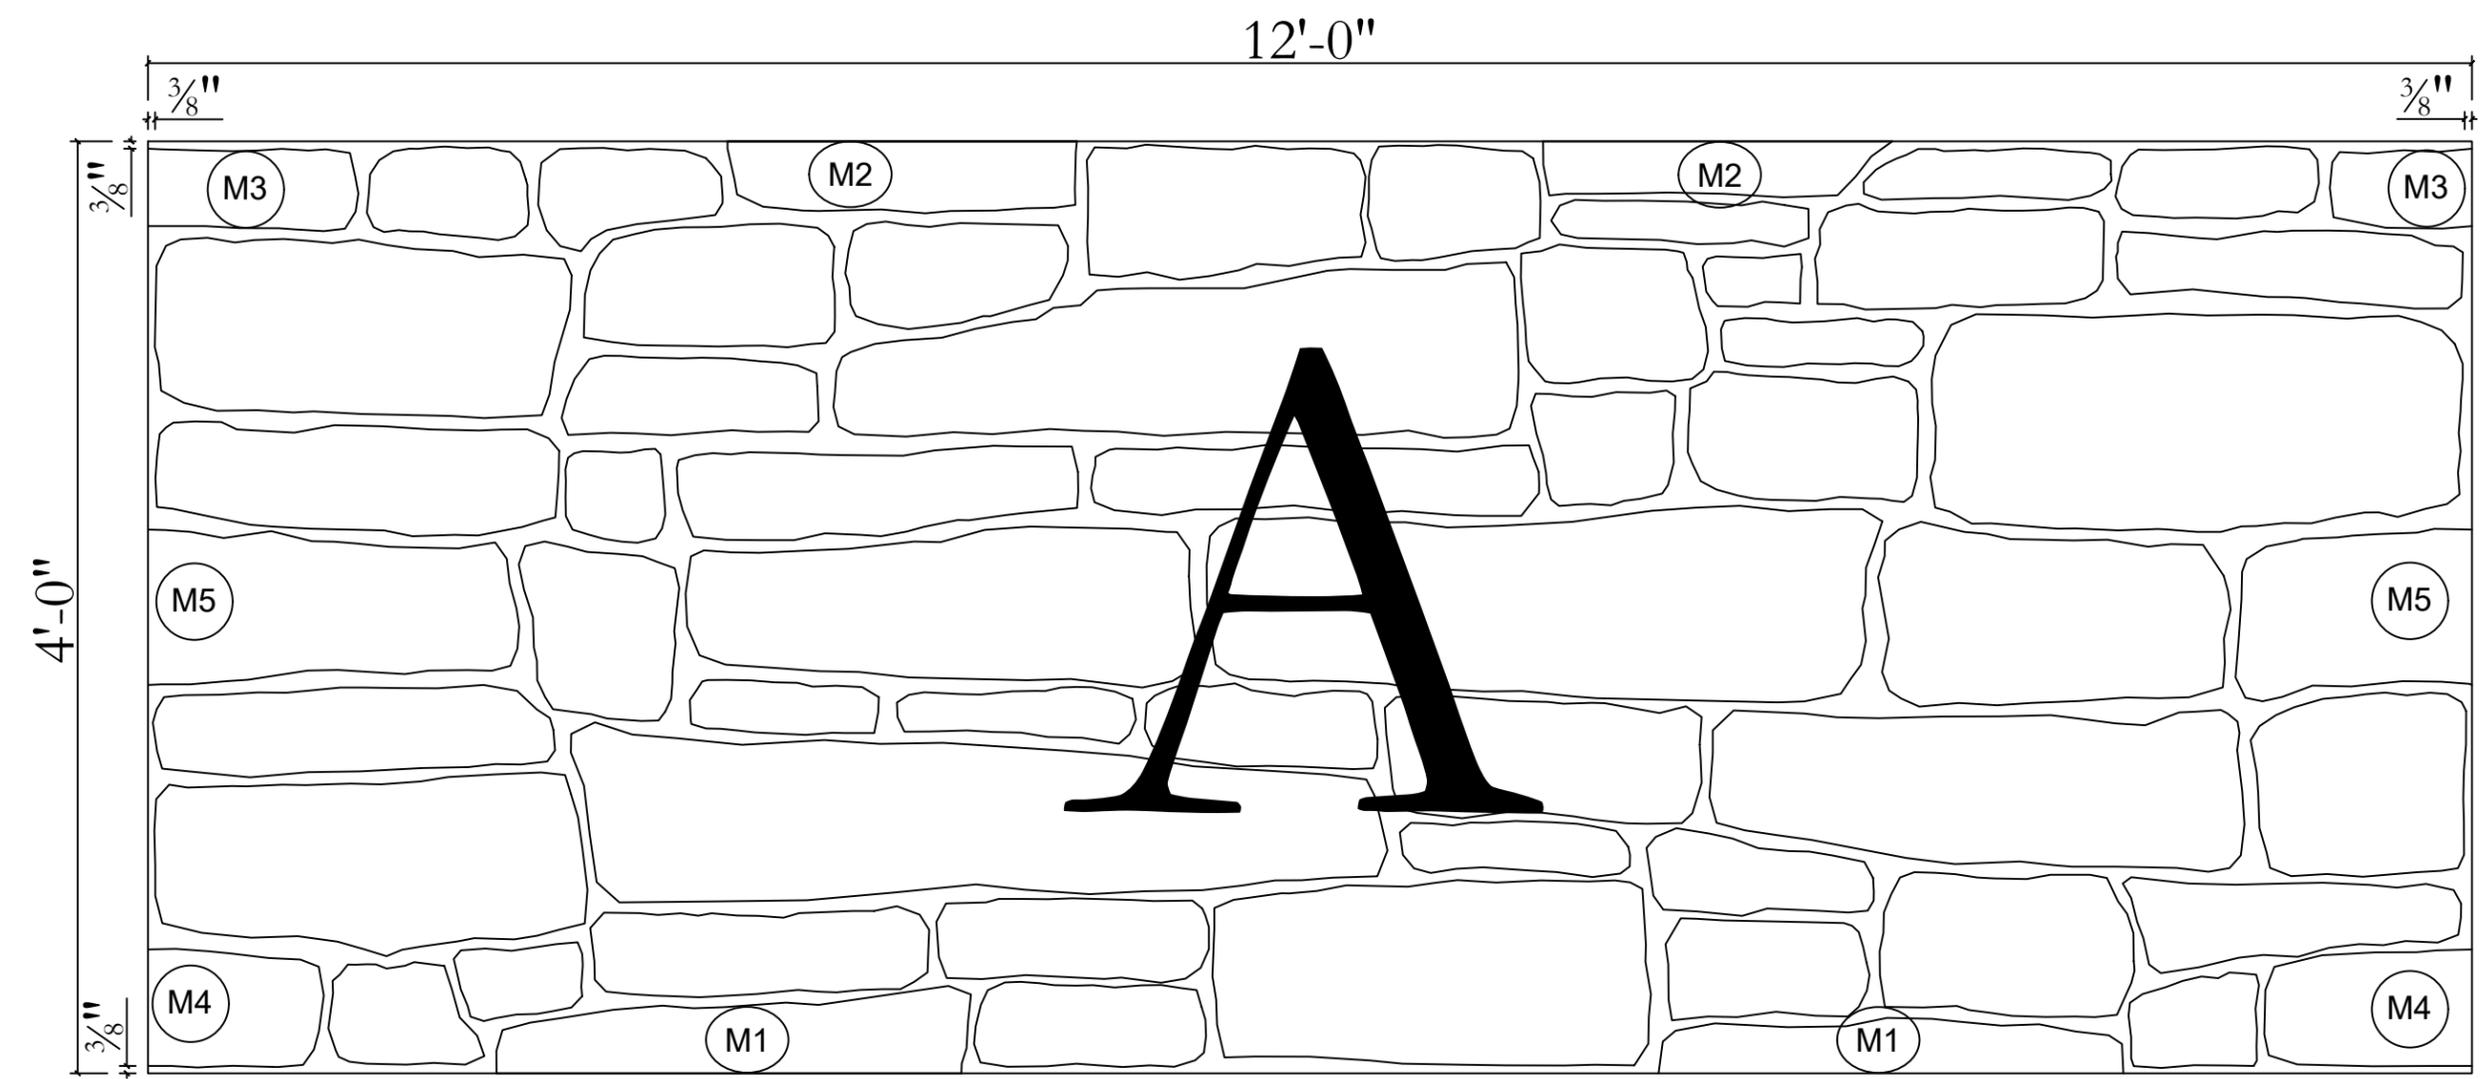
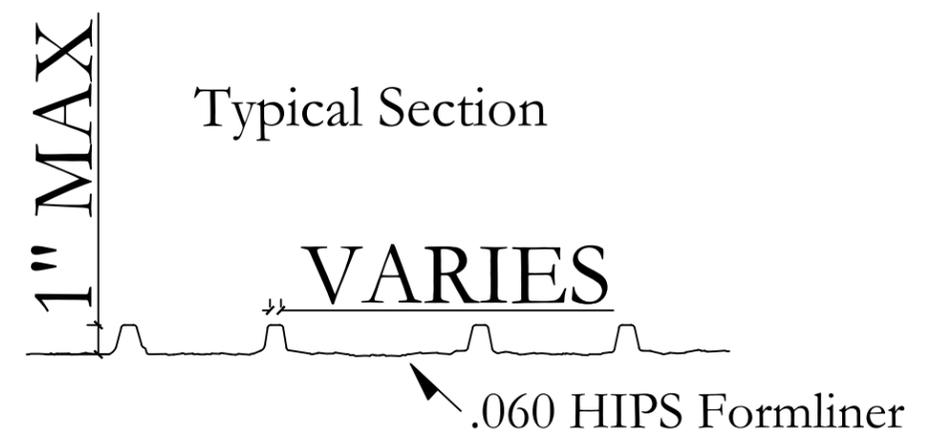
Typical Section

STONE LAYOUT FOR CONCEPT ONLY ACTUAL LAYOUT WILL VARY

VARIES

.060 HIPS Formliner

24'-0"

A noticeable seam will occur if not properly sealed when stacking liners.

8'-0"
A noticeable seam will occur if not properly sealed when stacking liners.

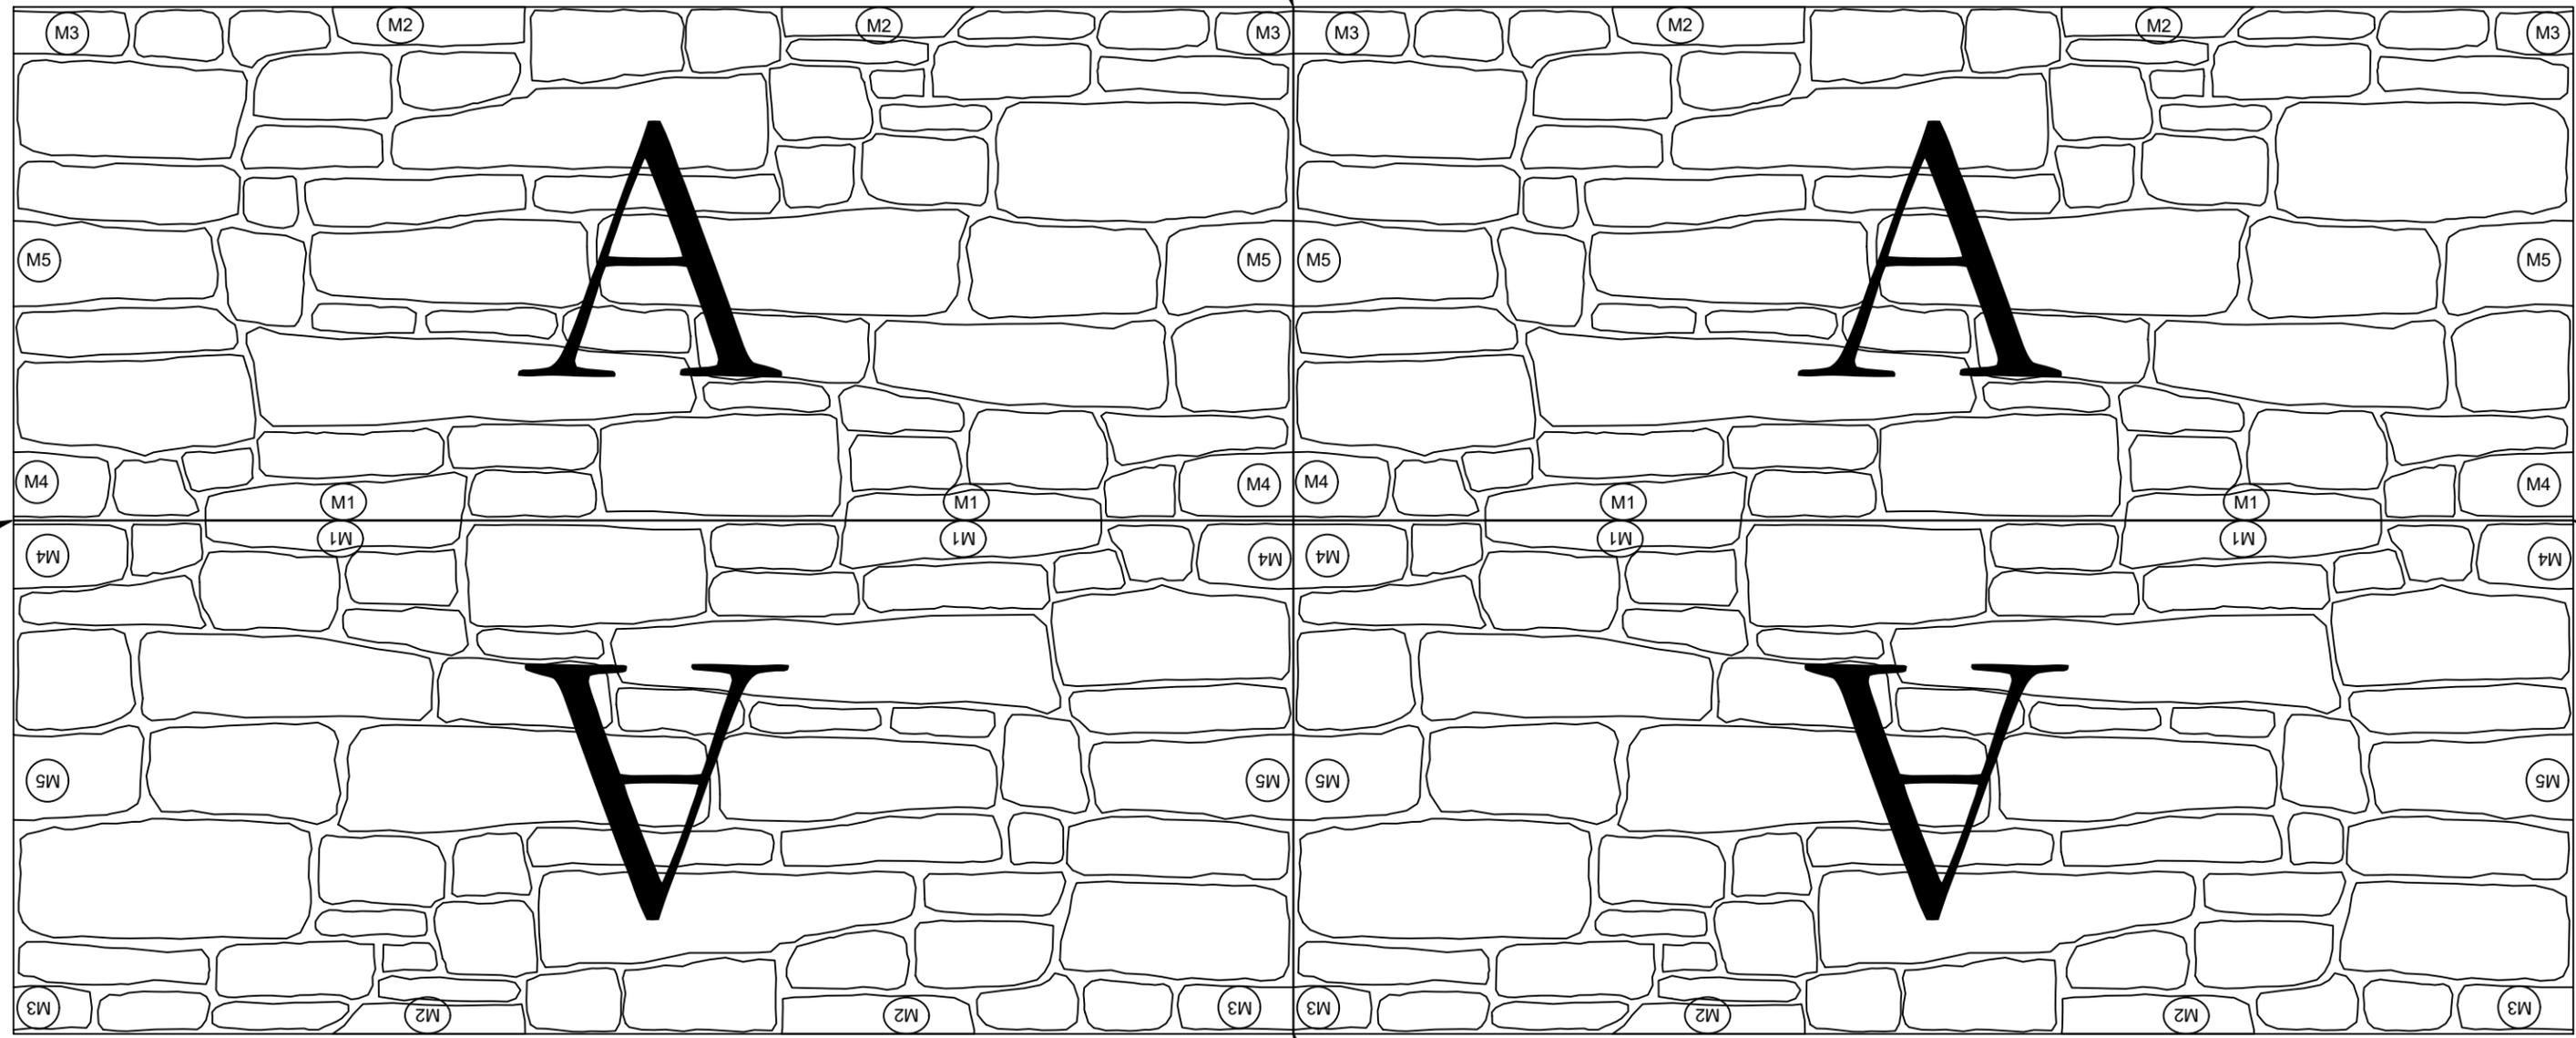
A noticeable seam will occur if not properly sealed when stacking liners.

24'-0"

8'-0"
