Customer:  
 Job Name:  
 Title: #918 12"x24" Split Limestone Running bond

Customer: \_\_\_\_\_  
 Job Name: \_\_\_\_\_  
 Title: #918 12"x24" Split Limestone Running bond Assembled

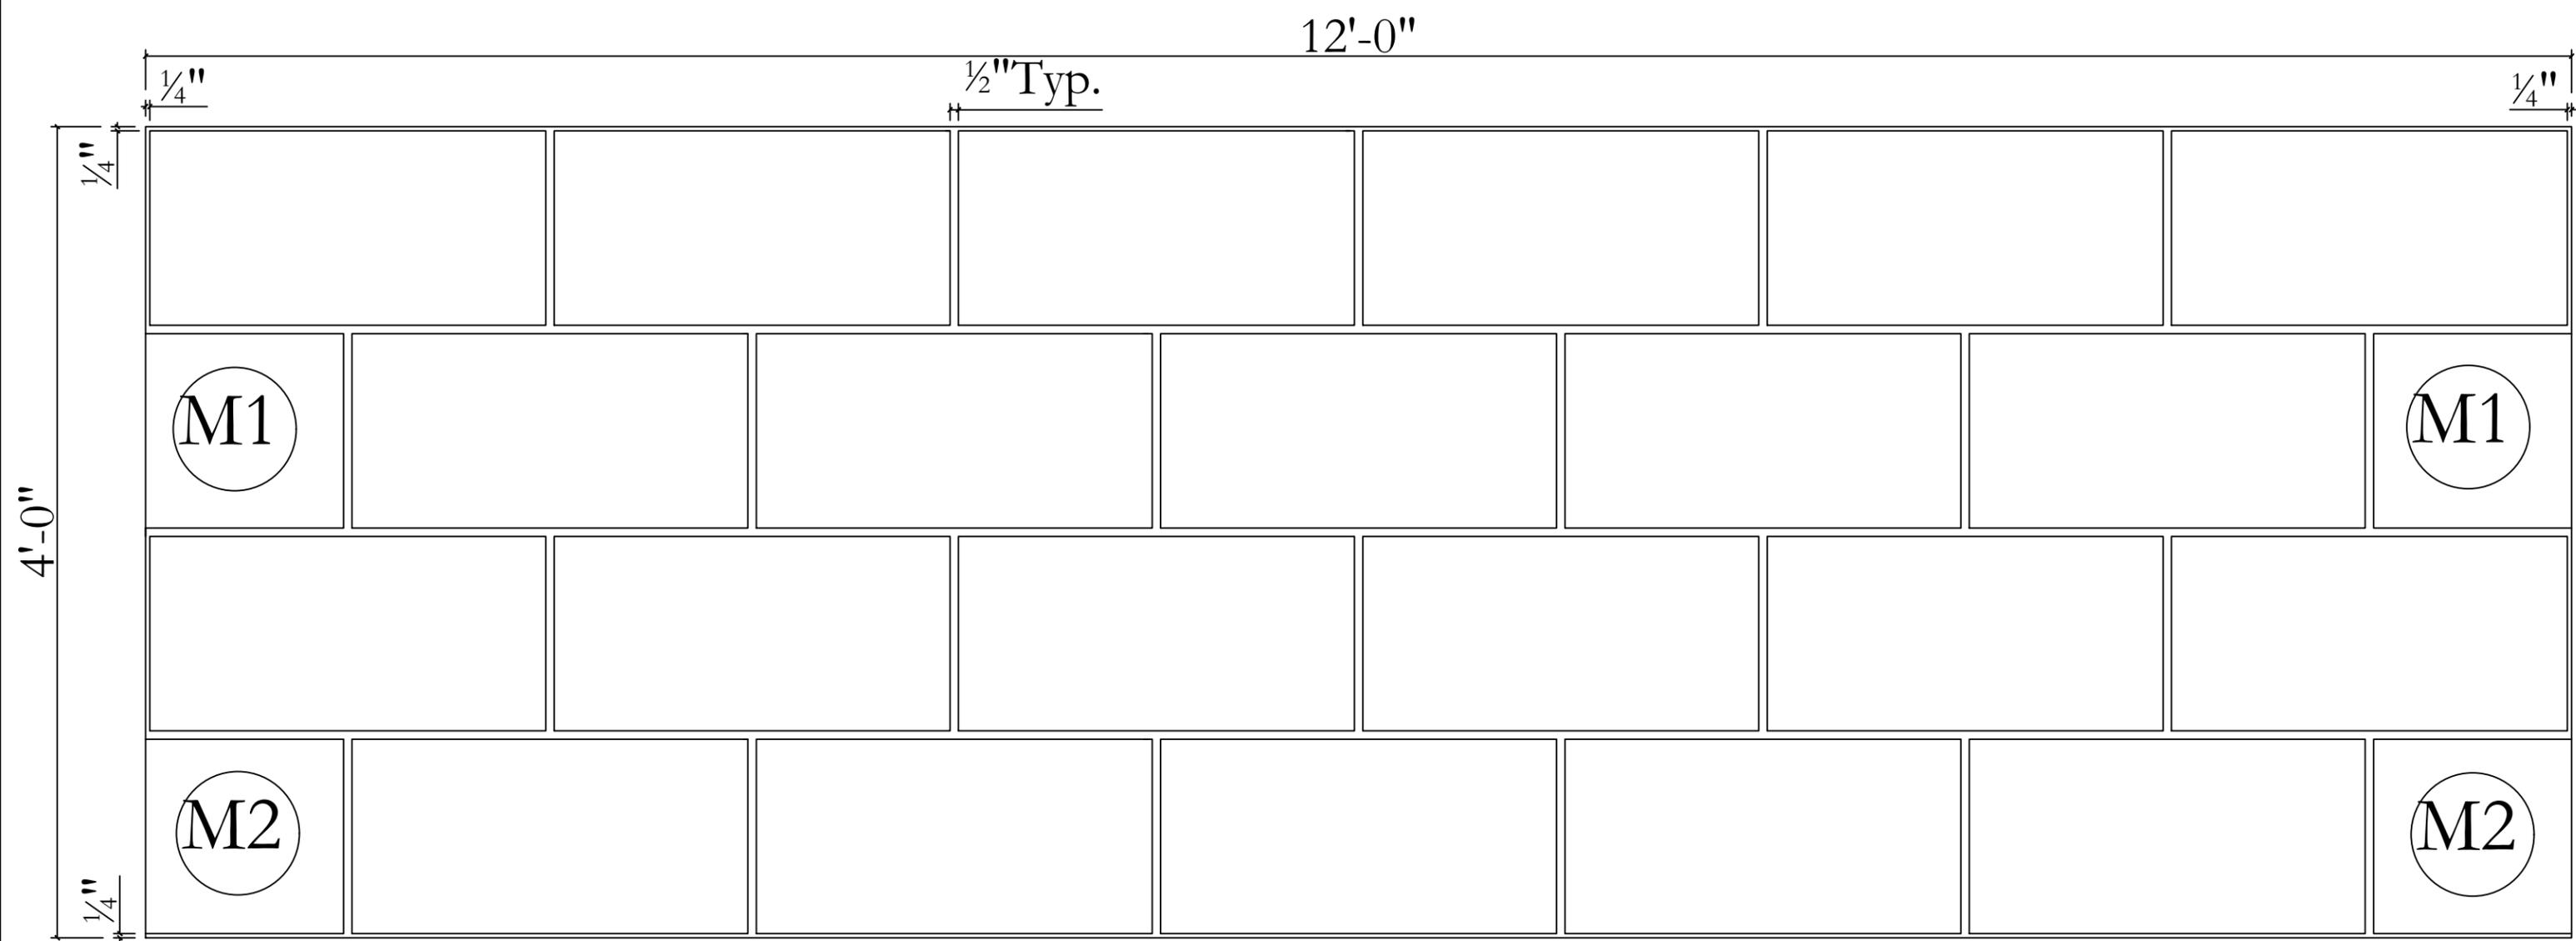
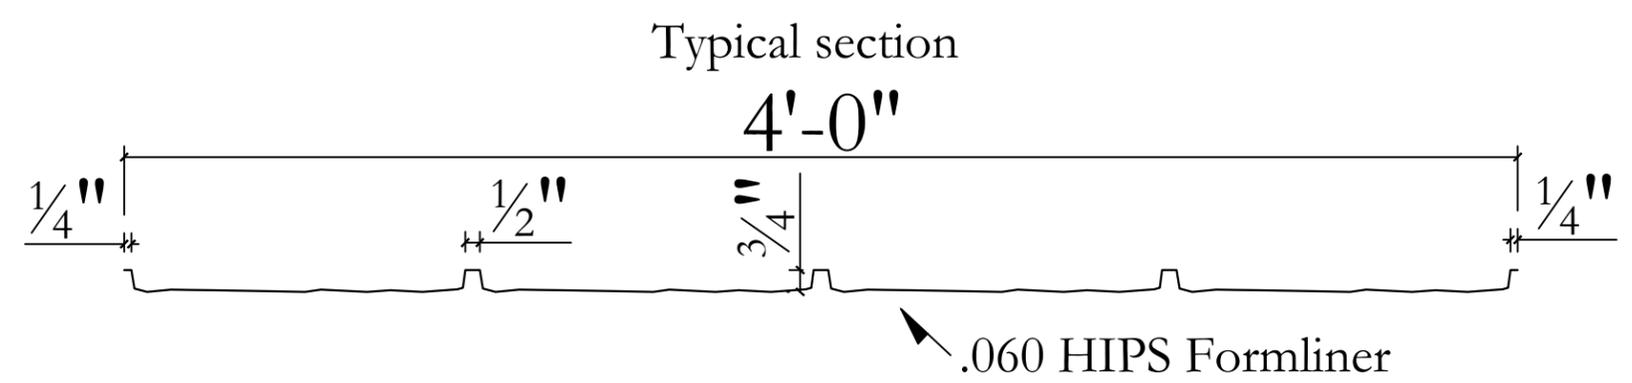
24'-0"

A noticeable seam will occur if not properly sealed when stacking liners.

8'-0"  
A noticeable seam will occur if not properly sealed when stacking liners.
