Customer:  
 Job Name:  
 Title: #918 12"x24" Split Limestone Zipper

Customer:  
 Job Name:  
 Title: #918 12"x24" Split Limestone Zipper Assembled

Customer: \_\_\_\_\_  
 Job Name: \_\_\_\_\_  
 Title: #918 12"x24" Split Limestone Zipper Assembled Outline Only

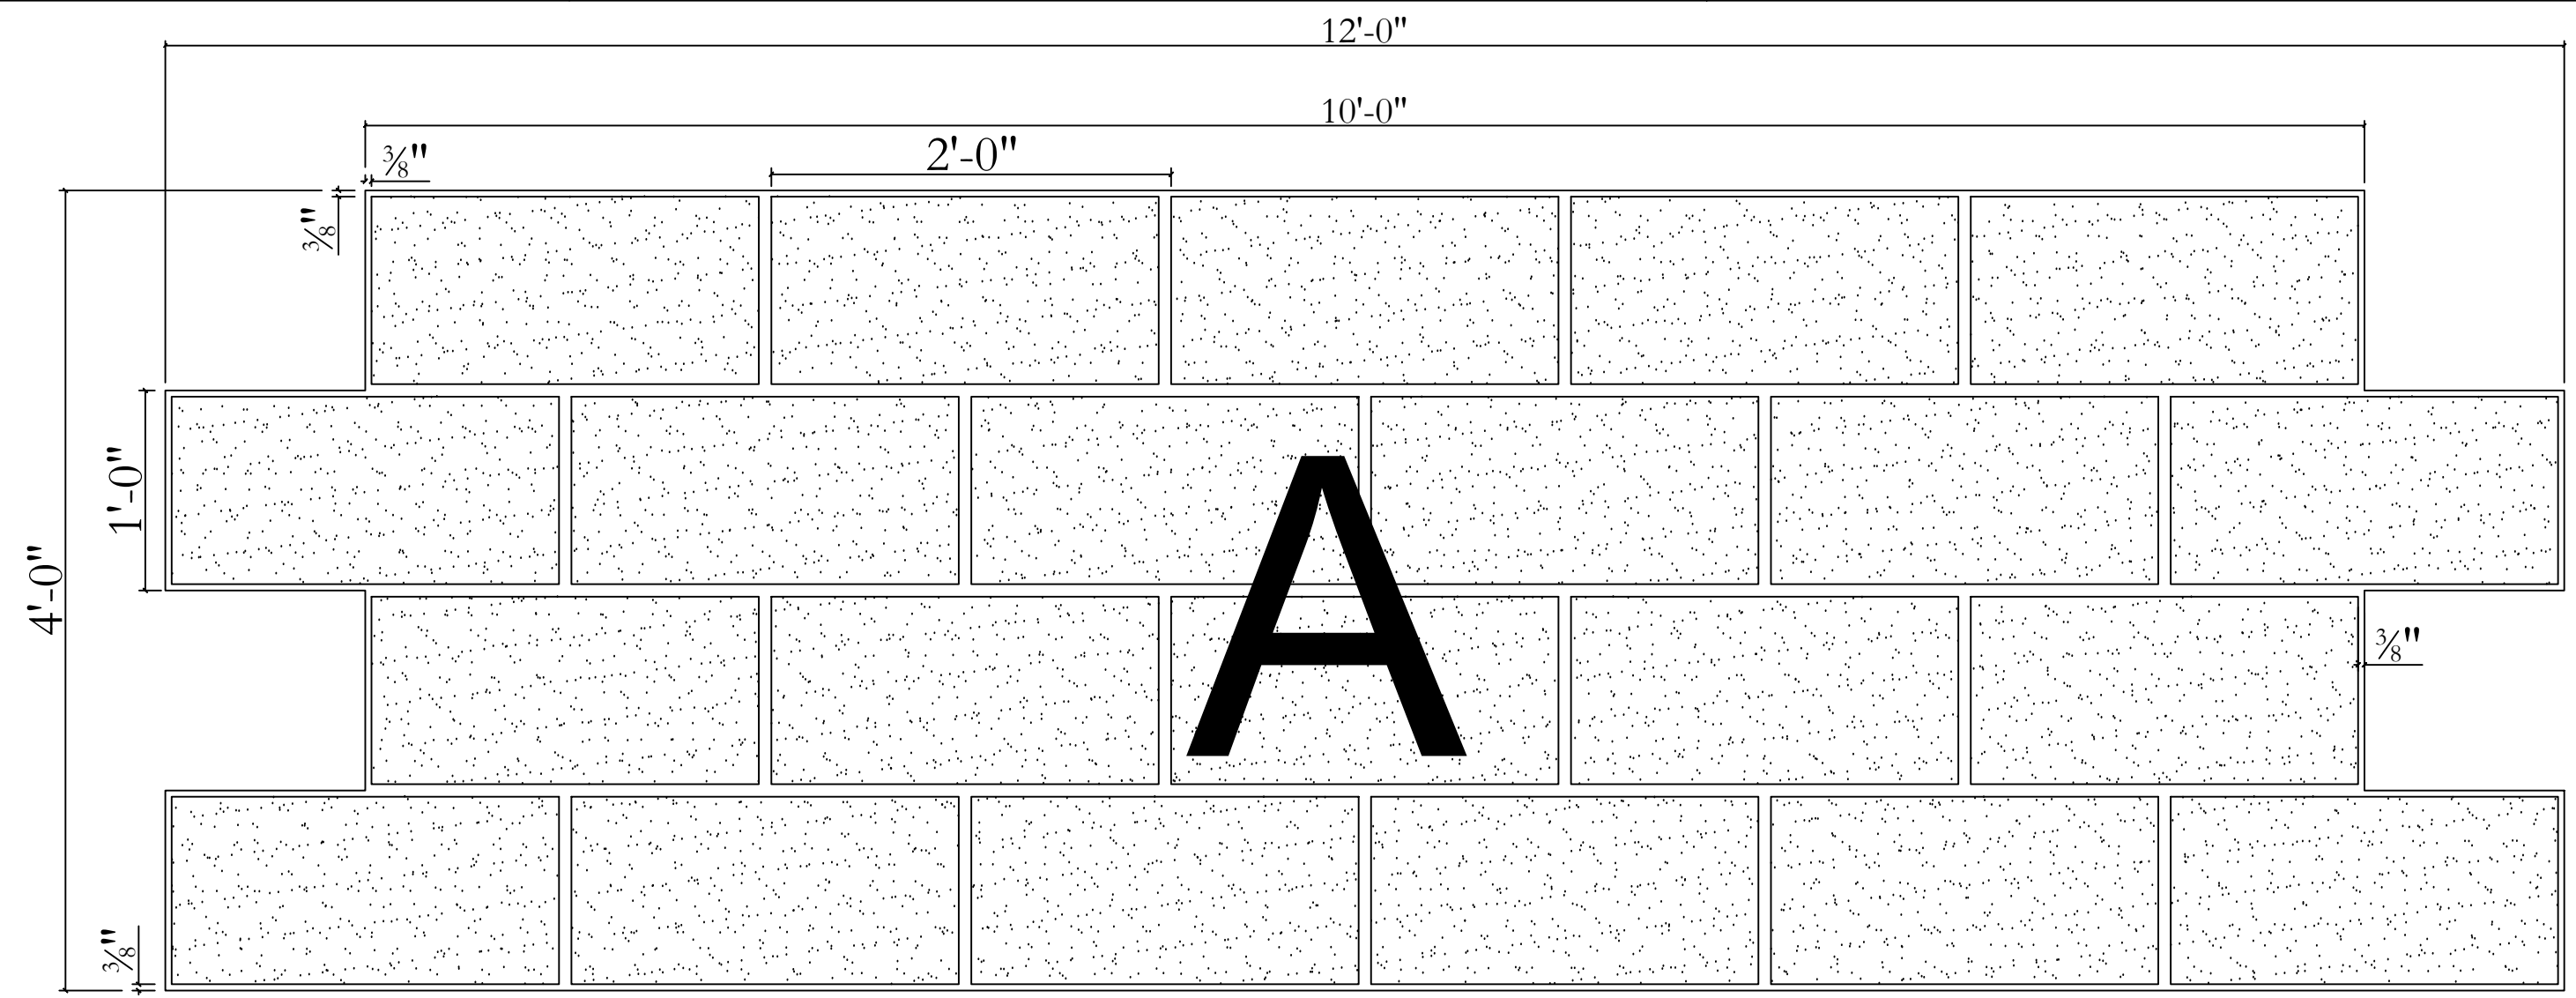
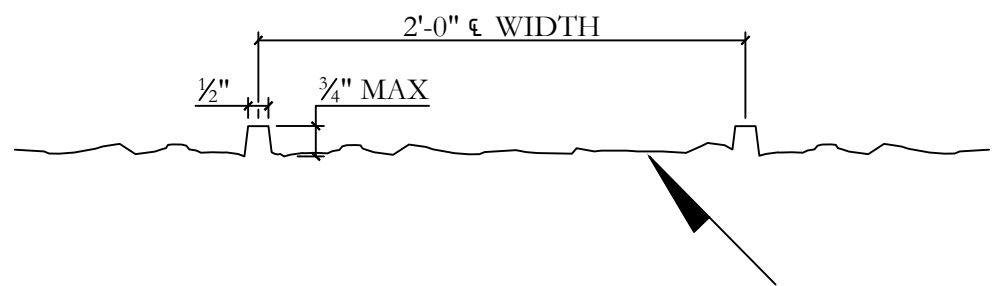
### Typical Section

\*\*\*Hatch texture for visual reference only. Actual texture will vary\*\*\*

.060 HIPS Formliner

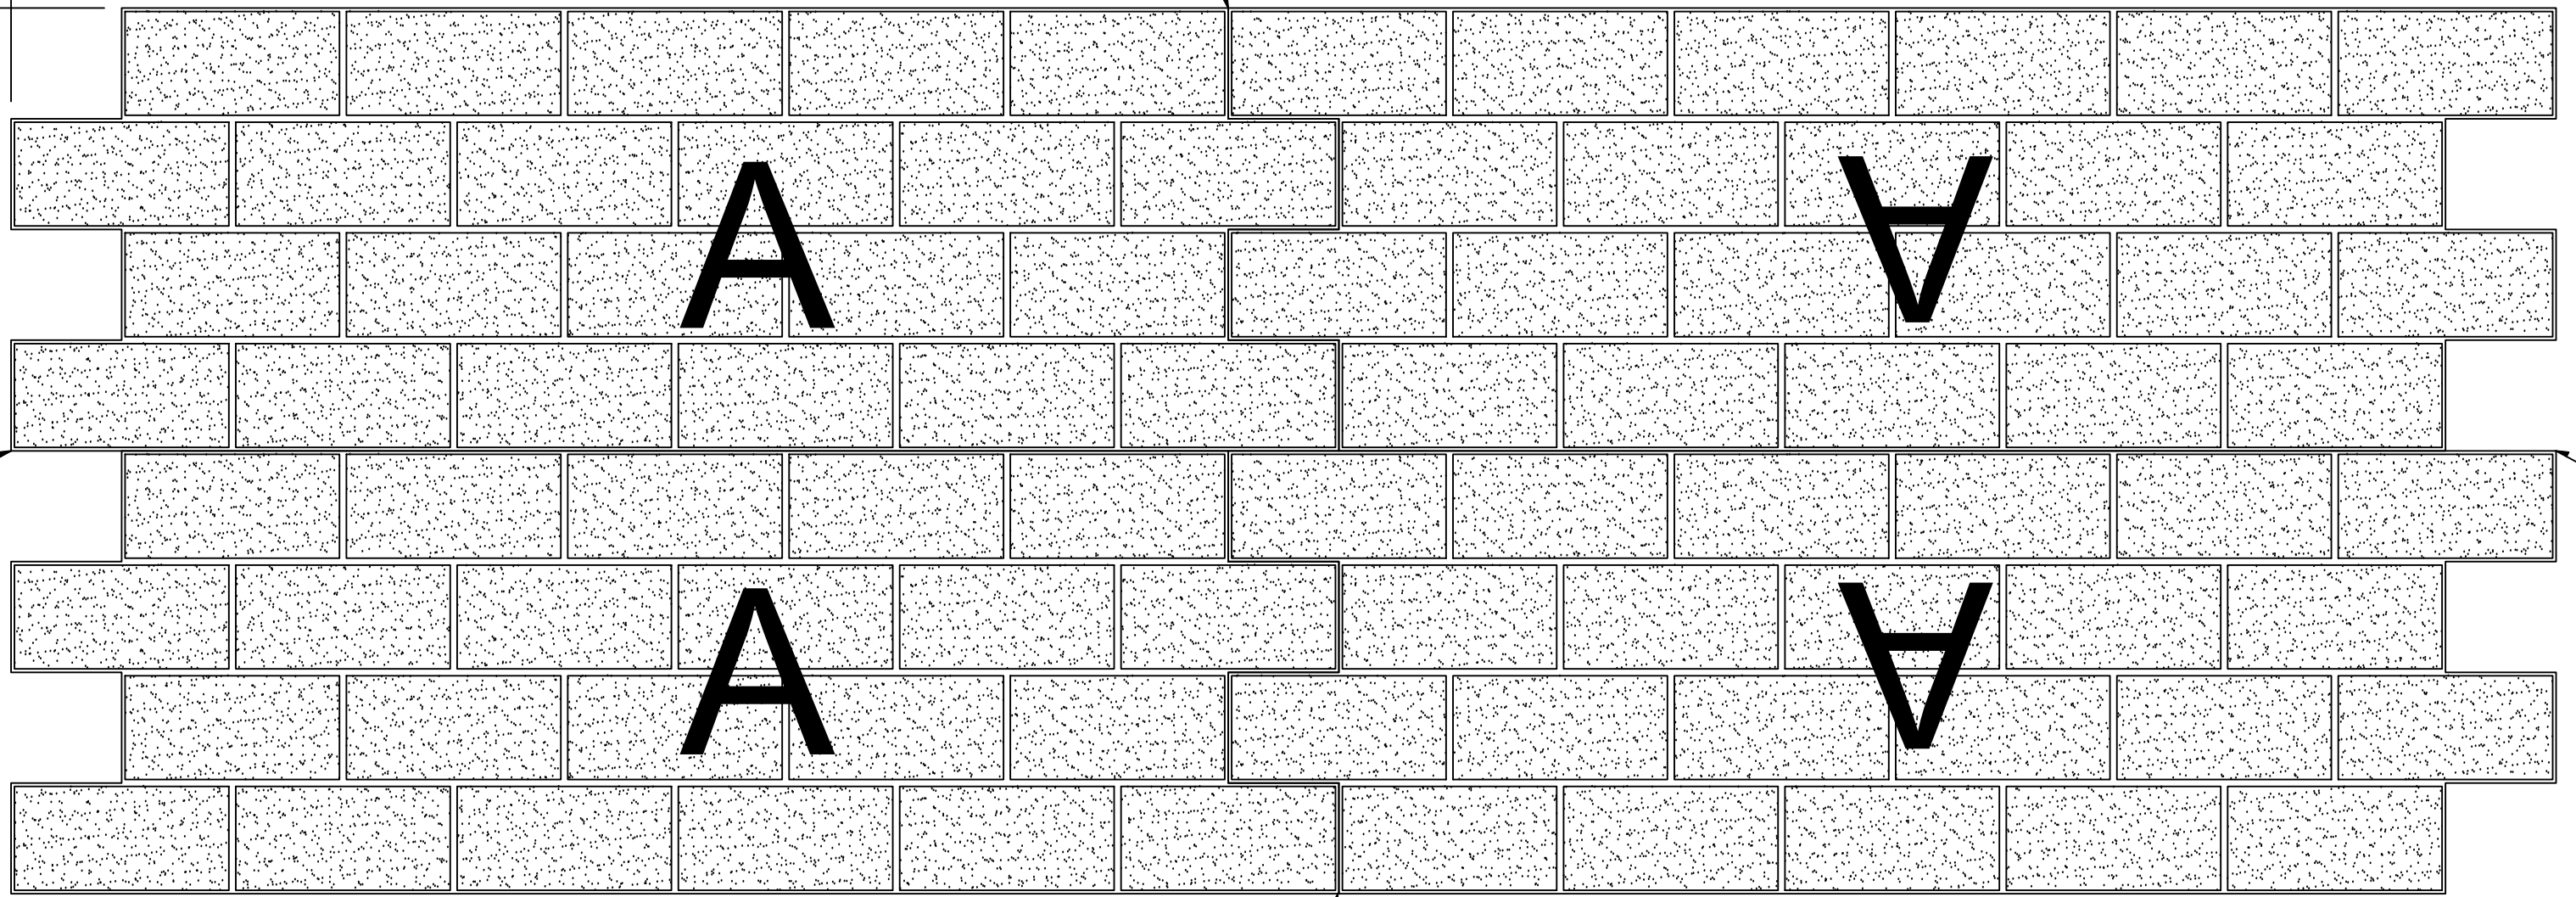
23'-0"

A noticeable seam will occur if not properly sealed when stacking liners.

8'-0"  
A noticeable seam will occur if not properly sealed when stacking liners
