Customer:  
 Job Name:  
 Title: #919 Weathered Cut Ashlar

Customer: \_\_\_\_\_  
 Job Name: \_\_\_\_\_  
 Title: #919 Weathered Cut Ashlar Assembled

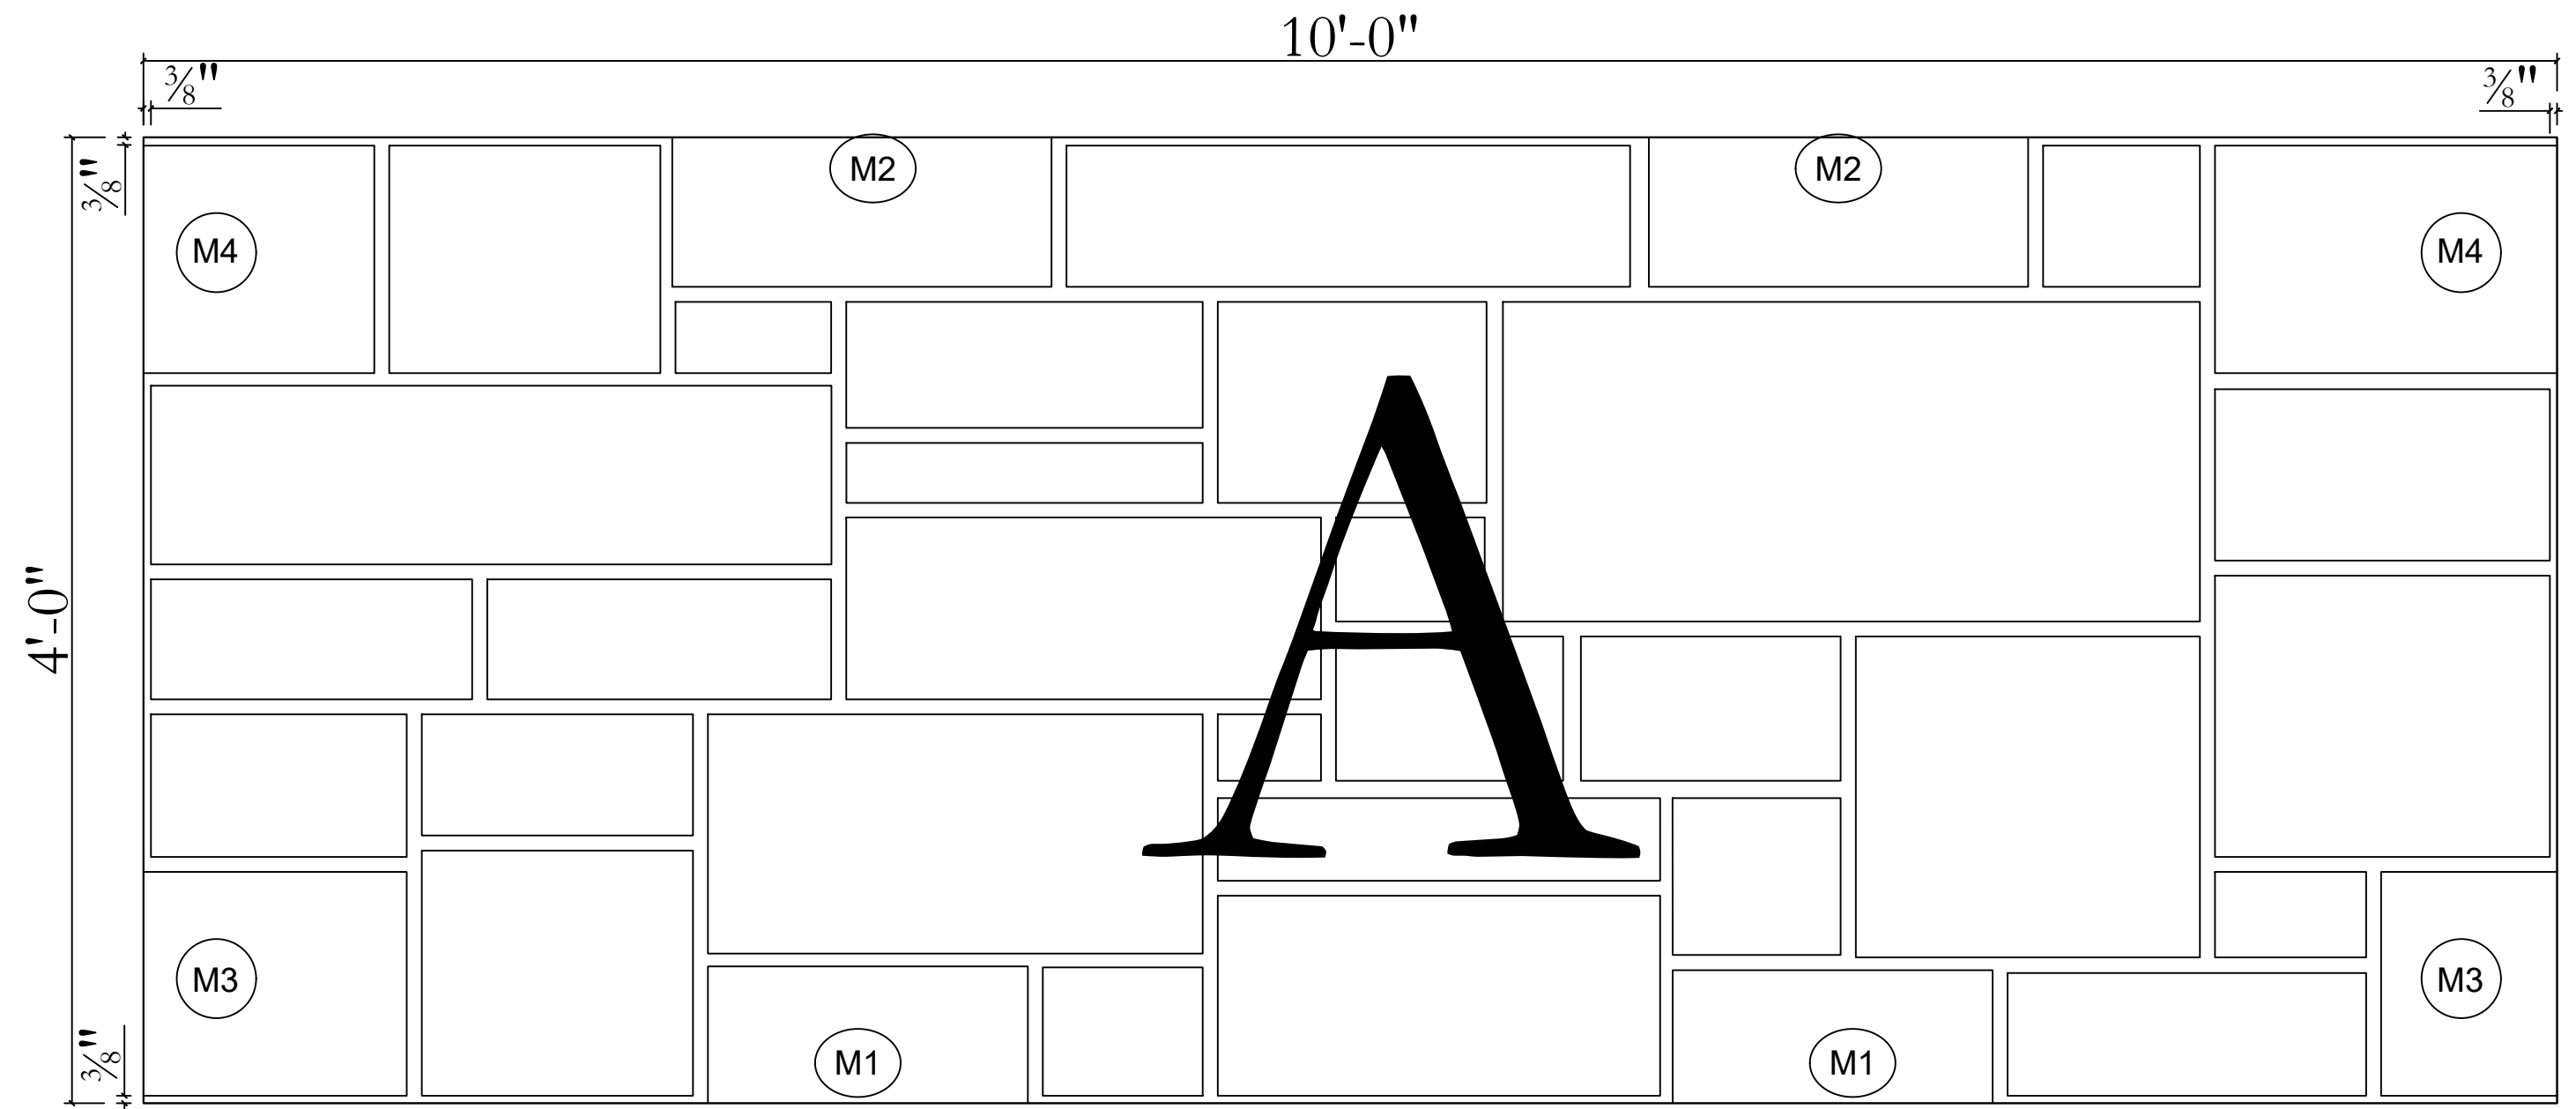
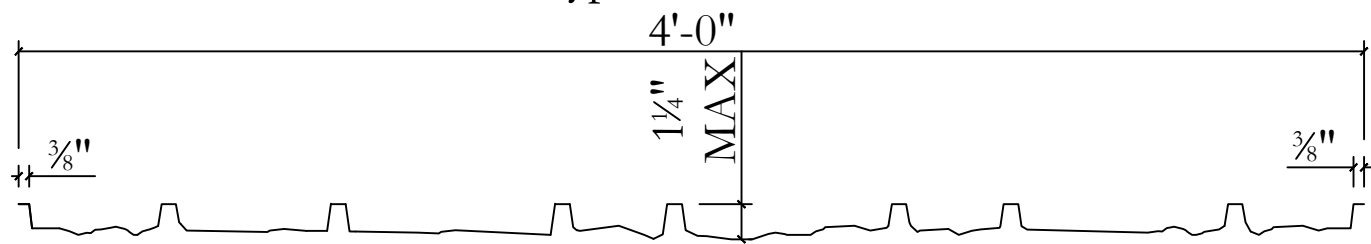
Typical section

↖ .080 HIPS Formliner

20'-0"

12'-0"

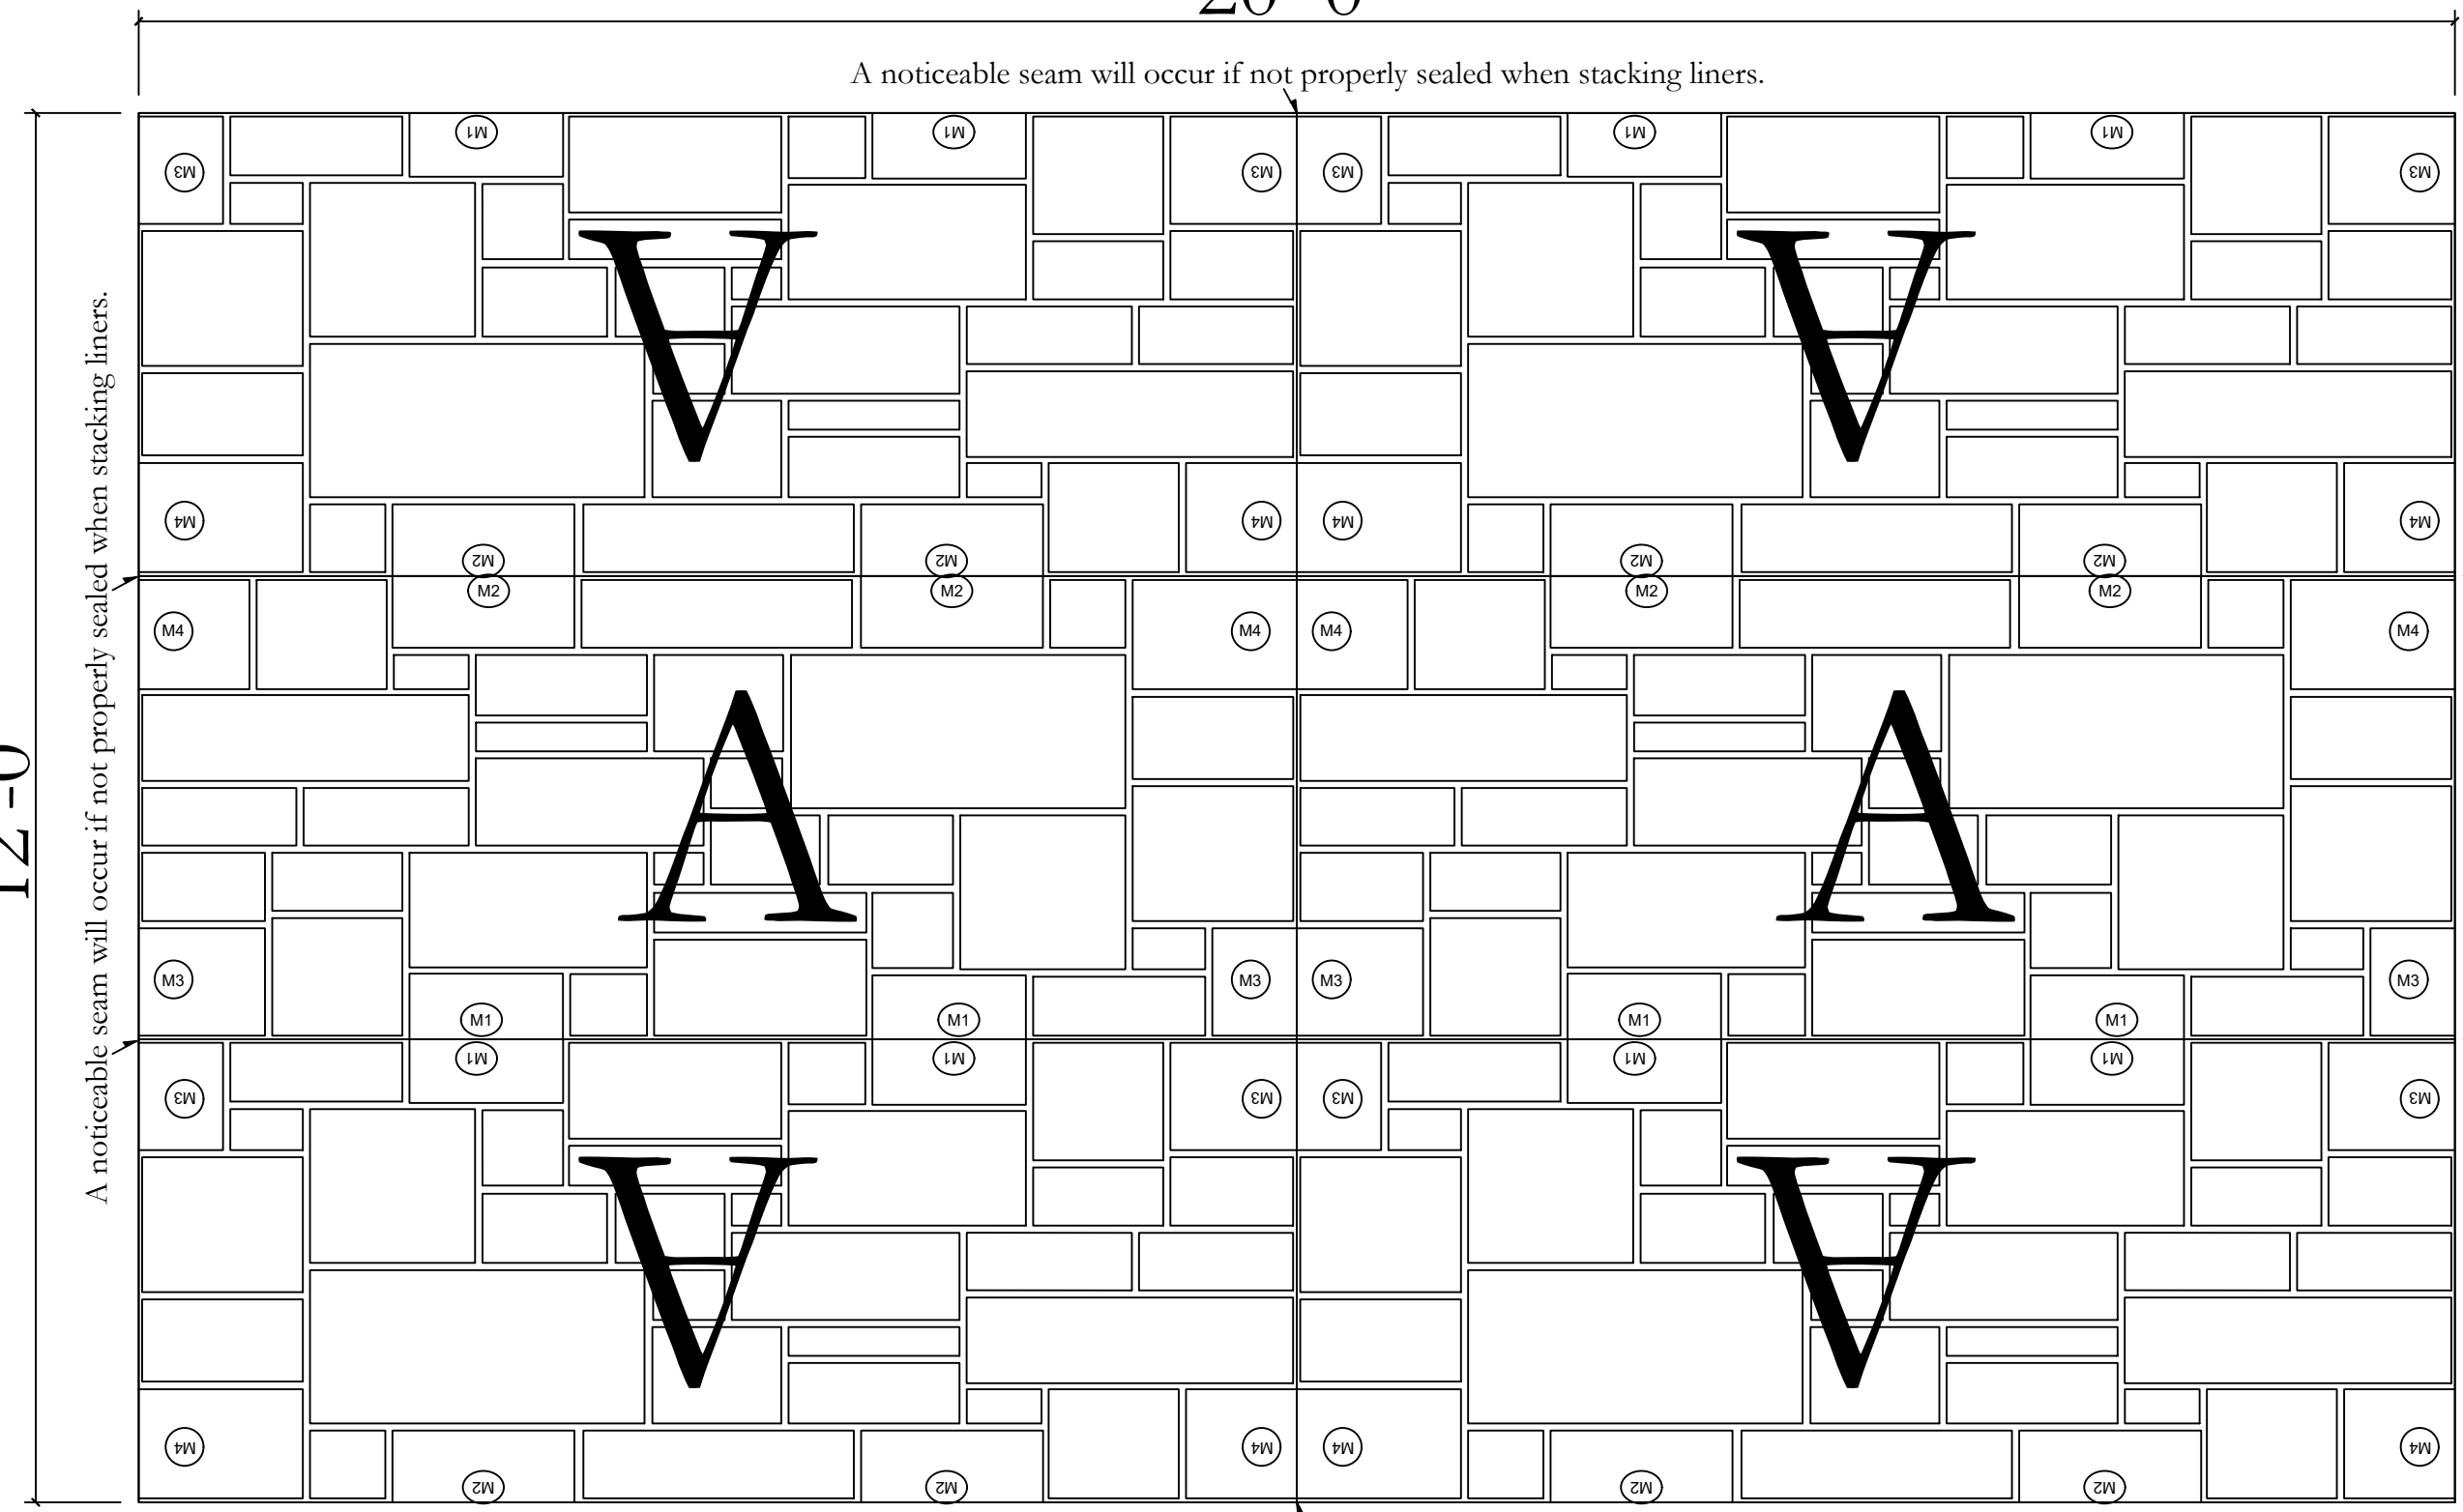
A noticeable seam will occur if not properly sealed when stacking liners.
