# 927 ATOMIC ASHLAR

Customer:  
 Job Name:  
 Title: #927 ATOMIC ASHLAR

Customer:	
Job Name:	
Title:	#927 ATOMIC ASHLAR ASSEMBLED

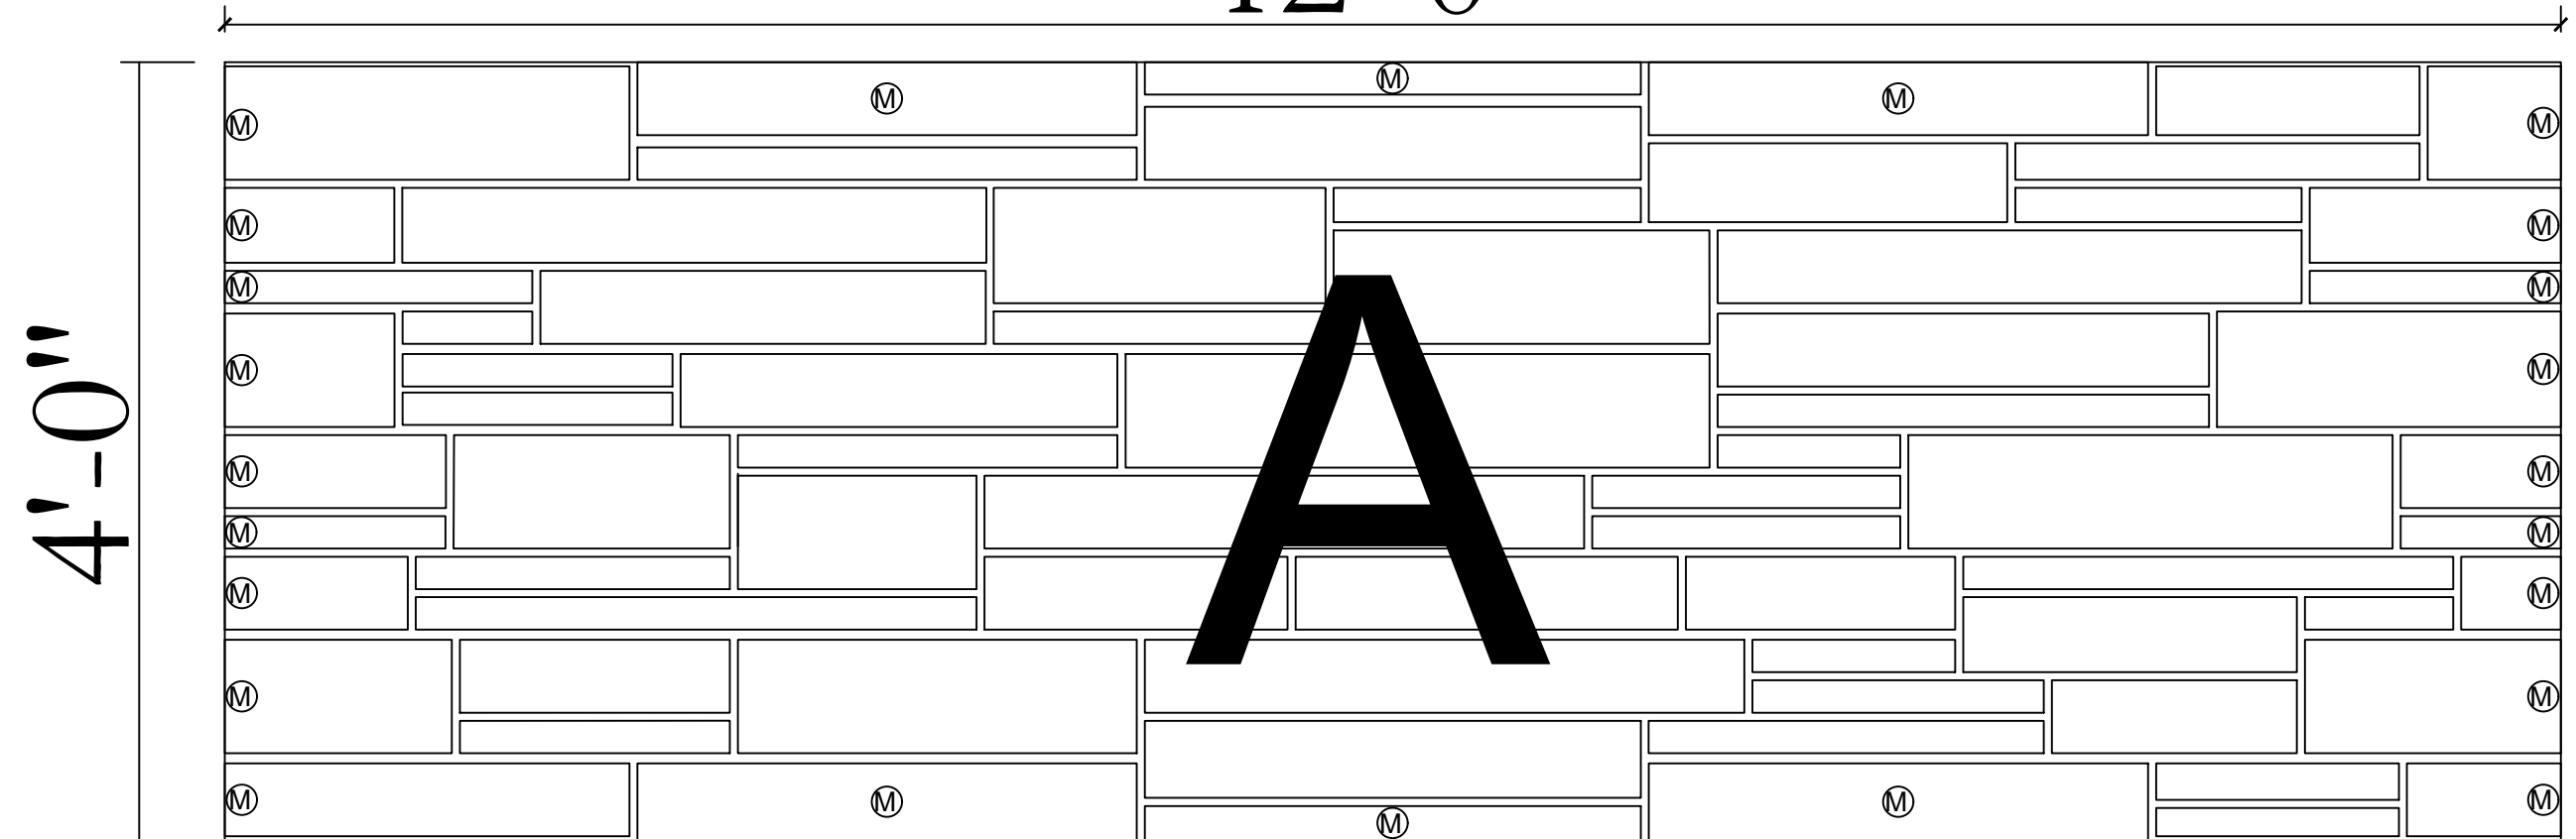
## 12'-0"

(M) MATCH STONES

STONE LAYOUT FOR VISUAL REFERENCE ONLY.  
ACTUAL STONE LAYOUT DETERMINED BY AP

Typical section

↙ .080 HIPS Formliner

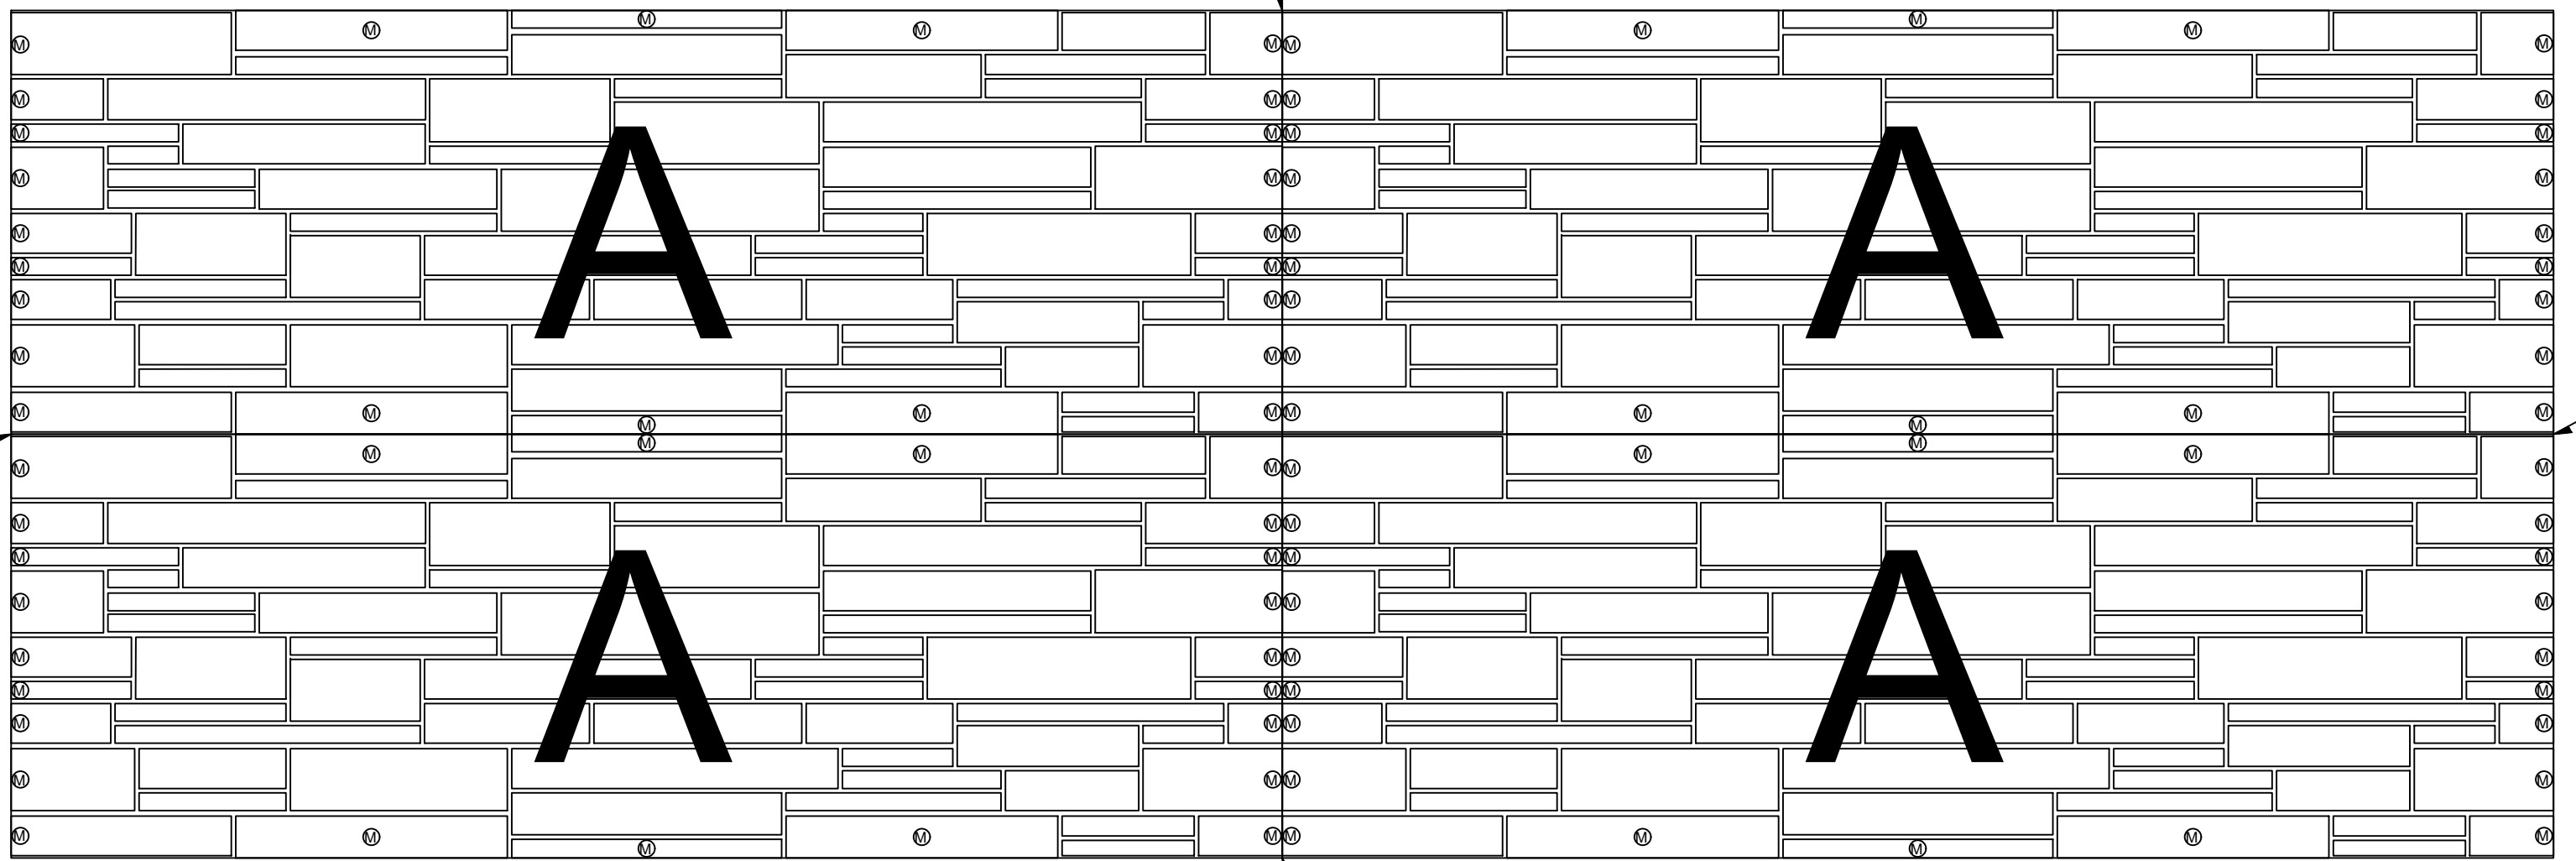
A noticeable seam will occur if not properly sealed when stacking liners.
