ITEM # 308176

Customer:  
Job Name:  
Title: #942 Ranger Split Stone

Customer:  
Job Name:  
Title: #942 Ranger Split Stone Assembled

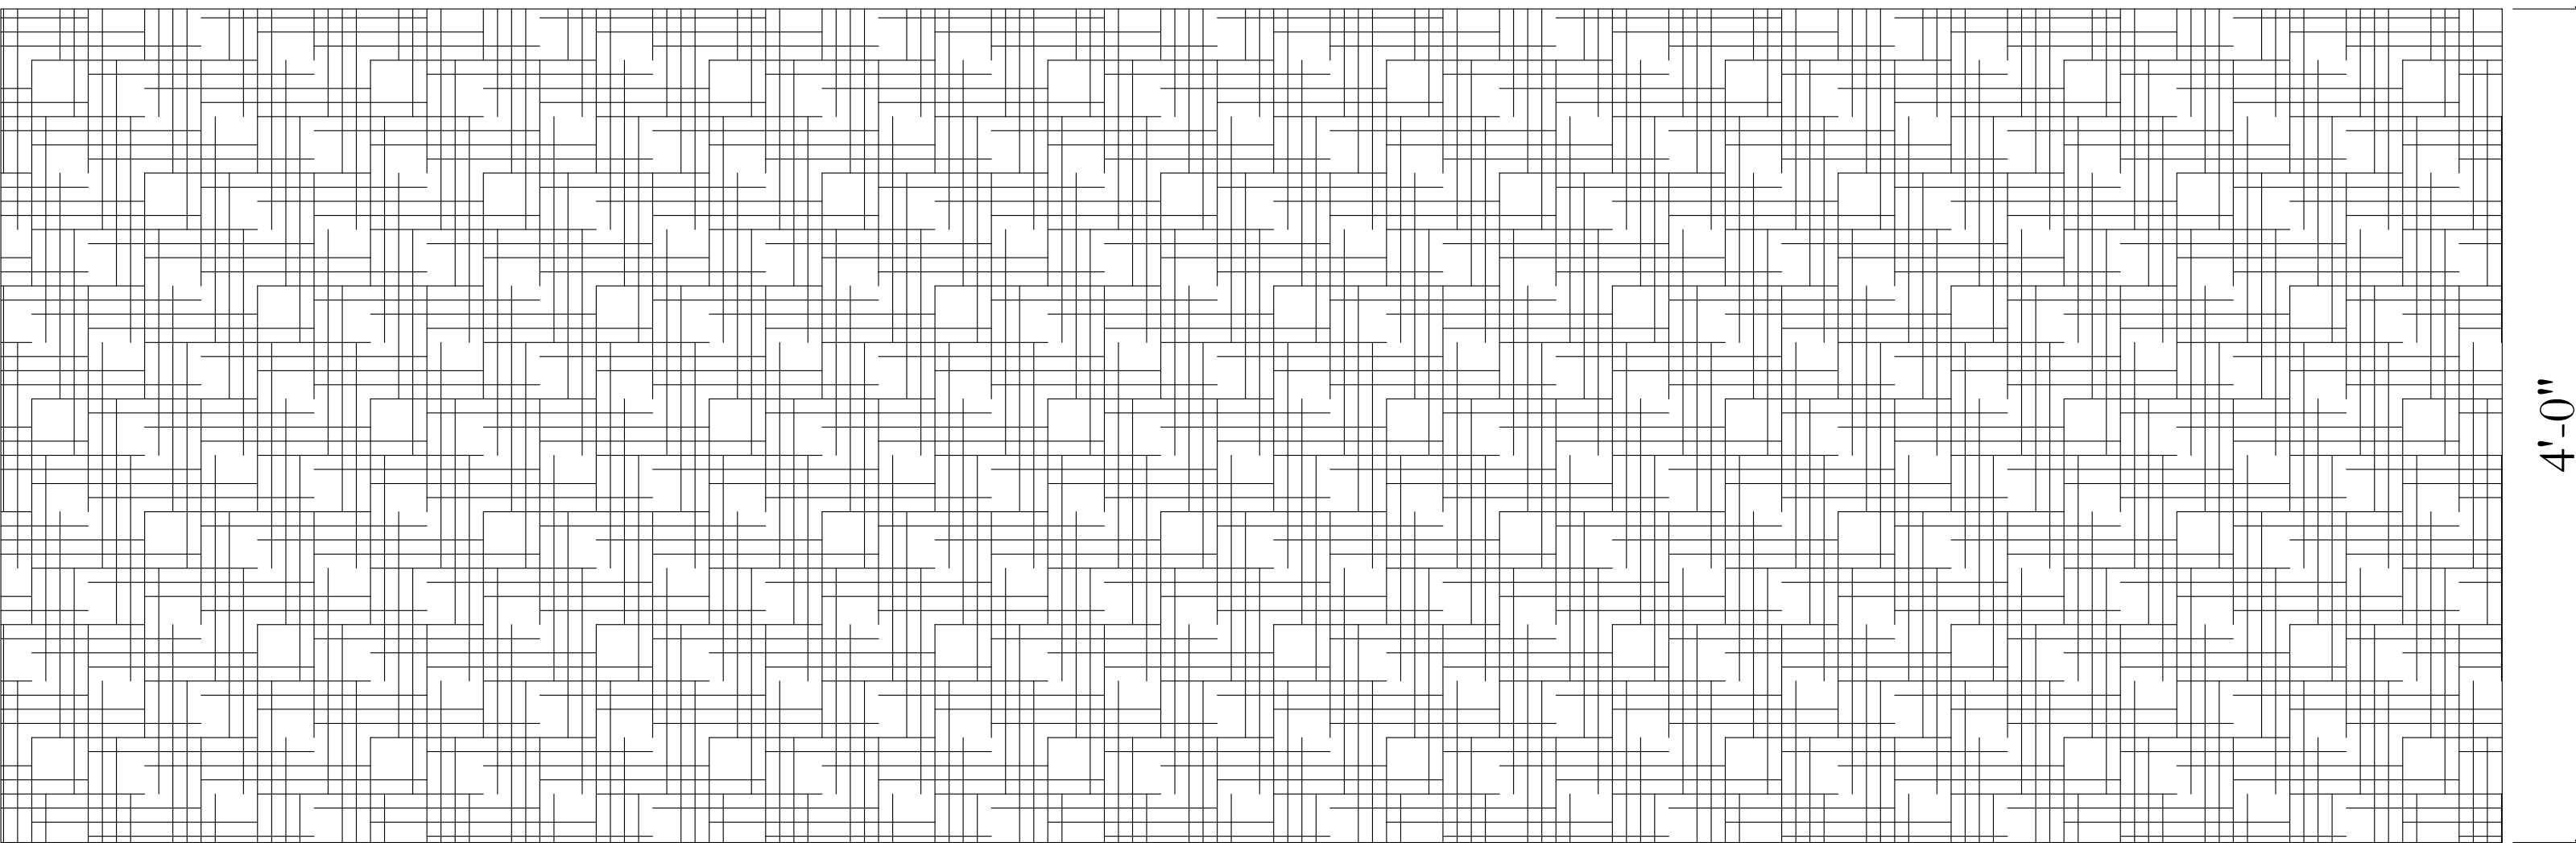
Typical Section

12'-0"

4'-0"

Hatch for visual reference only. Actual pattern will vary

.060 HIPS Formliner

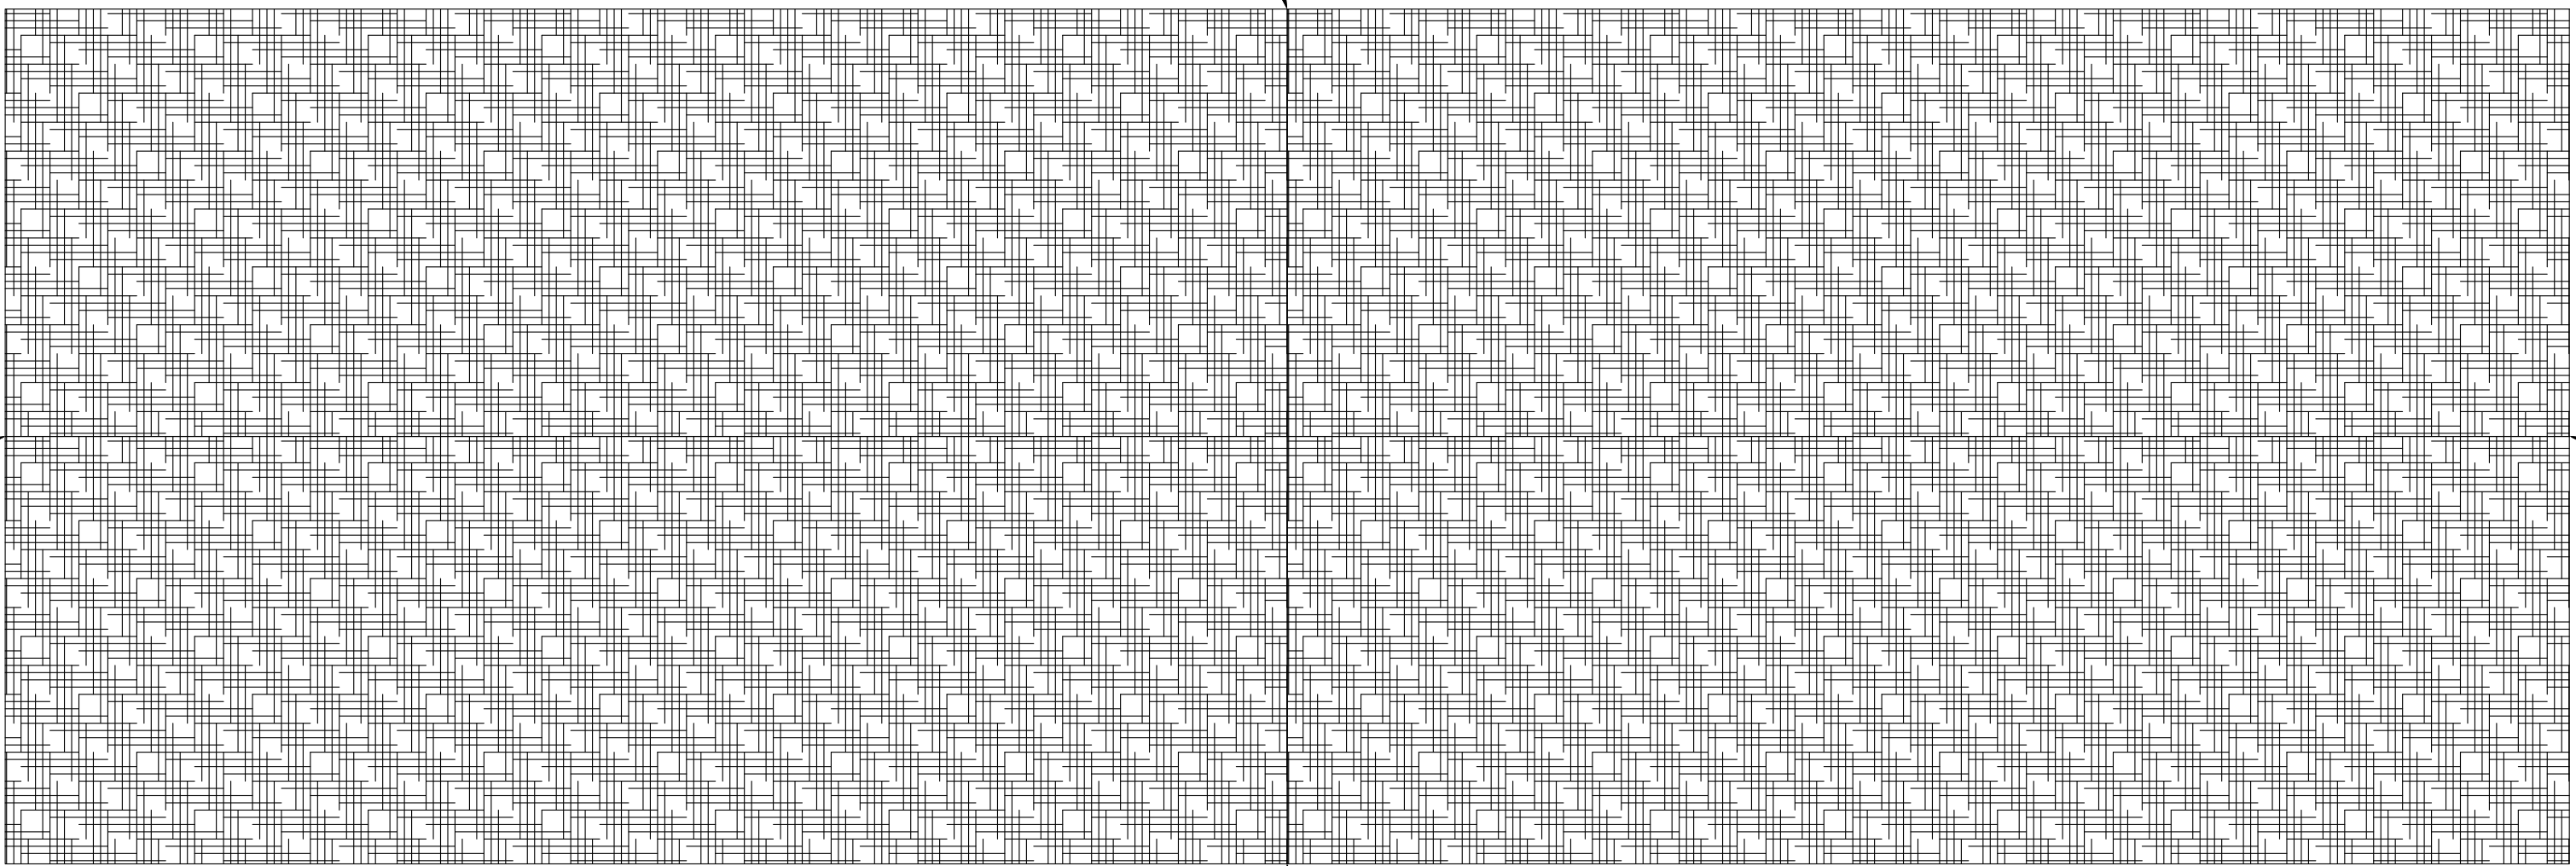
24'-0"

A noticeable seam will occur if not properly sealed when stacking liners.

8'-0"
