# #101A Zippered 29.86 Sq' 7'-8<sup>3</sup>/<sub>8</sub>"

Customer:		Drawn By:		Date:	
Job Name:		Approved By:		Date:	
Title:	#101A Velour Modular Running Bond Zipper	Scale:	None	Tolerance:	±3/16
		Page:	1	Drawing Number:

Customer:  
 Job Name:  
 Title: #101A Velour Modular Running Bond Zipper Assembled

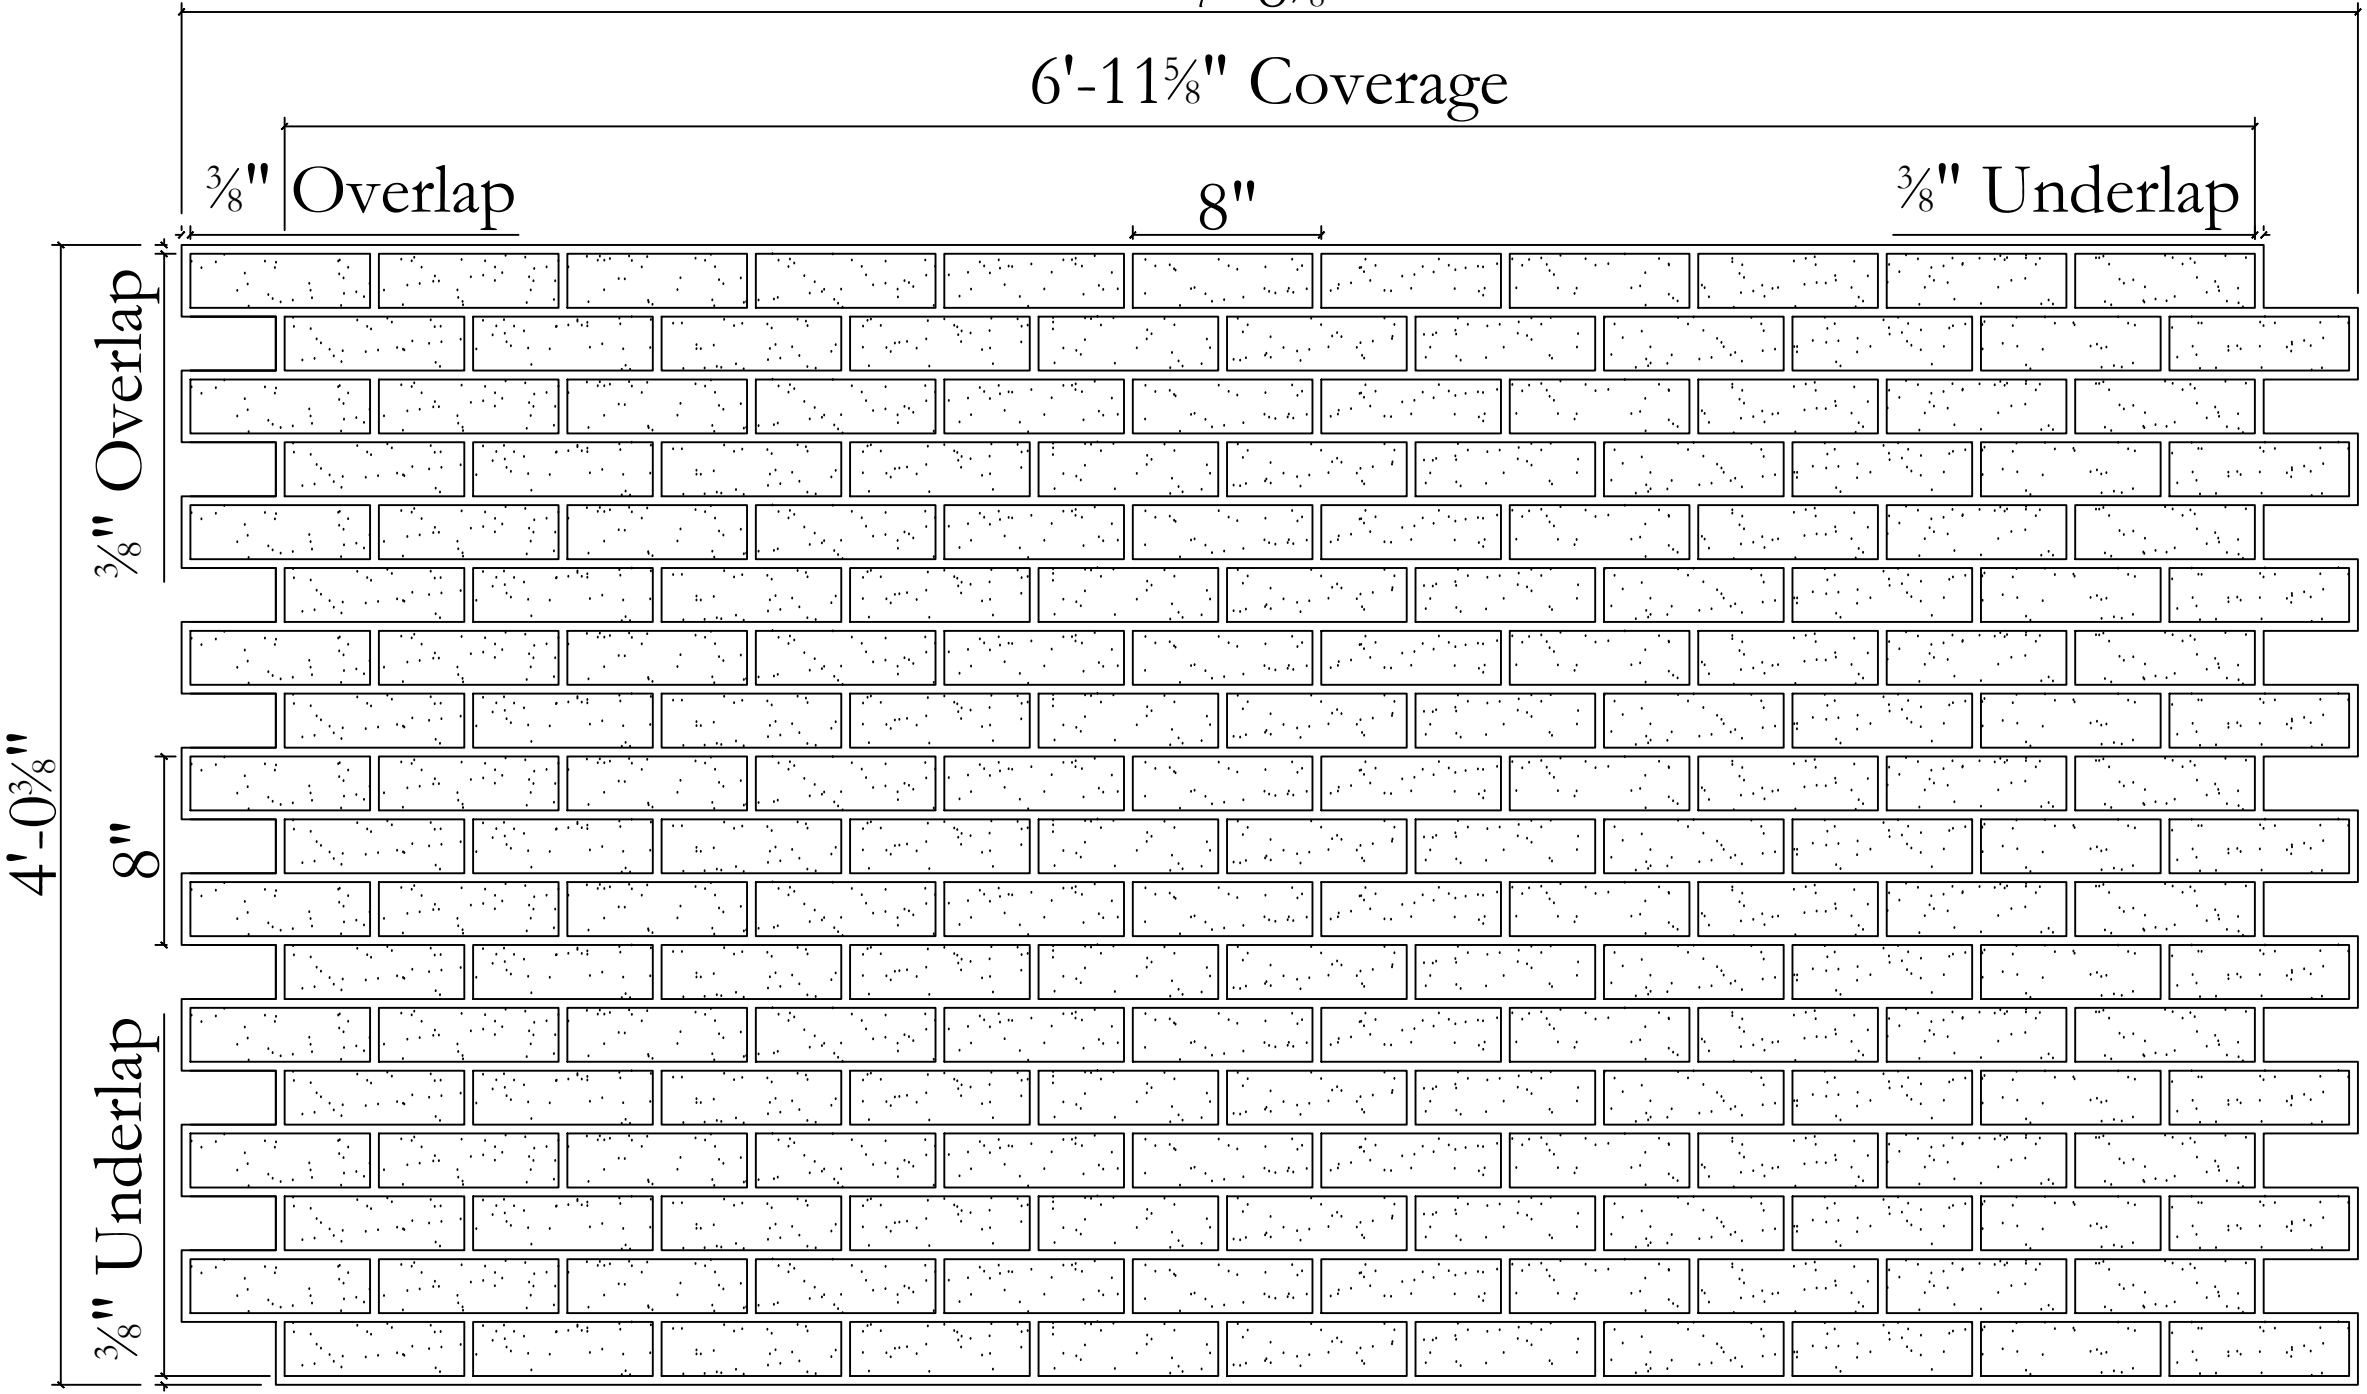
## 6'-11<sup>5</sup>/<sub>8</sub>" Coverage

\*\*Hatch texture for visual reference only. Actual texture to be AP #101 Velour\*\*

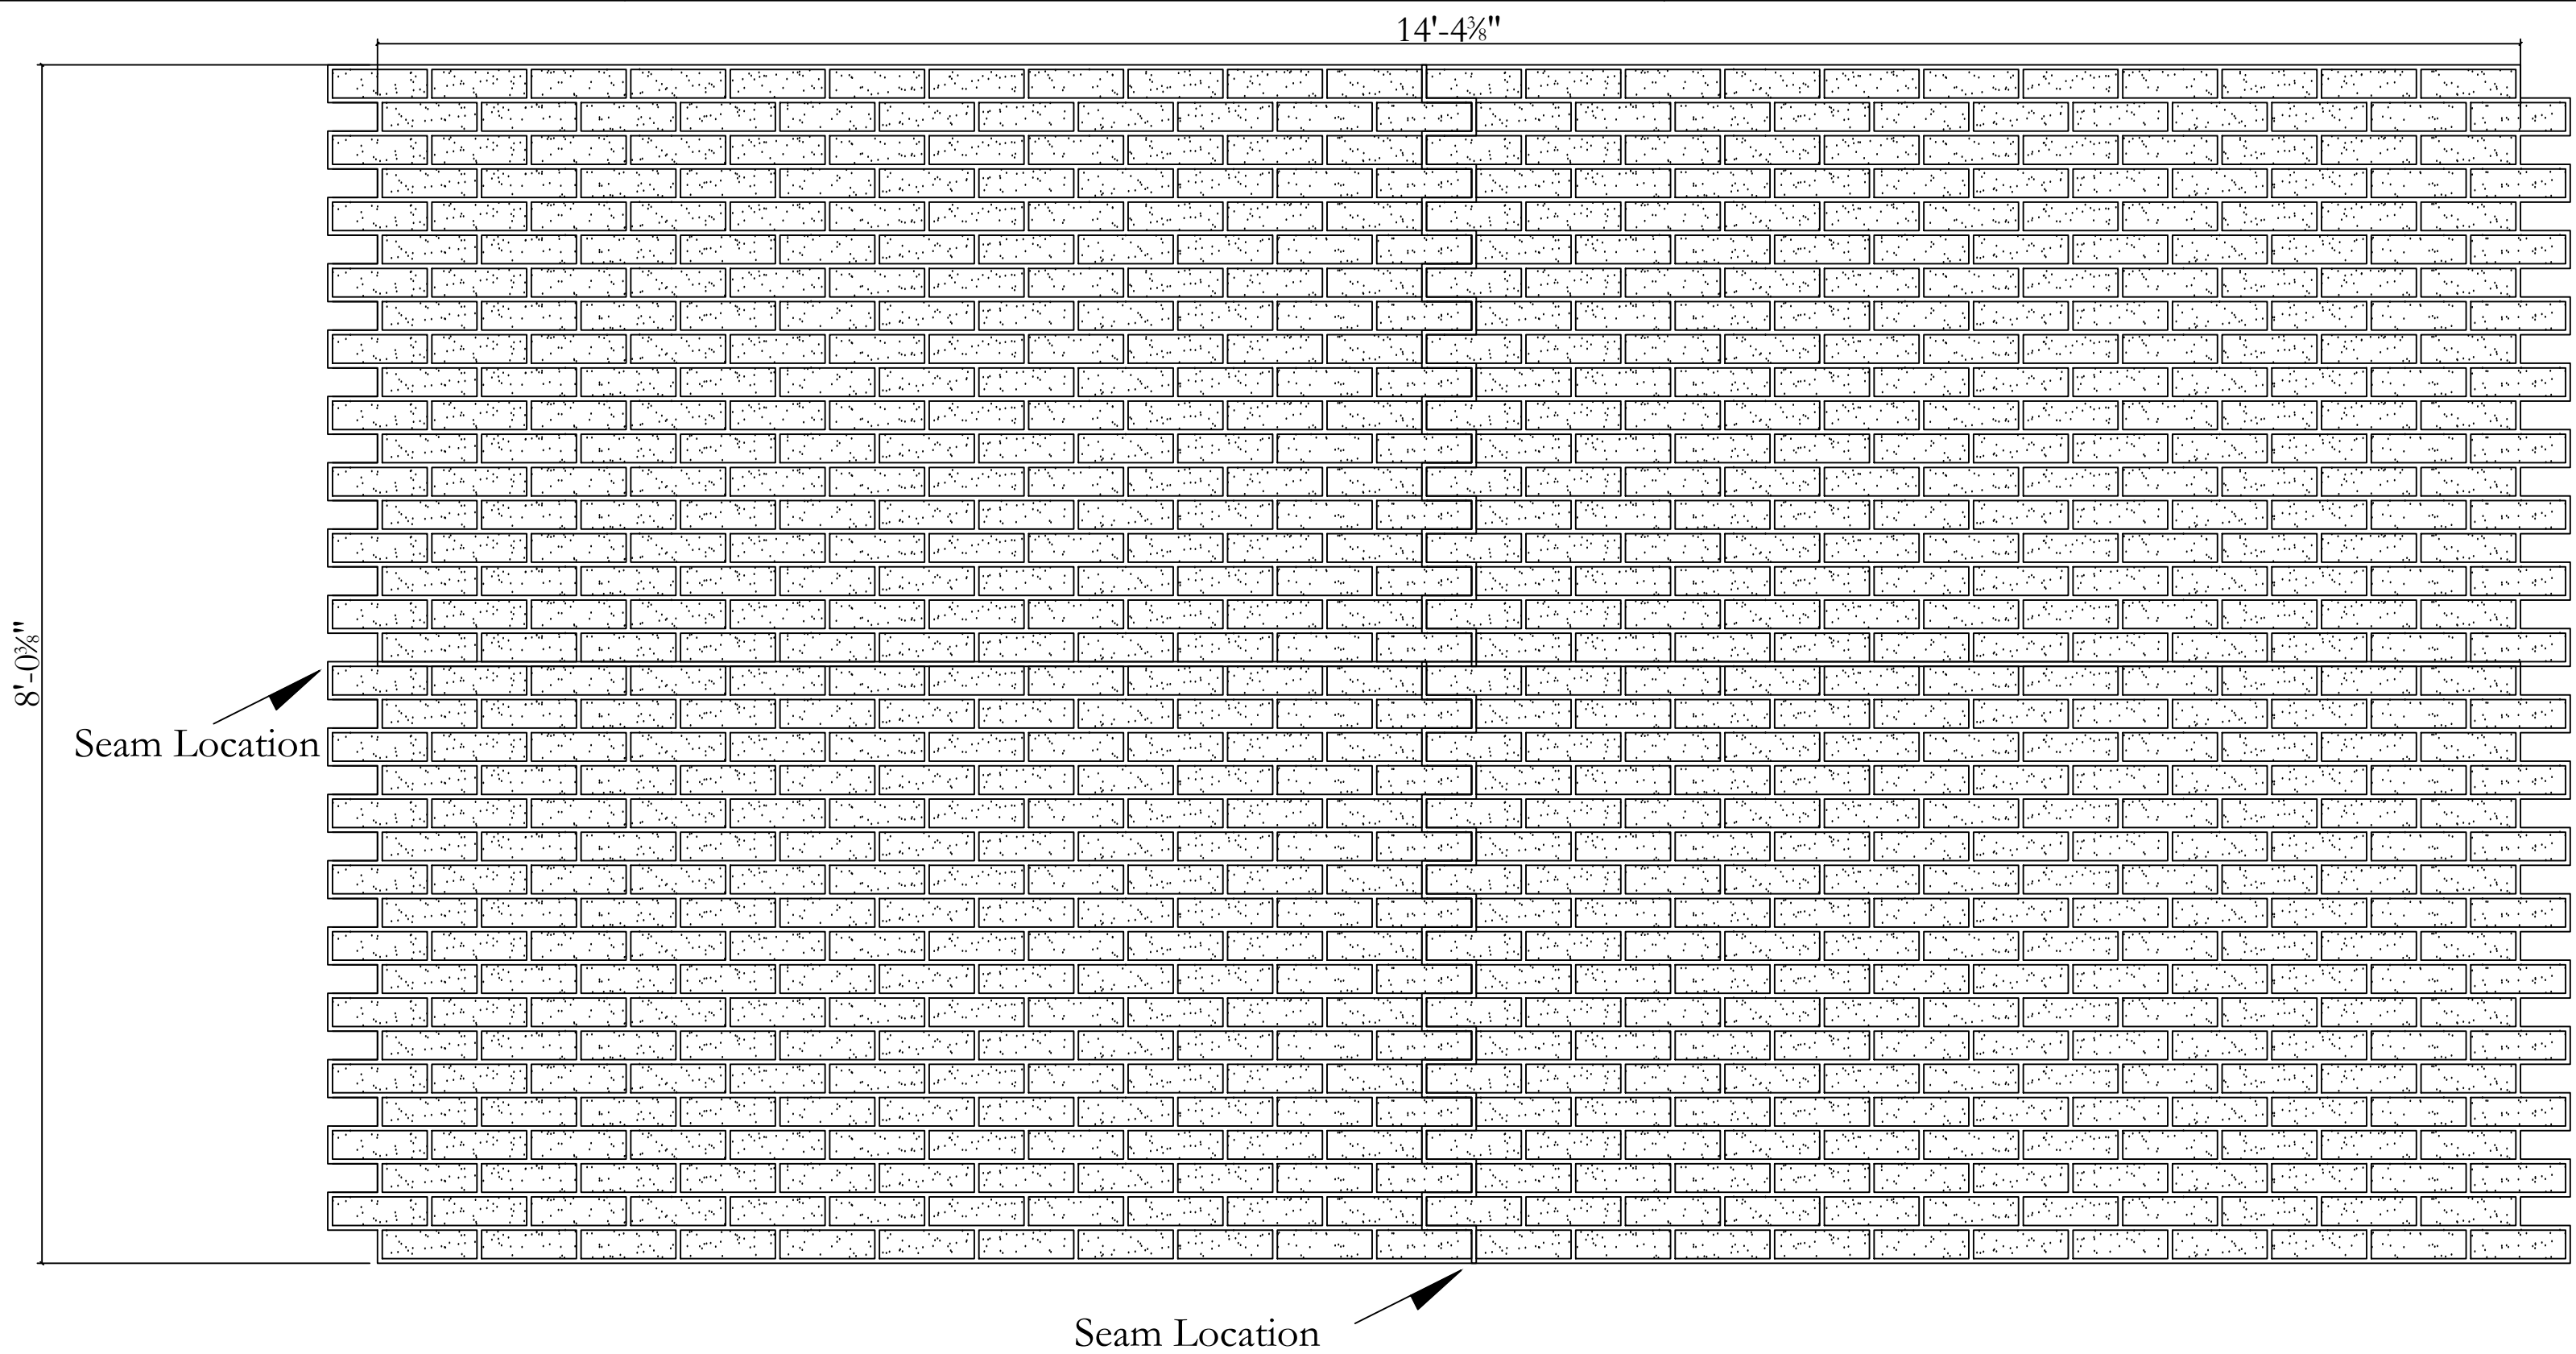
8'-0 3/8"  
Seam Location

Seam Location
