Customer:	
Job Name:	
Title:	#894 16in Quarry Stone

Customer:  
 Job Name:  
 Title: #894 16in Quarry Stone Assembled

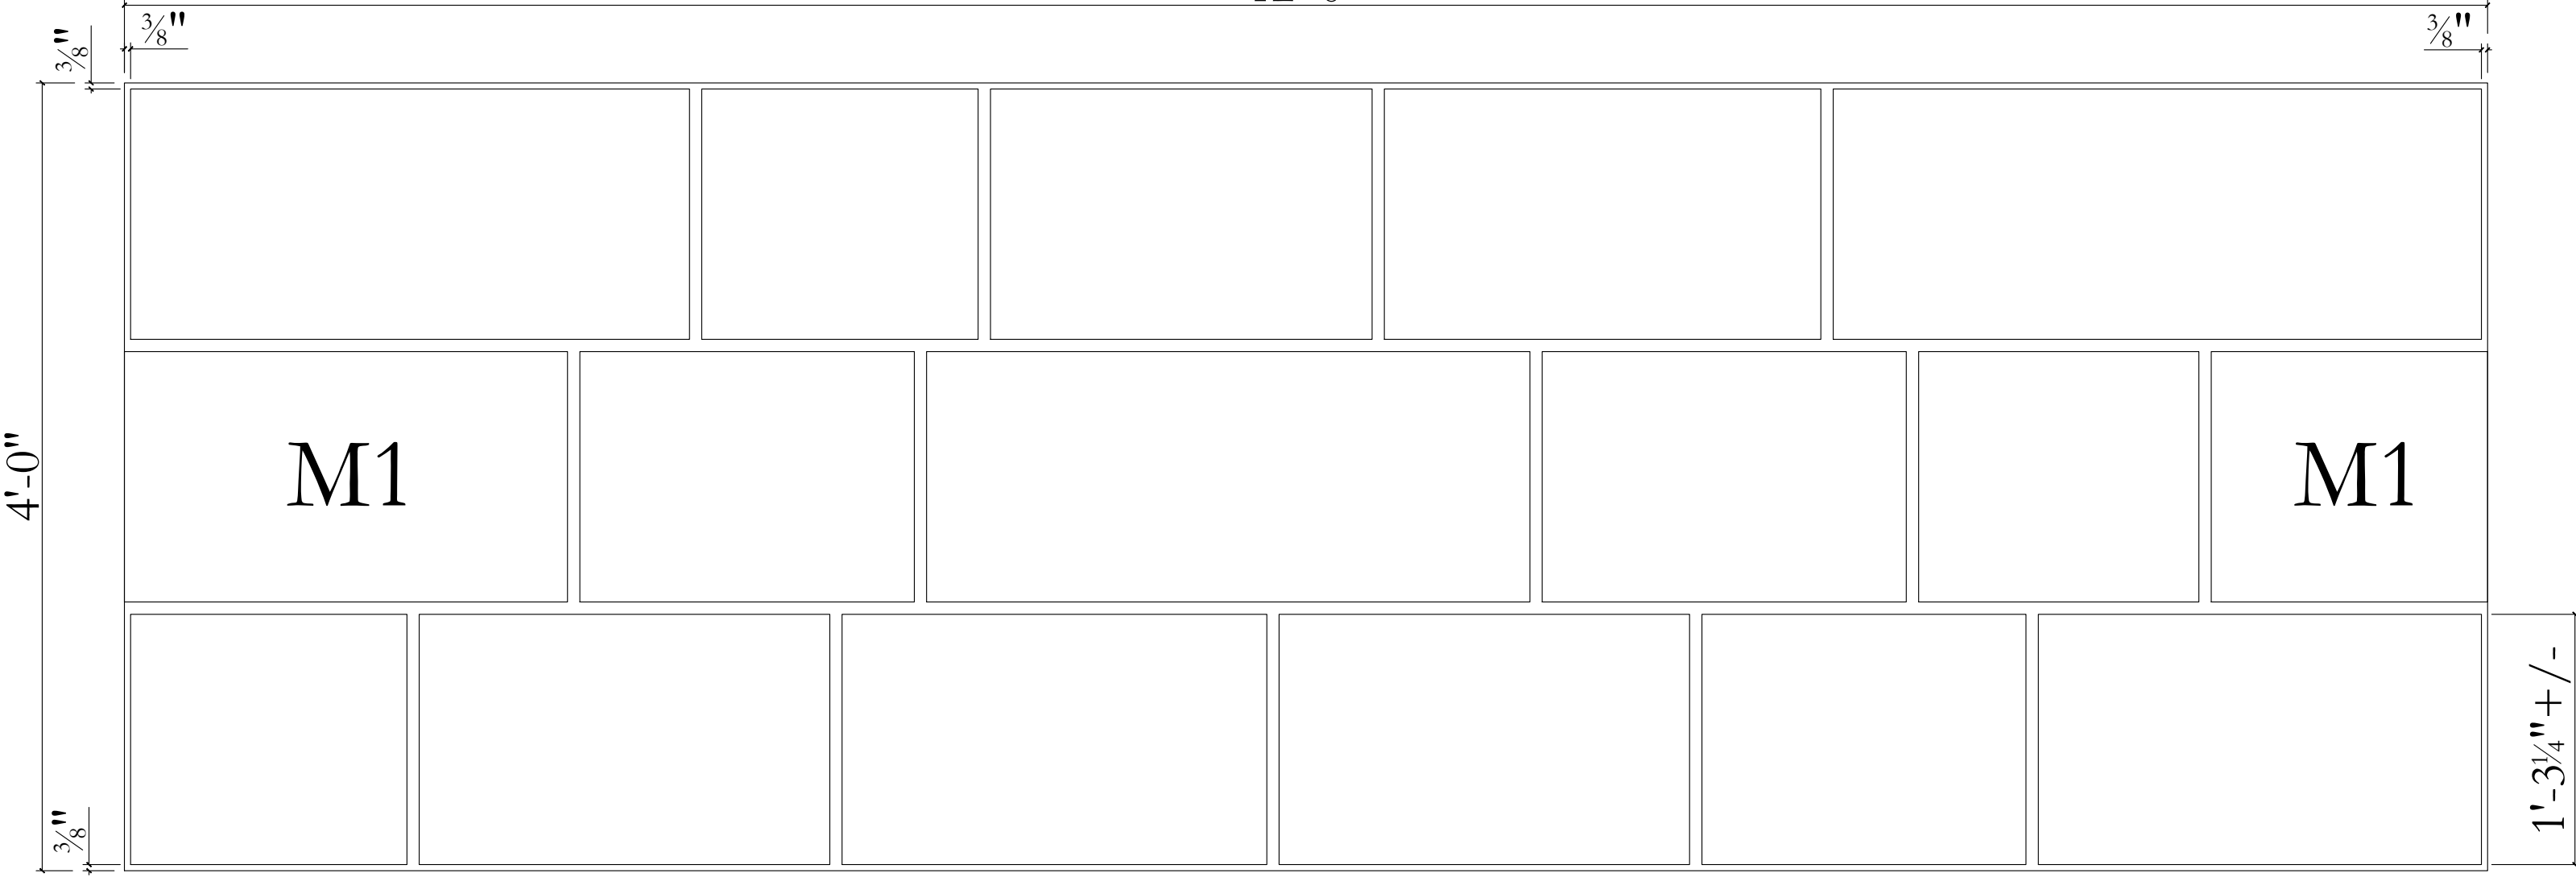
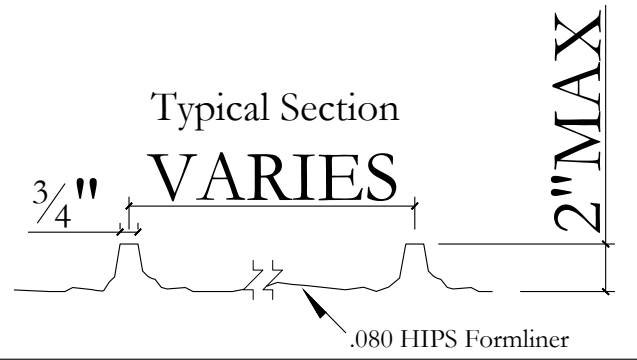
12'-0"

16" Quarry Stone - 2" Relief Stone sizes will vary

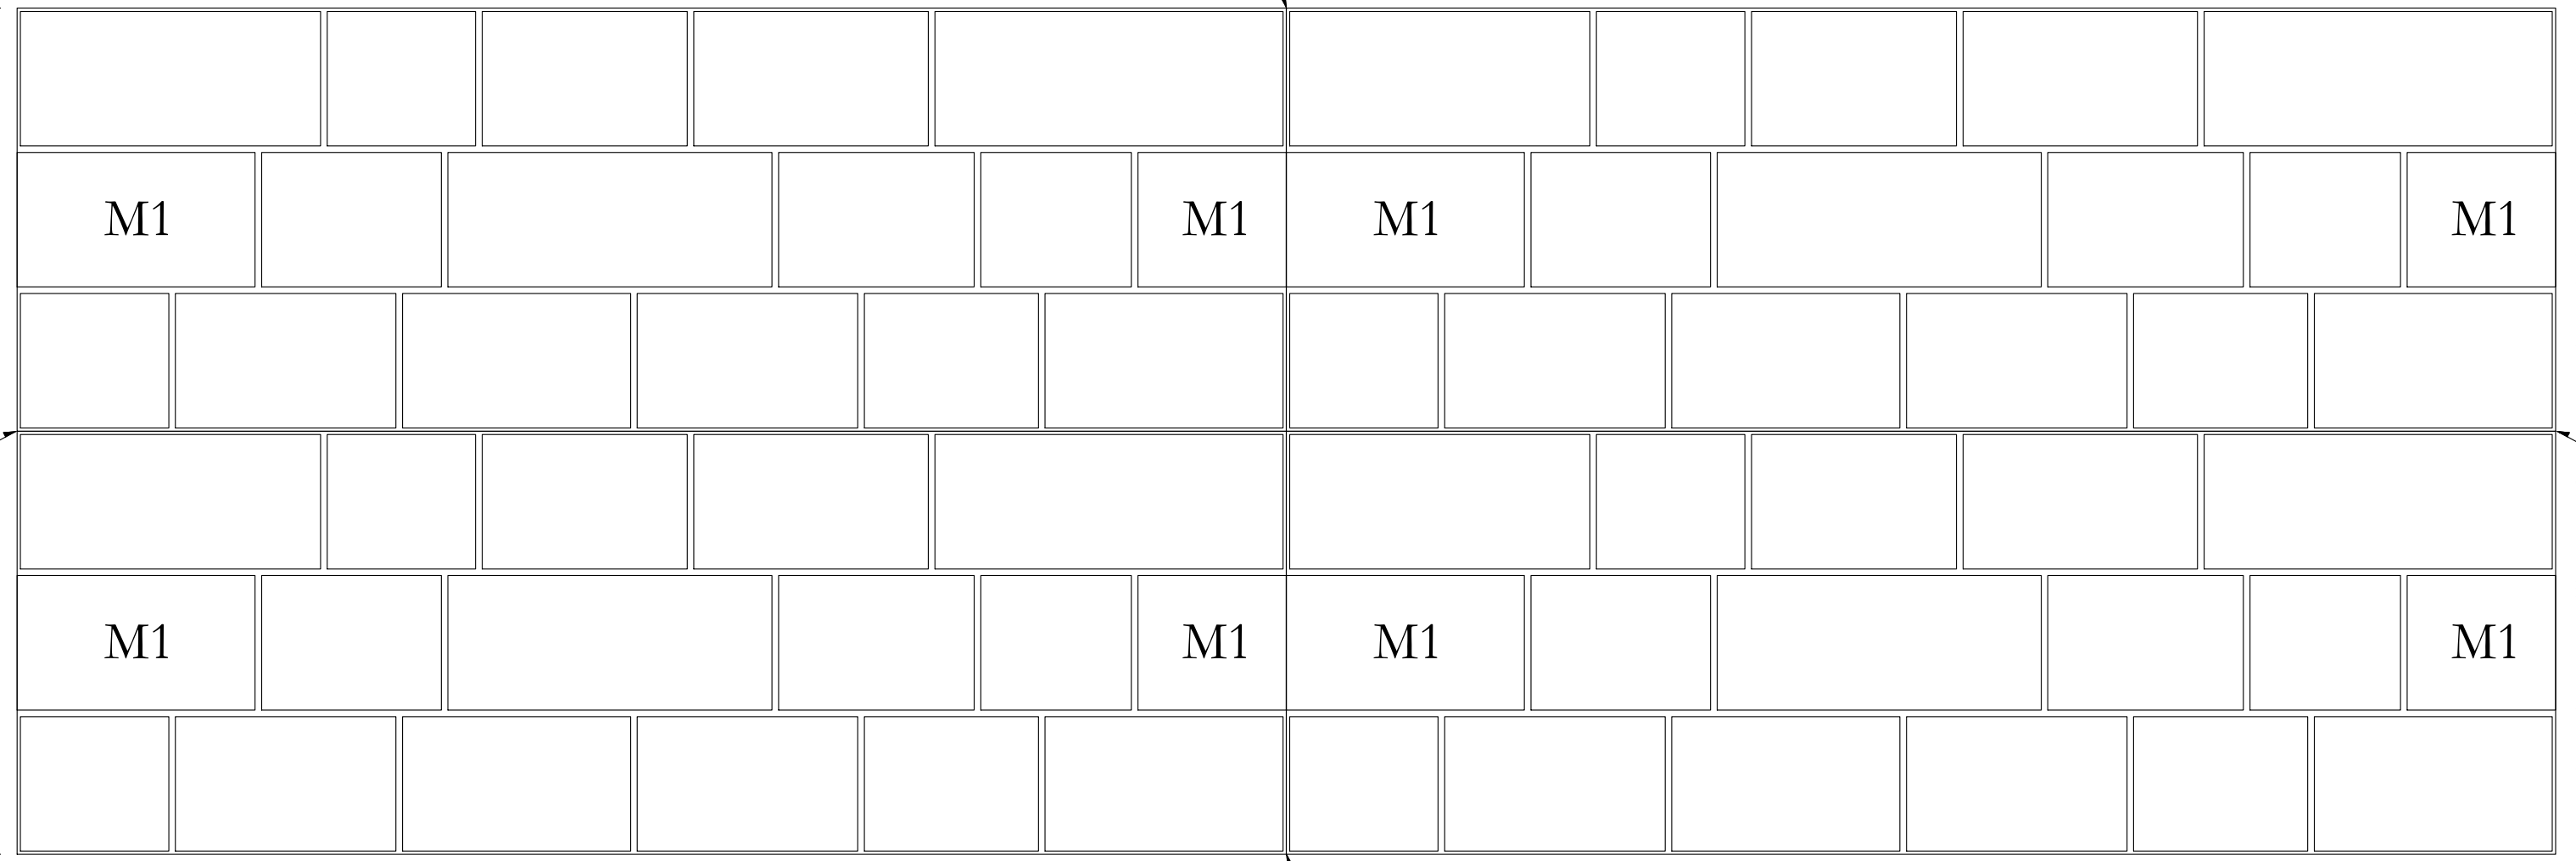
24'-0"

A noticeable seam will occur if not properly sealed when stacking liners.

8'-0"  
A noticeable seam will occur if not properly sealed when stacking liners.
