ITEM # 308798

Customer: _____
 Job Name: _____
 Title: 111 Ohio Sand Brick

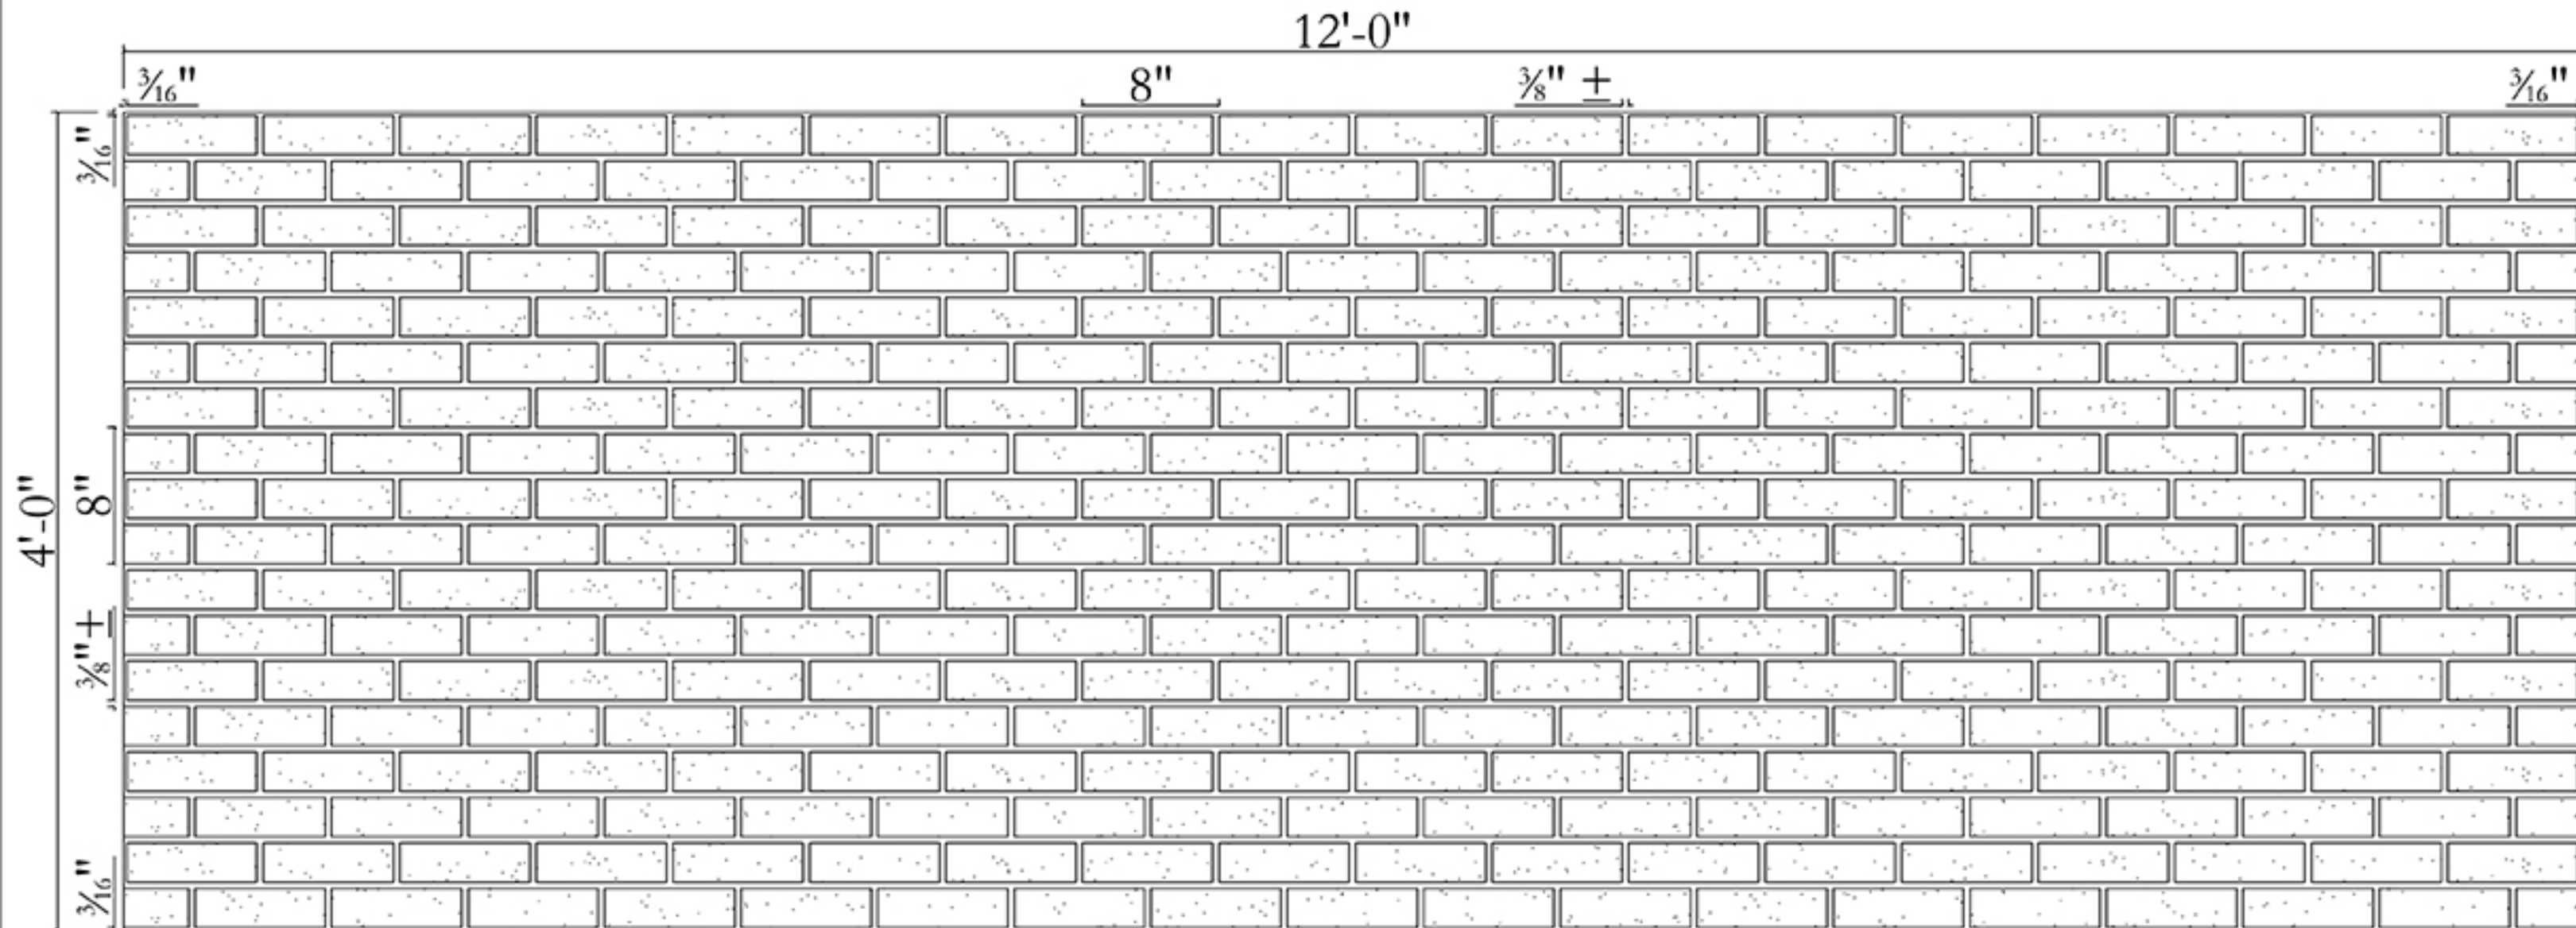
Typical Section

Hatch Texture For Visual Reference Only. Actual Texture Will Vary
