#204 1.5" Standard Fractured Fin Horizontal

Customer:	
Job Name:	
Title:	204 1.5" Standard Fractured Fin Horizontal

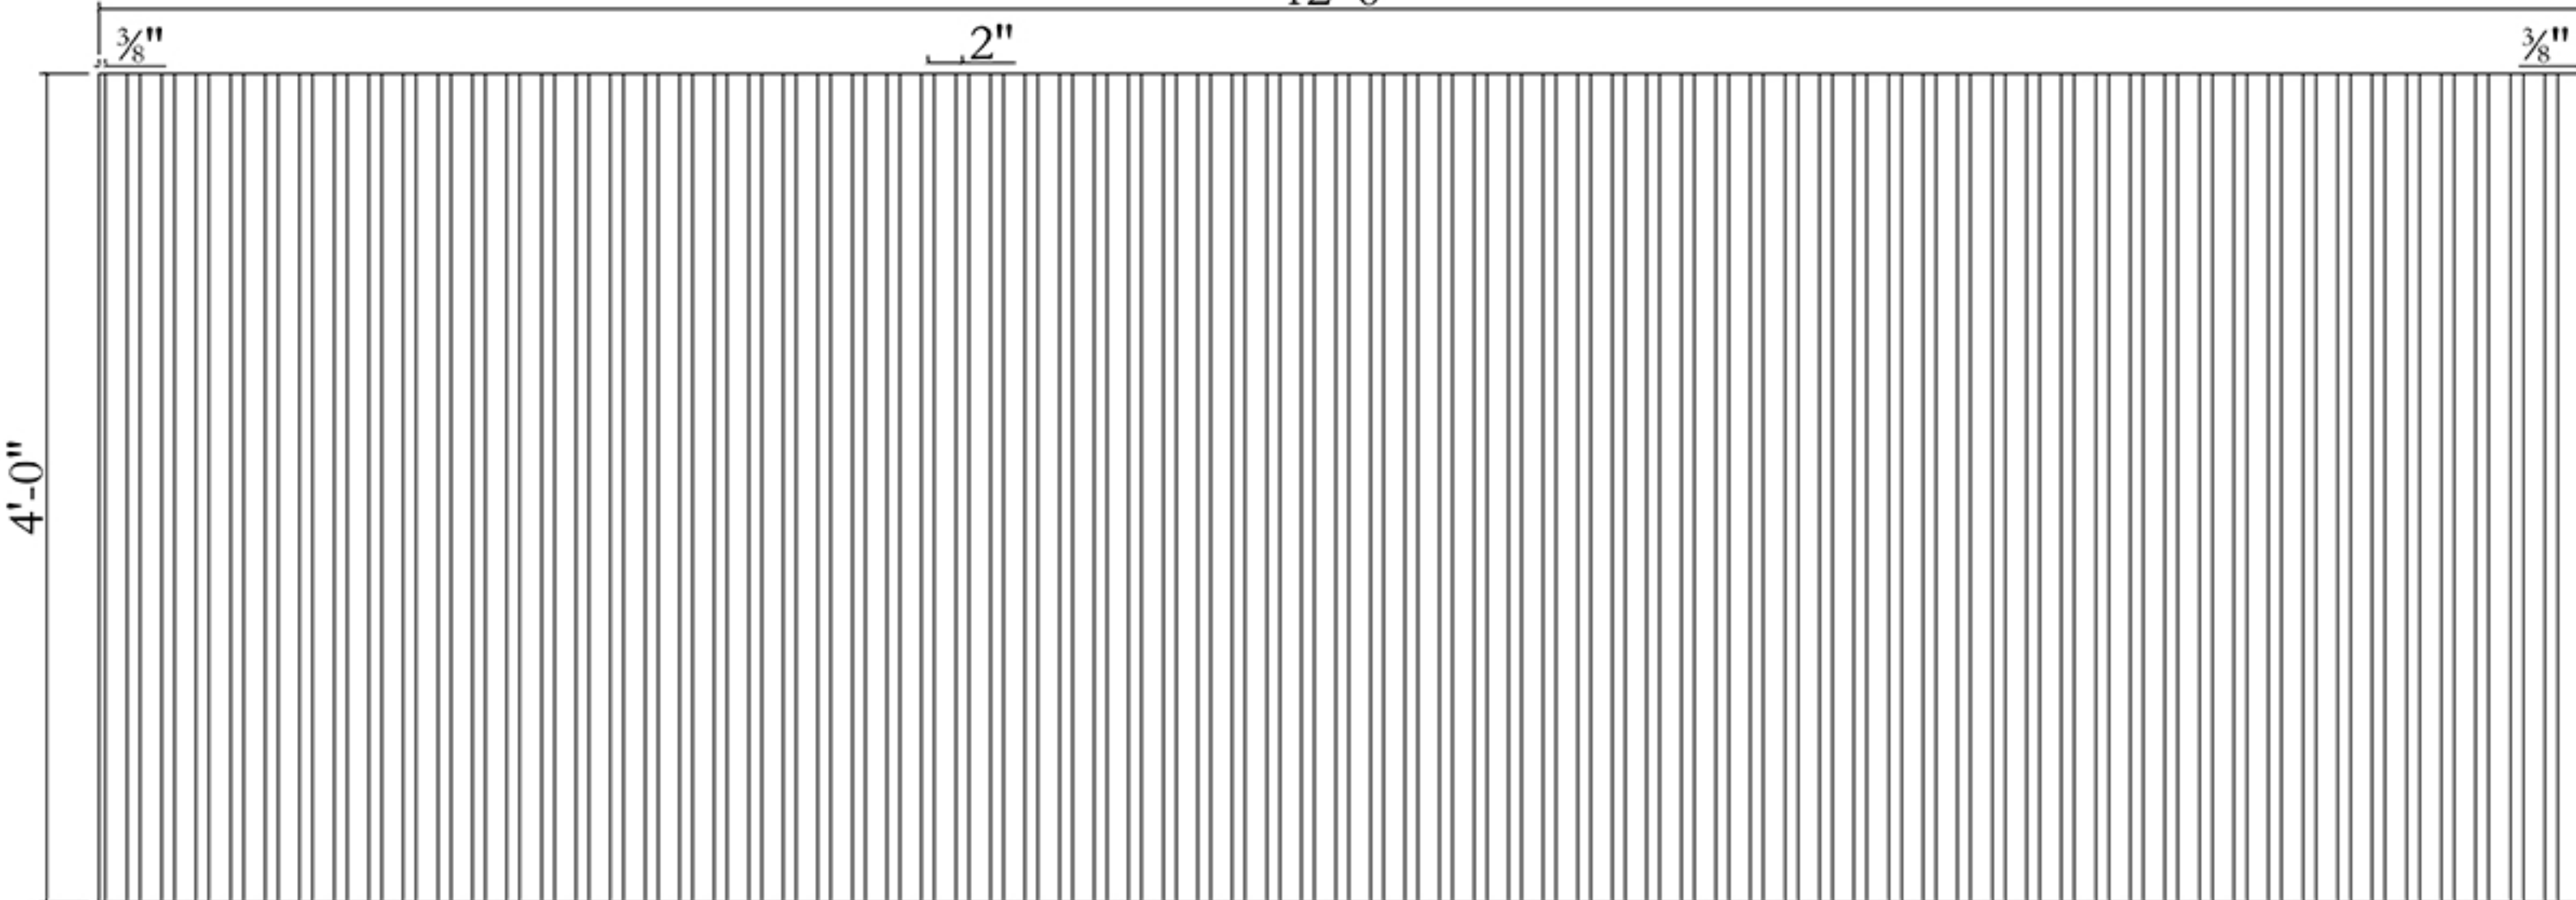
12'-0"
