ITEM # 304870

Customer:  
 Job Name:  
 Title: #904 Ashlar Stone

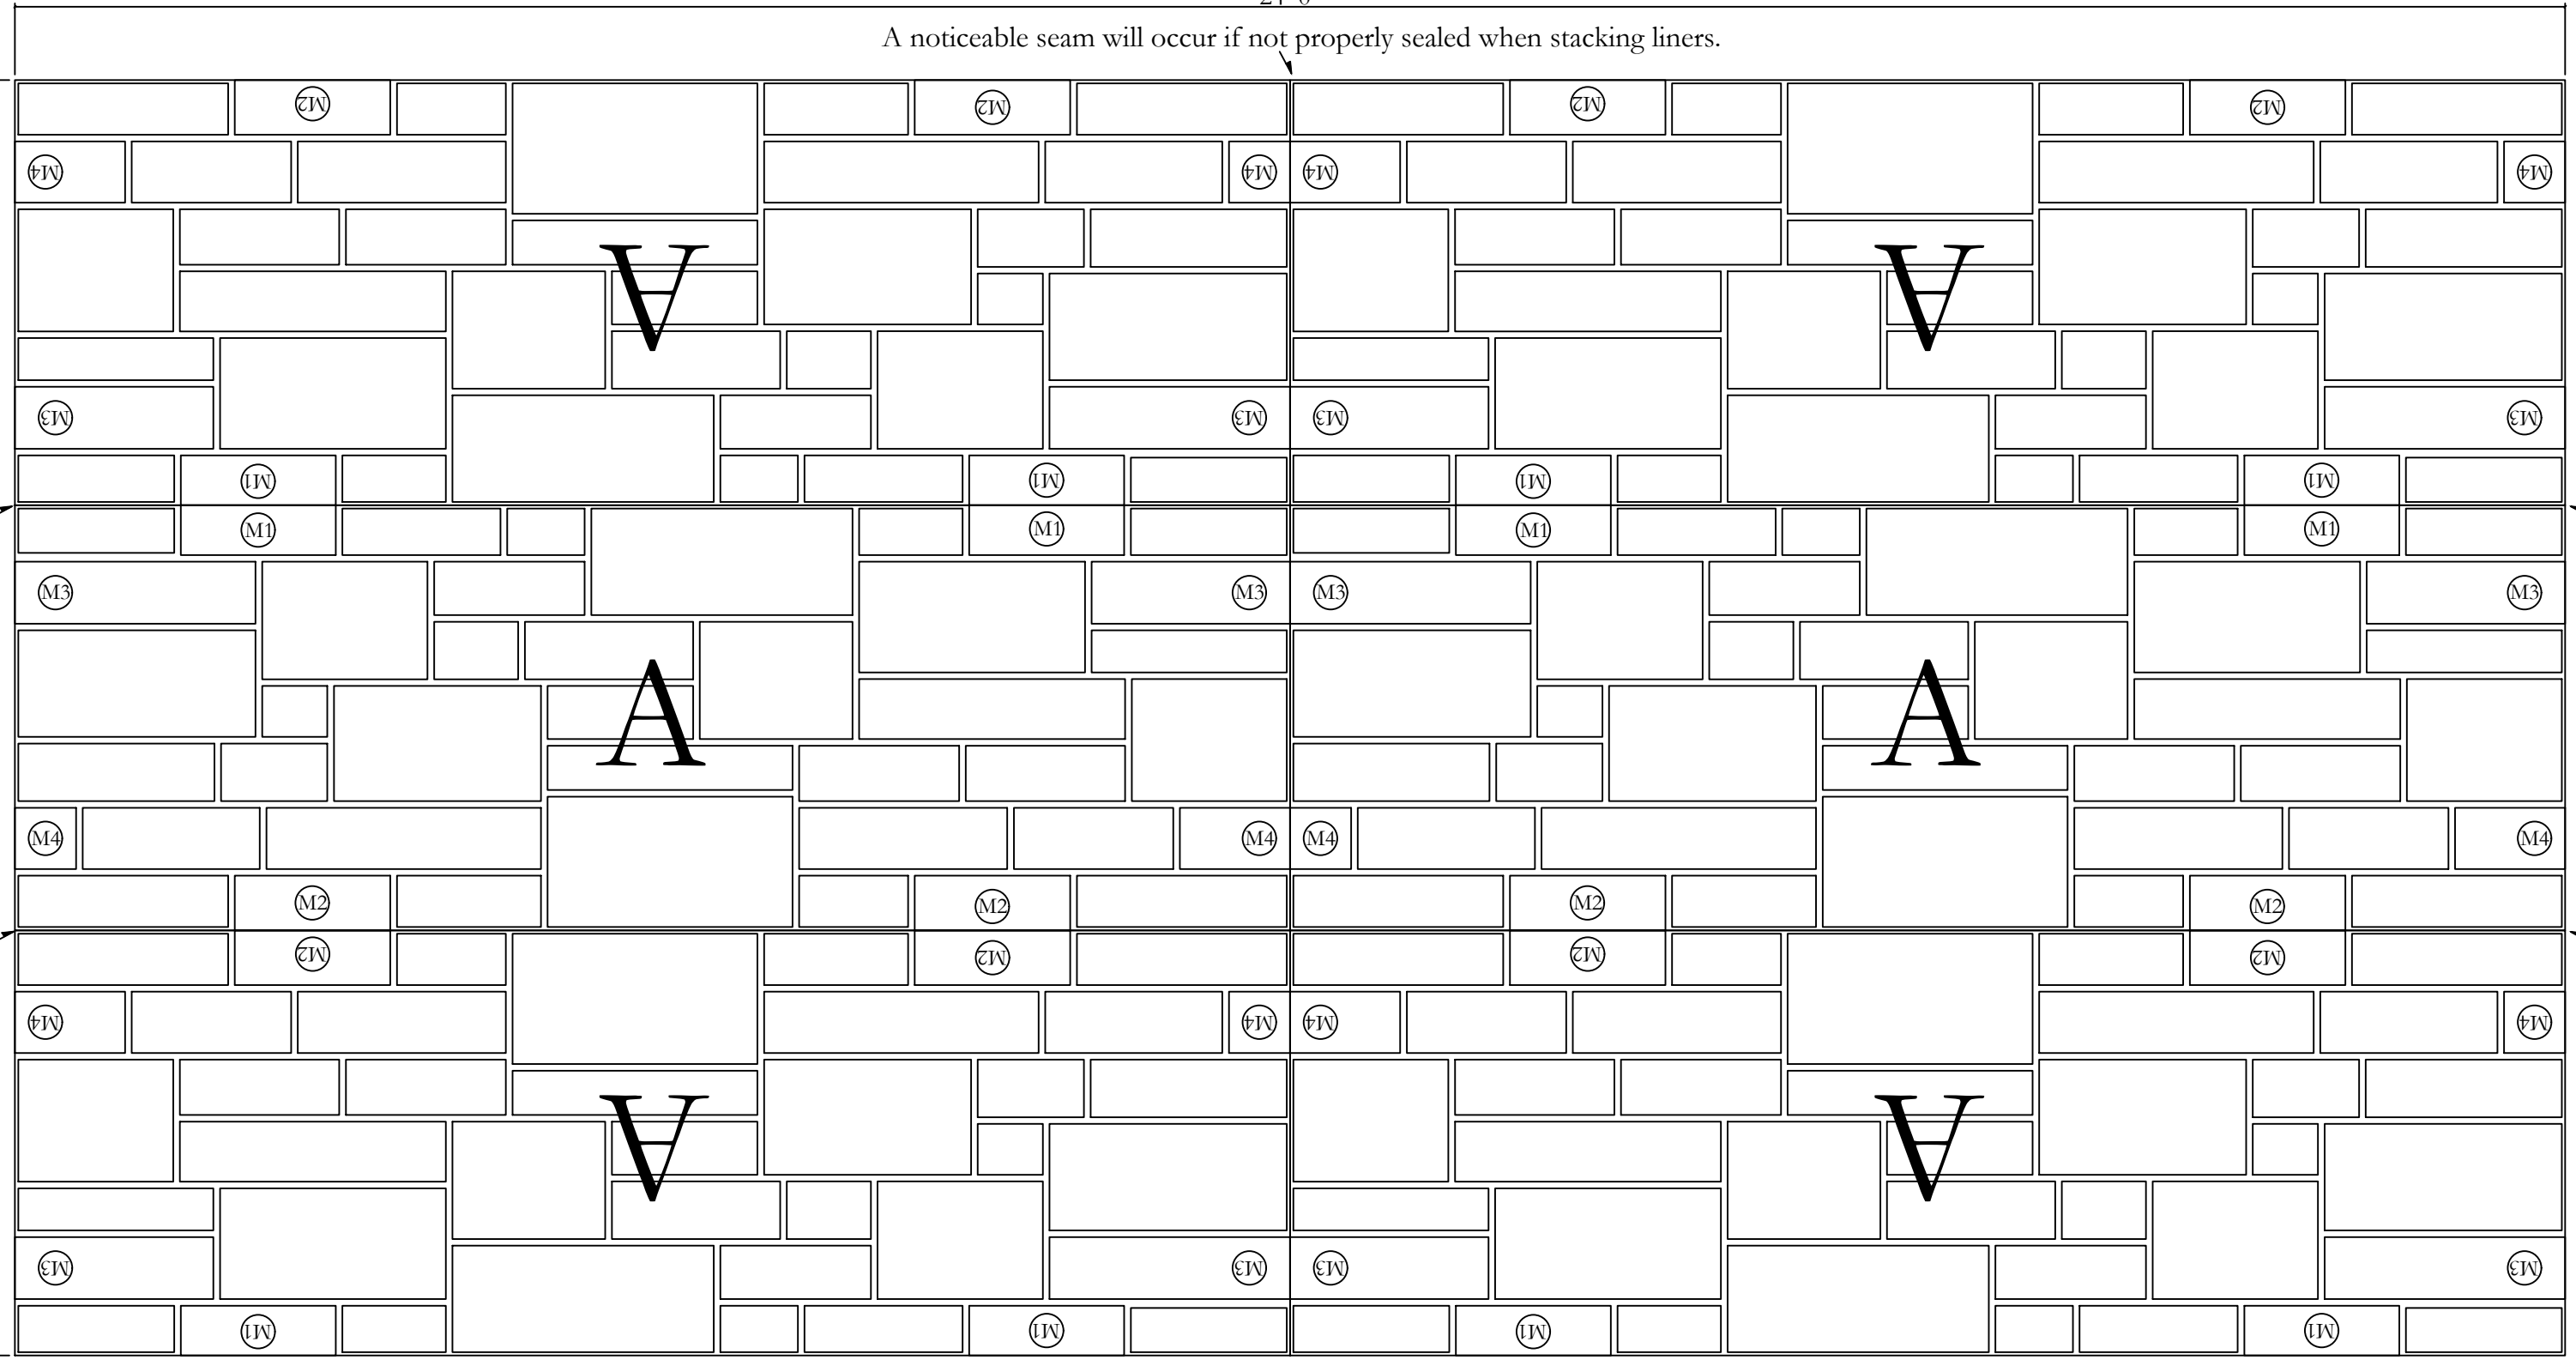
24'-0"

12'-0"

A noticeable seam will occur if not properly sealed when stacking liners.
