ITEM # 304897

Customer:  
 Job Name:  
 Title: #905 Small Aged Ashlar Stone

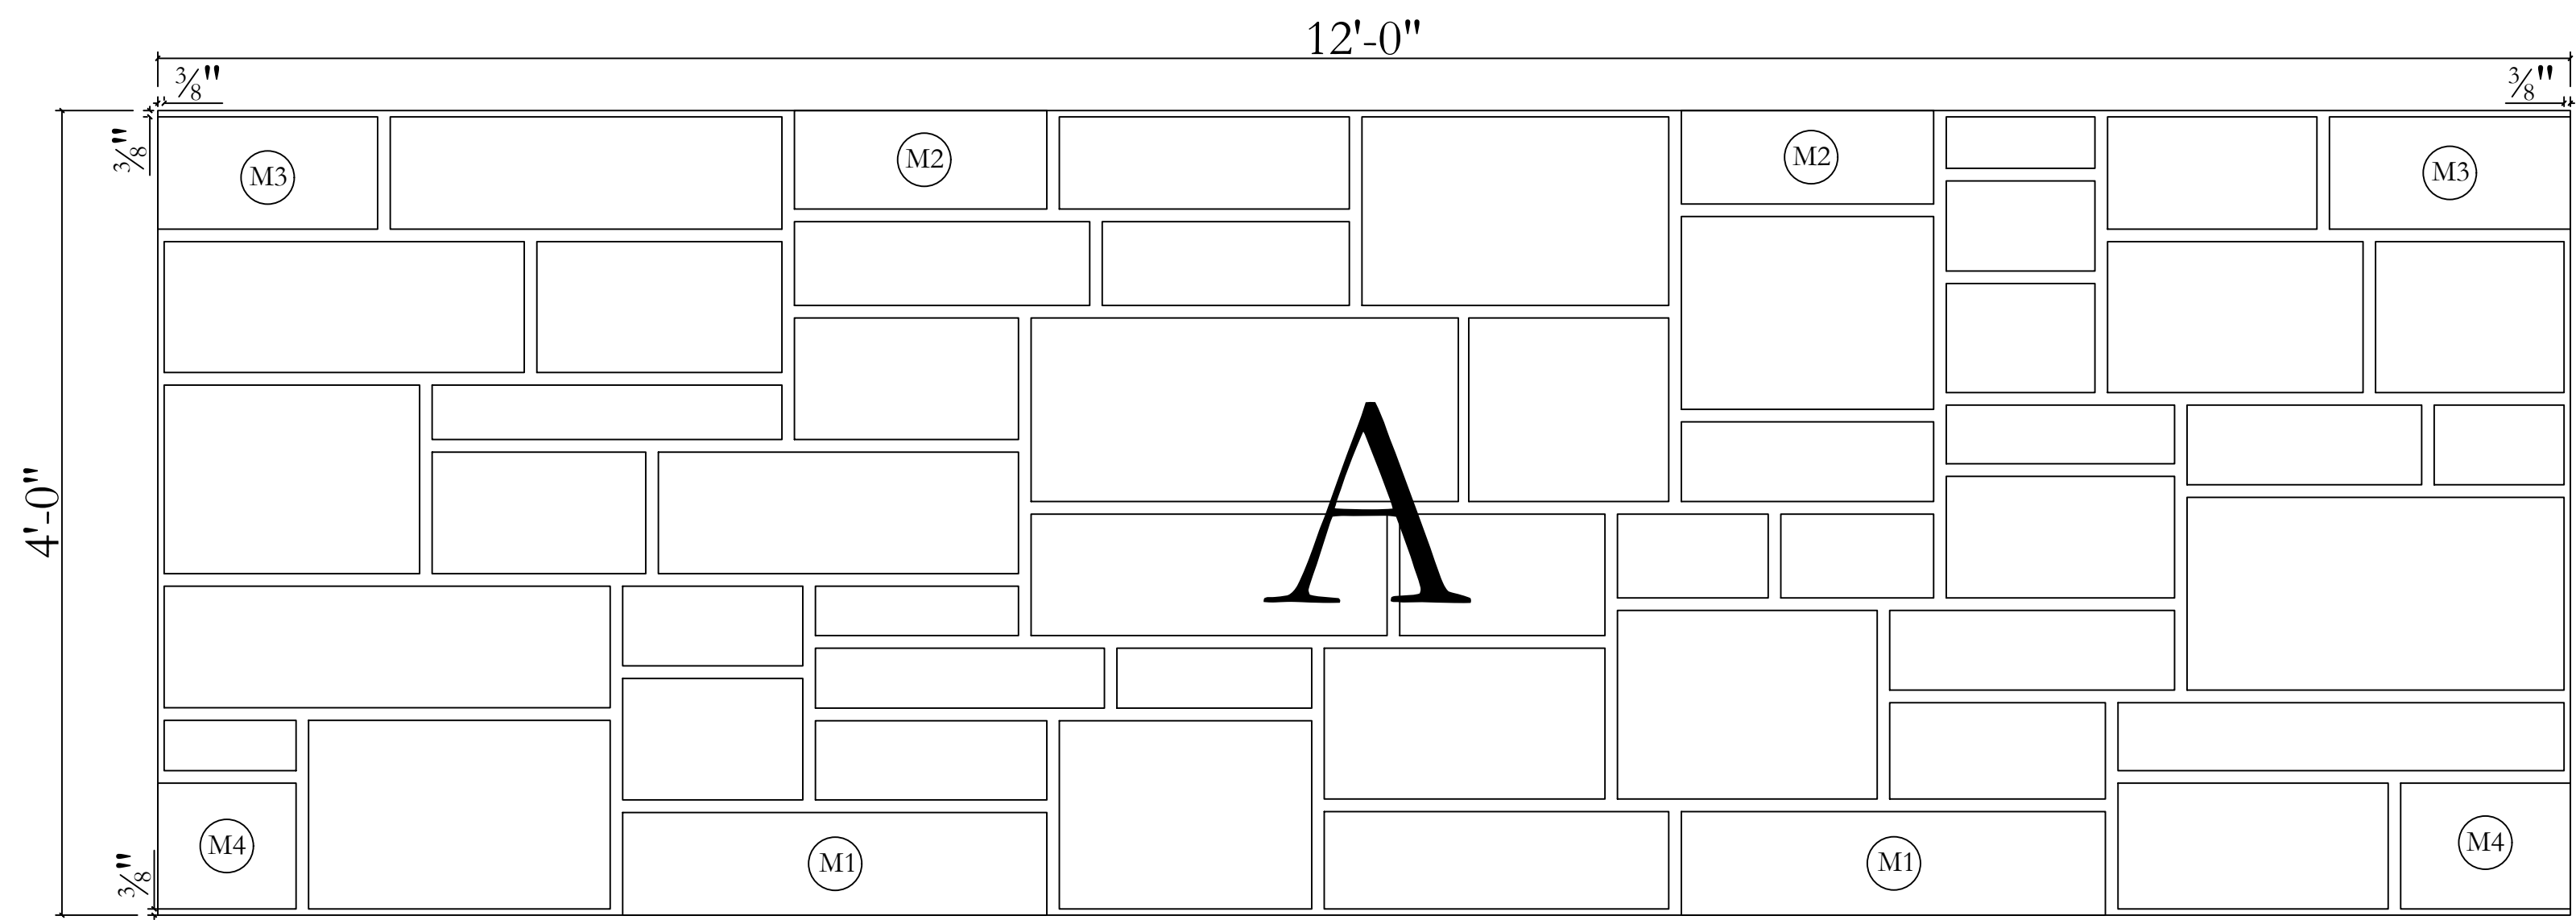
24'-0"

A noticeable seam will occur if not properly sealed when stacking liners.

12'-0"  
A noticeable seam will occur if not properly sealed when stacking liners.

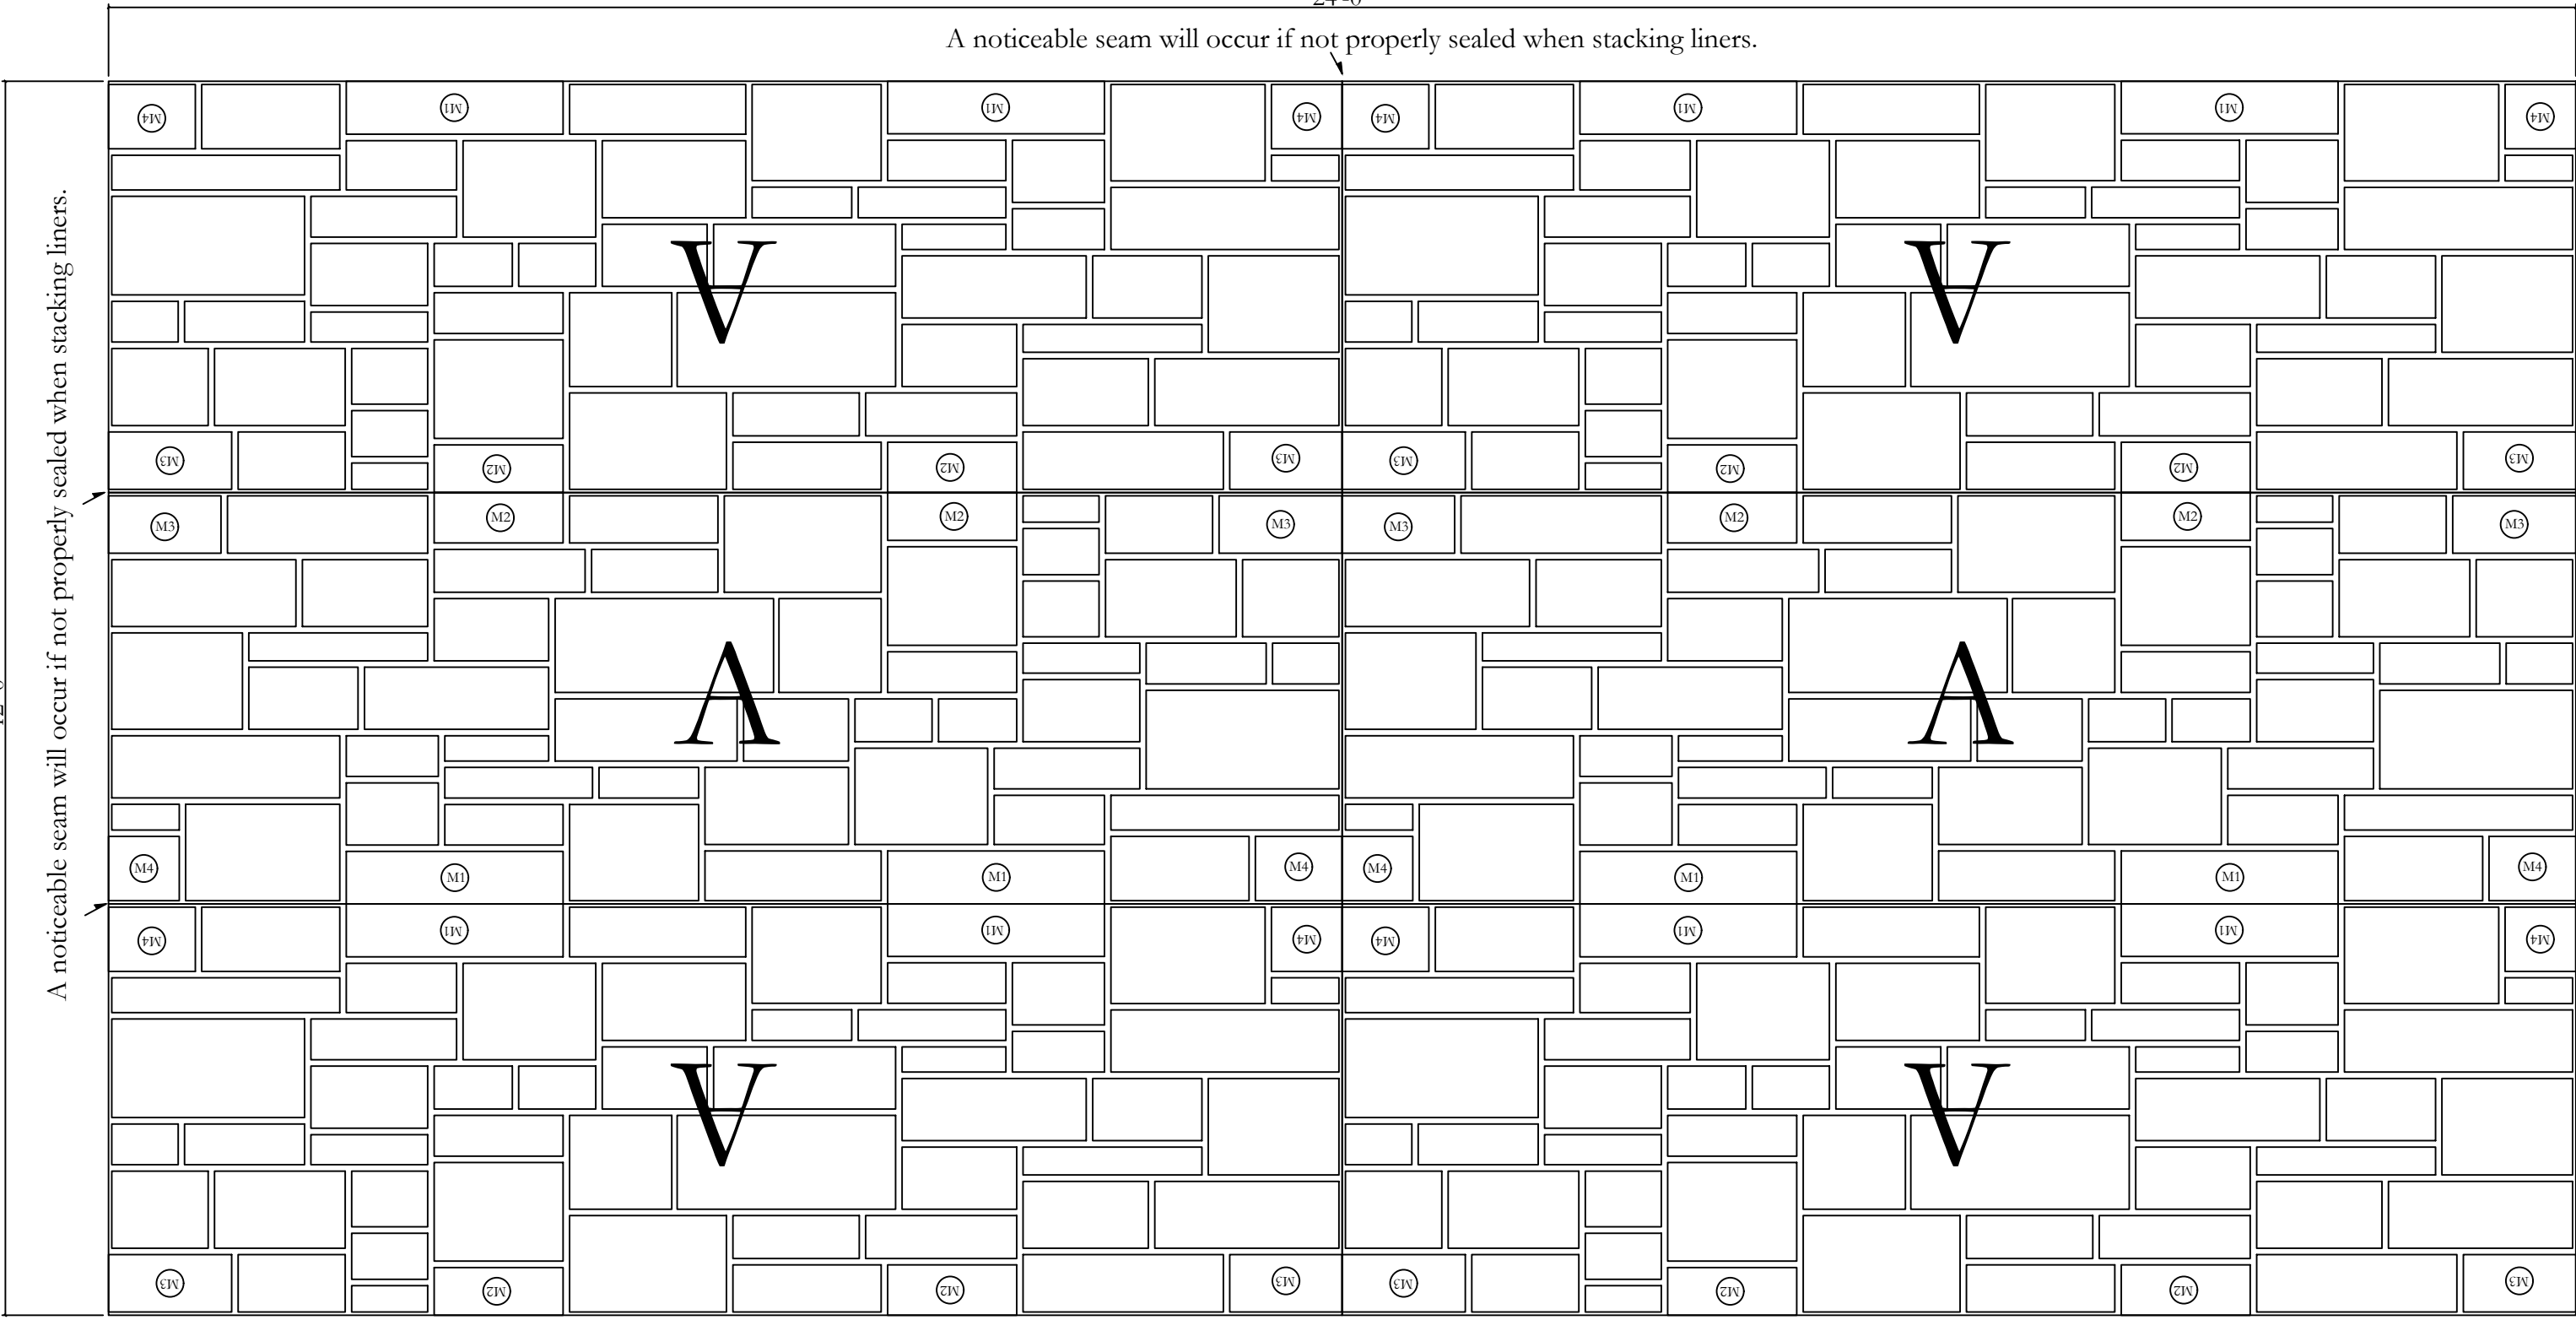
Customer:  
 Job Name:  
 Title: #905 Small Aged Ashlar Stone

A noticeable seam will occur if not properly sealed when stacking liners.
