Customer:
 Job Name:
 Title: #907 Coral Ashlar Stone

Customer:
 Job Name:
 Title: #907 Coral Ashlar Stone Assembled

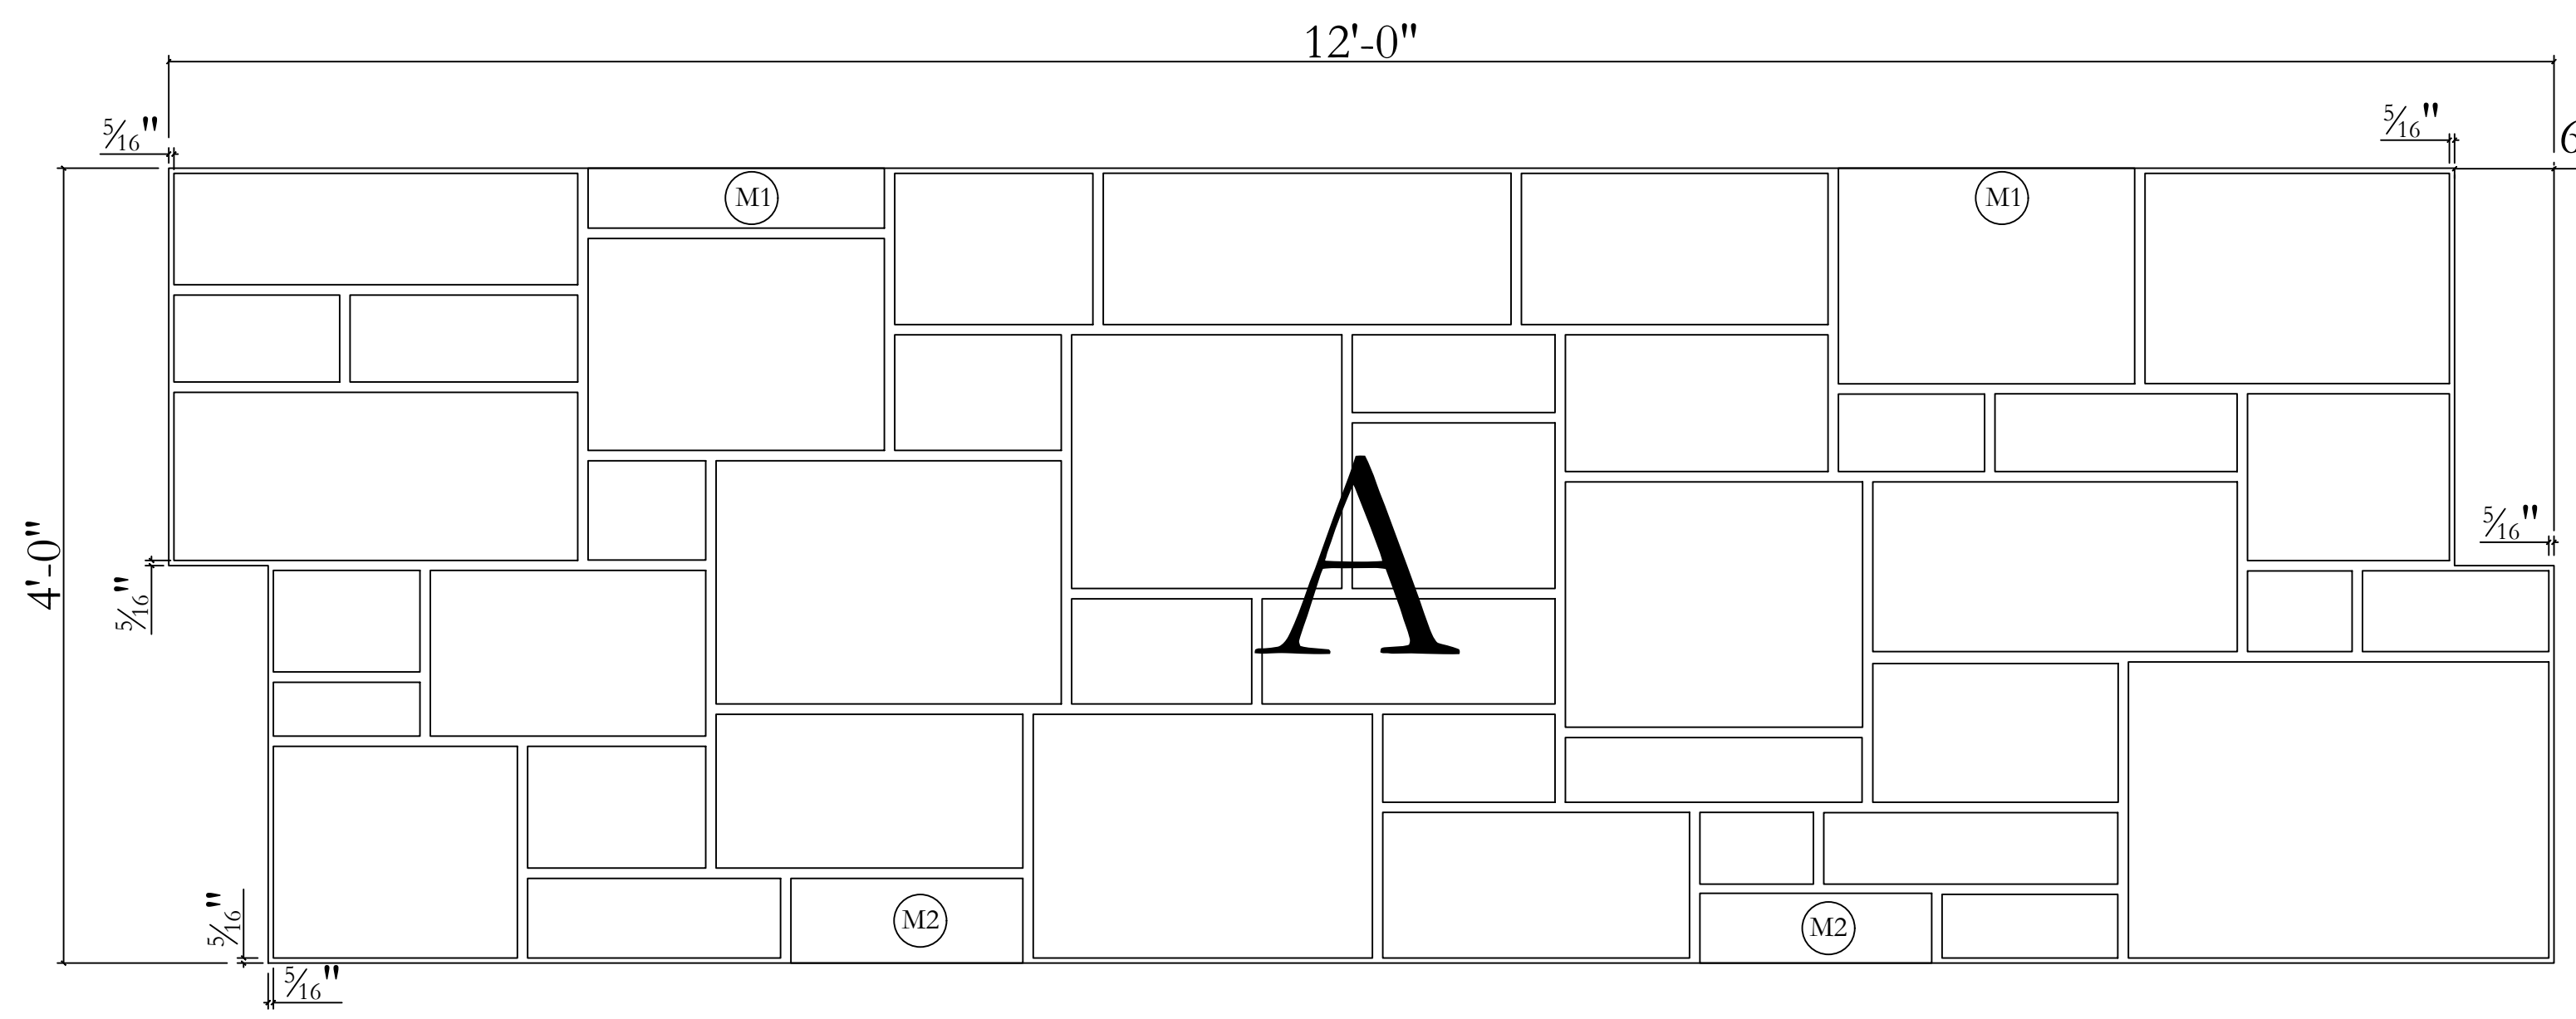
22'-11¹/₆"

A noticeable seam will occur if not properly sealed when stacking liners.

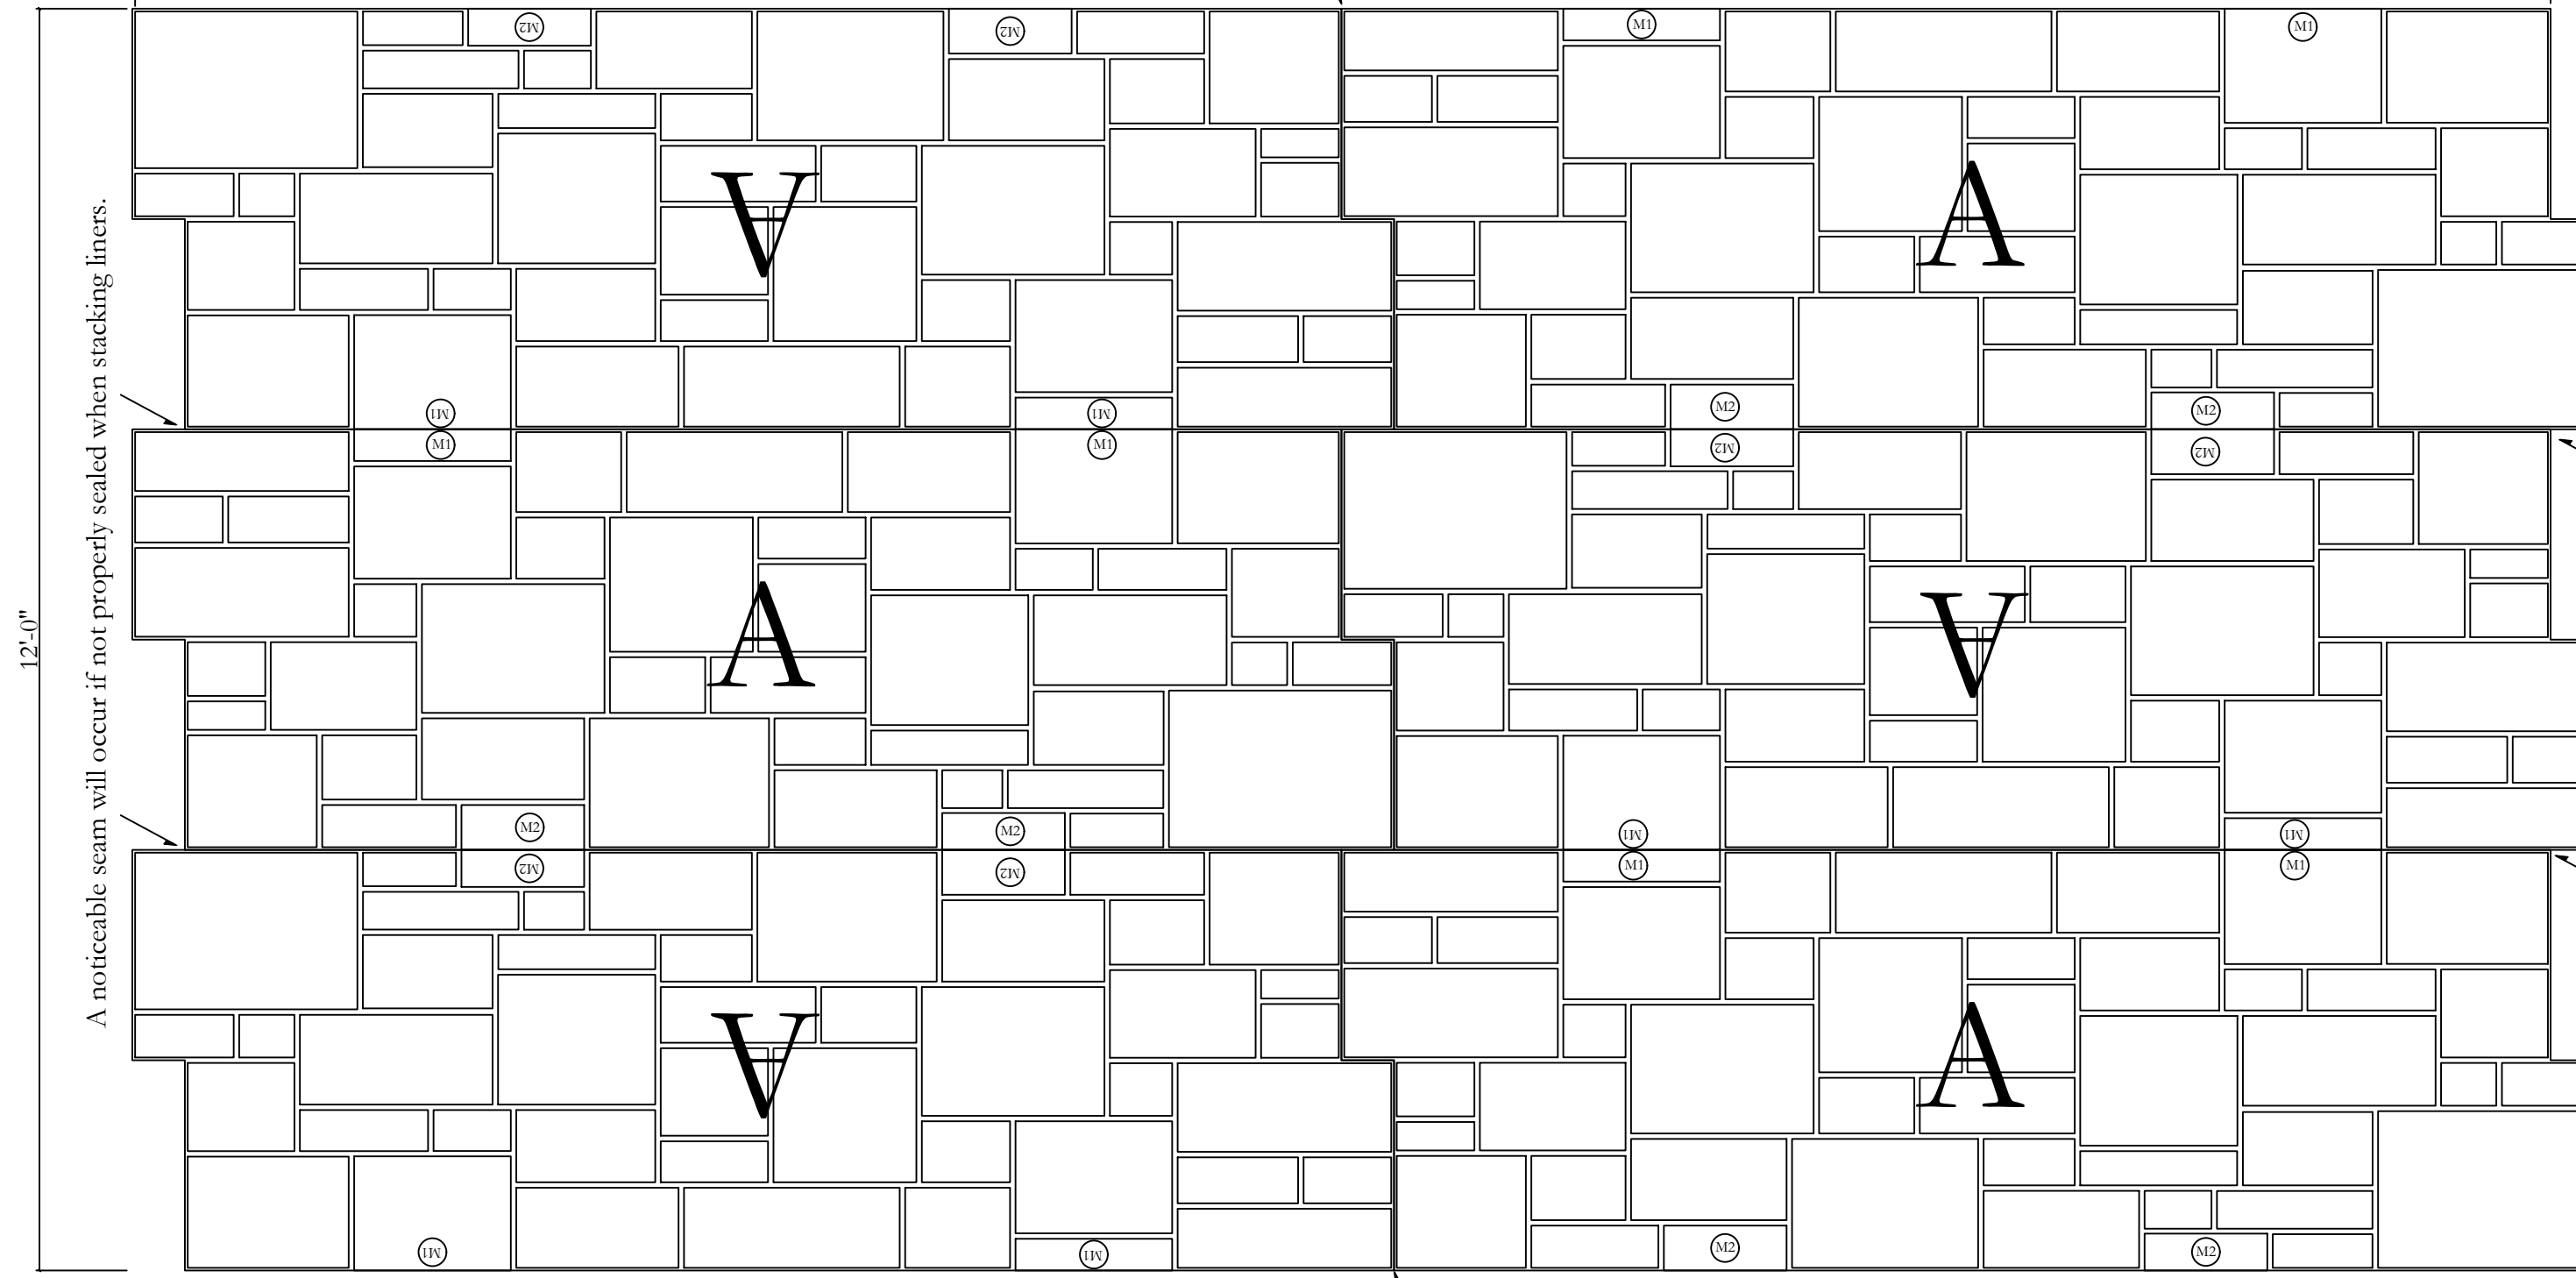
12'-0"
A noticeable seam will occur if not properly sealed when stacking liners.

A noticeable seam will occur if not properly sealed when stacking liners.
